GEOTECHNICAL REPORT

Geotechnical Report for Selkirk Avenue / Pritchard Avenue Alley

Project Name: 2008 City of Winnipeg Alley Renewal Program Client: KGS Group Inc. Site: Alley btwn Selkirk to Pritchard Ave. & Powers to Andrews St. Testhole Location: Centre of alley, in line with the property line of 506/504 Pritchard Street			Date Drilled: February 26, 2008 Depth of Testhole: 2.1 m Logged by: Keith Villiers							
Subsurface Profile			Laboratory Testing							
Depth (m)	Symbol	Description	Water Content (%)				Gravel (%)	Sand (%)	Silt (%)	Clay (%)
			PL	0	25	50

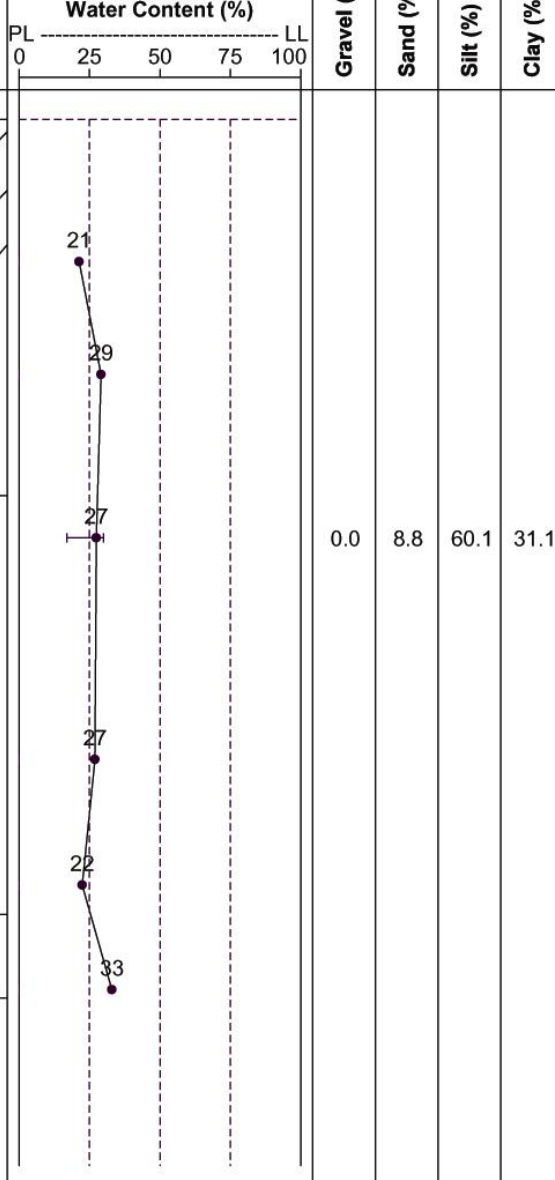
Test Hole Log for TH2

0.0		Ground Surface								
		Asphalt								
		Concrete - poor condition								
		Granular Base - 37.5 mm aggregate size								
0.5		Clay - black to grey, stiff, moist, high plasticity, with gravel - grey below 0.5 m, firm, with silt layers

1.0		Clayey Silt - tan, firm, moist, intermediate plasticity, trace sand, with clay - with clay layers below 1.7 m								
1.5										
2.0		Clay - brown, stiff, moist, high plasticity, with silt layers

2.5		<ul style="list-style-type: none"> • Testhole terminated at 2.1 m. • Frost present to a depth of 1.4 m. • No water seepage or soil sloughing were observed during or after the completion of drilling.

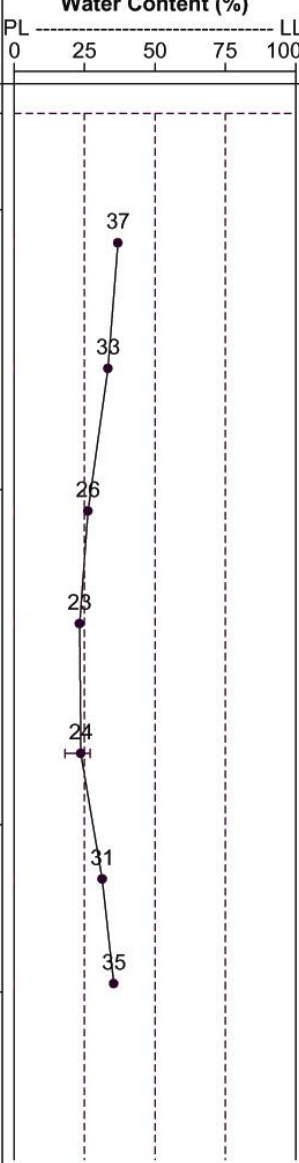
Test Hole Log for TH2

0.0		Ground Surface								
0.0 - 0.3

Concrete								
0.3 - 1.0

Clay - black, soft to firm, moist, high plasticity, some silt, trace sand, some wood debris

Clayey Silt - tan, firm, moist, low plasticity, some clay								
1.8 - 2.1

Clay - brown, stiff, moist, high plasticity								
2.1 - 2.5		<ul style="list-style-type: none"> • Testhole terminated at 2.1 m. • Frost present to a depth of 1.4 m. • No water seepage or soil sloughing were observed during or after the completion of drilling.
