GEOTECHNICAL INVESTIGATION MEMORANDUM

PROJECT NO: 15-0107-011

RE: Fort Rouge Outfall Chamber Upgrades
Geotechnical Site Investigation

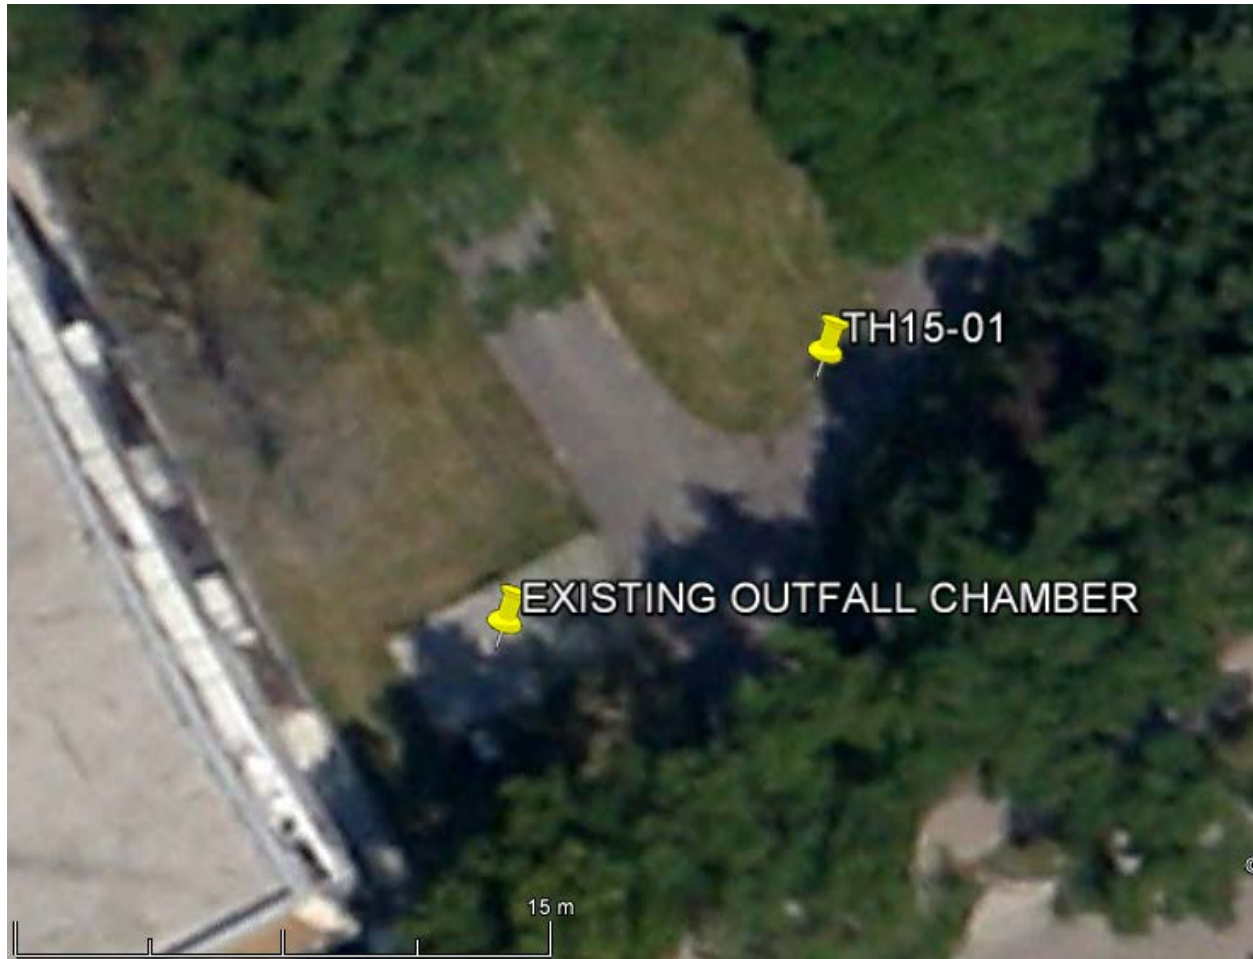
FIGURE 01: TEST HOLE LOCATION

On August 18, 2015 KGS Group completed a geotechnical investigation near the existing outfall chamber. The drilling program consisted of one (1) test hole advanced using solid stem augers into the underlying till using a Mobile B37X track mounted rig. Drilling services were provided by Maple Leaf Drilling Ltd. with continuous KGS Group supervision. The approximate location of the test hole is shown on Figure 01.

One (1) test hole was drilled into till northeast of the outfall chamber on the east side of the sidewalk. Upon completion of the drilling the sidewalls squeezed in the lower silt till at a depth of 12.8 m below existing grade. Groundwater infiltration from the silt till was noted in the test hole while drilling. The water level in the test hole was 7.9 m below existing grade at the completion of drilling.
