Cornish Library Renovation

Demolition Plans

A-101

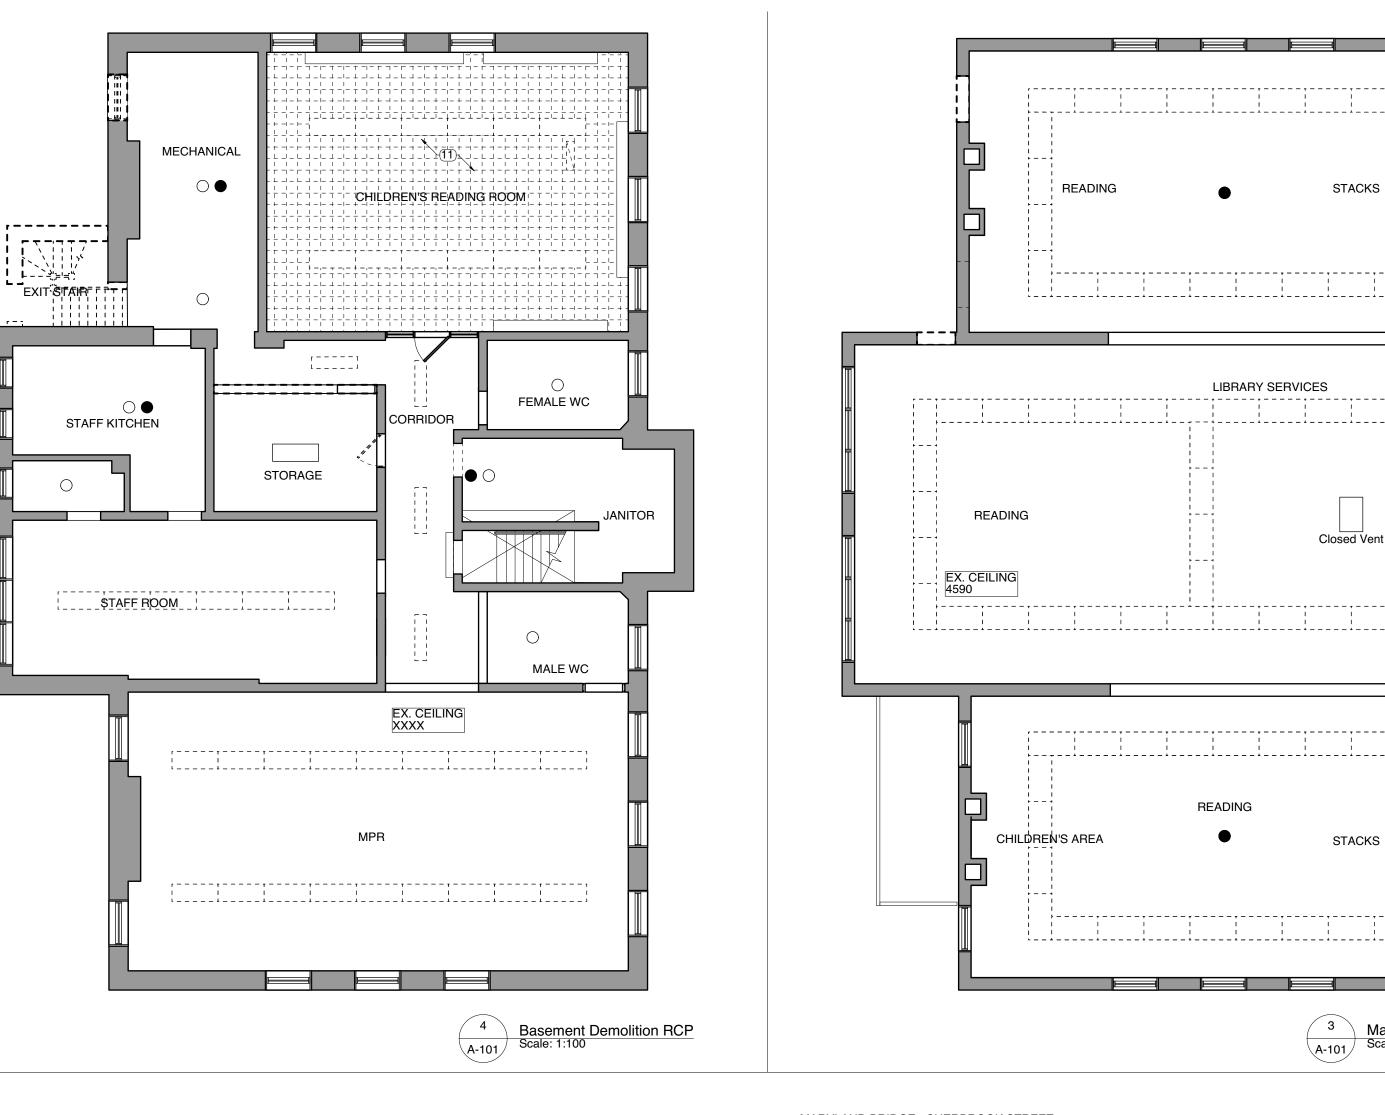
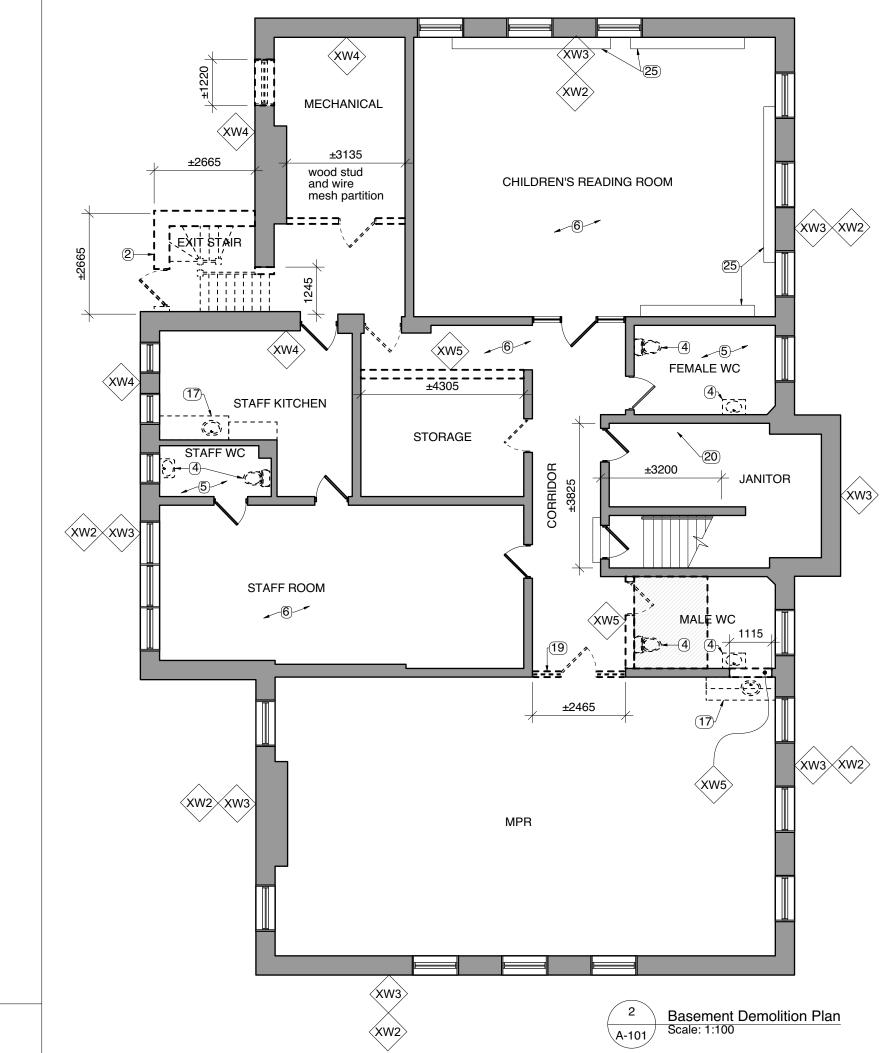
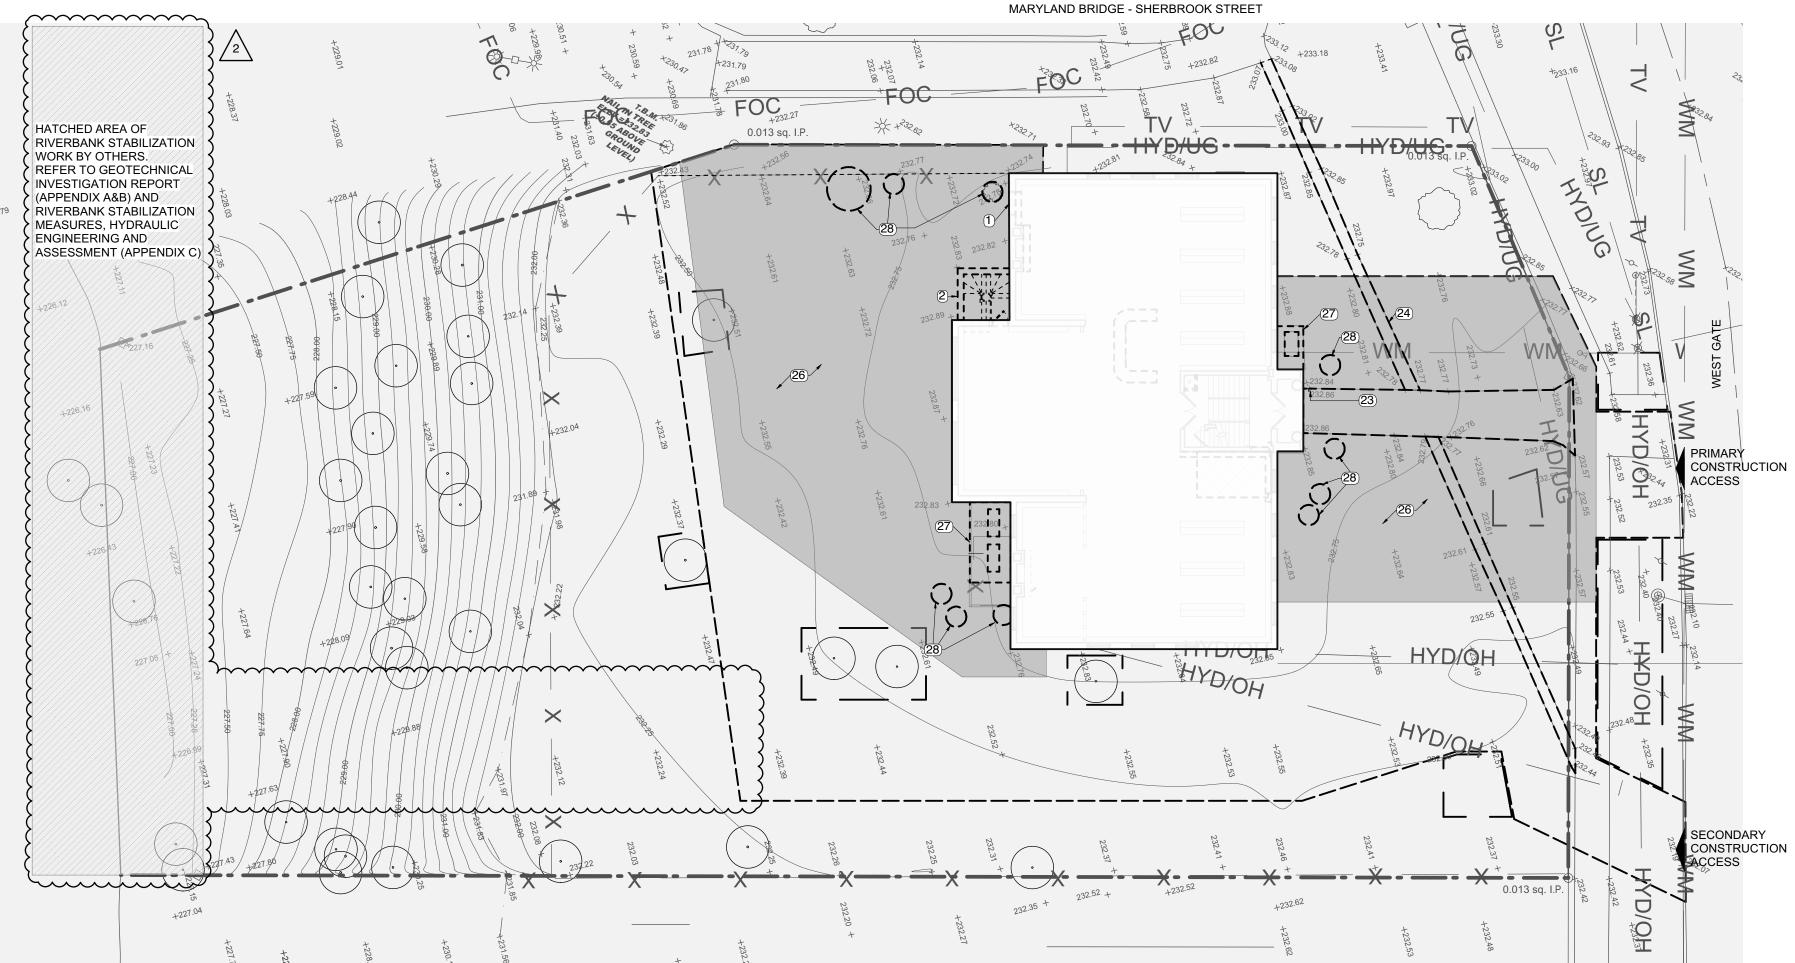
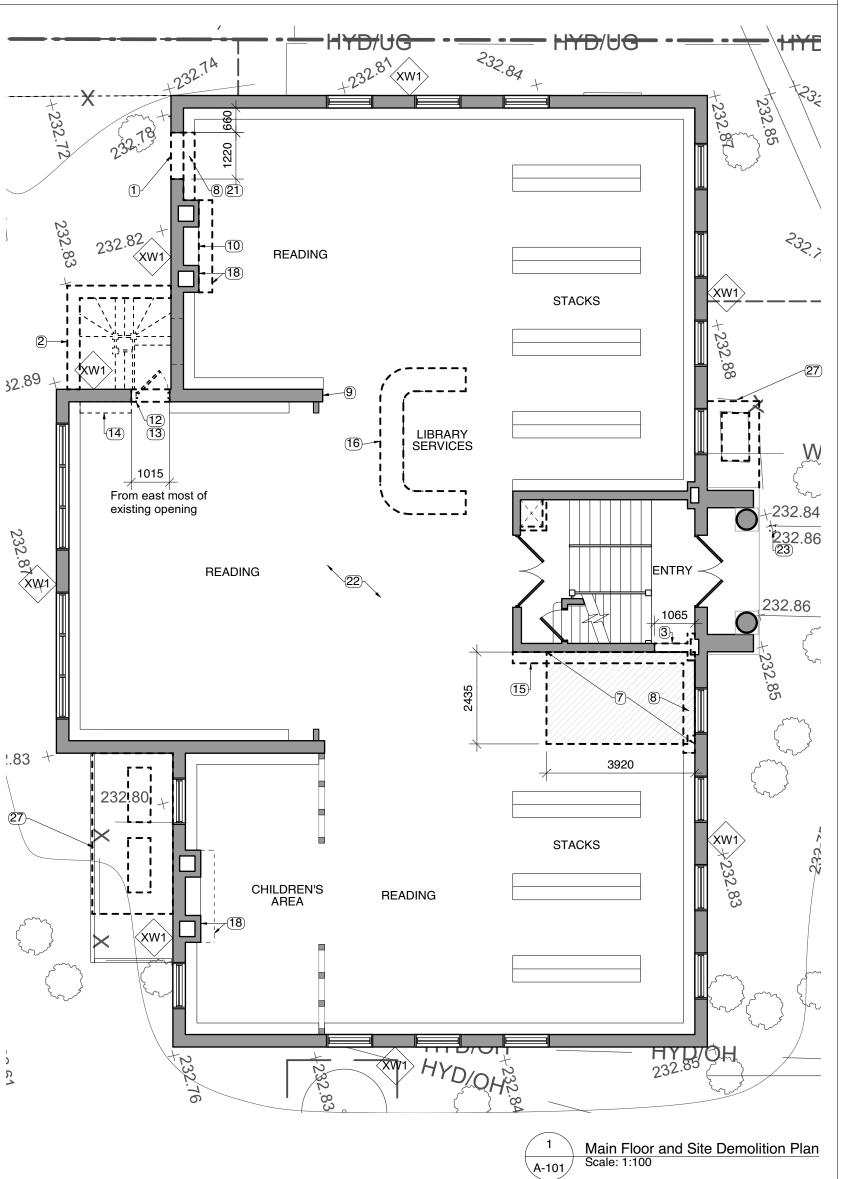
- 1. Existing window to be removed and salvaged. Wall below window to be demolished to top of structural floor.
- 2.) Existing exit stair structure to be demolished. Salvage wood railings for reuse elsewhere in this project.

- 3.) Existing wall to be demolished to extend entry landing for lift access. Refer to elevations for extents.
- 4. Existing plumbing fixture to be demolished. Coordinate with Mechanical.

- 5. Existing ceramic tile floor and base to be removed.
- 6. Existing vinyl tile to be removed. 7. Extent of existing floor structure to be demolished to accomodate

- 8. Existing radiator to be removed. Coordinate with Mechanical. Existing water fountain to be relocated. Coordinate with
- Mechanical. (10.) Existing gas fireplace and associated lines to be removed. Coordinate with Mechanical.

- Existing ACT, including fixtures, to be demolished. Coordinate removals of fixtures, devices, ductwork, etc. with Mechanical and
- 12. Existing opening to be widened. Existing door, trim and hardware to be removed and turned over to Owner.

- 13. Existing exit sign, fire alarm pull station, and exit alarm to be
- removed. Coordinate with Electrical.
- (14.) Existing bookshelves to be modified to suit new opening. (15.) Existing bookshelves to be removed.

- (16.) Existing circulation desk to be demolished. Coordinate removal of wiring with Electrical.
- 17. Existing upper and lower cabinets to be demolished including kitchen style sink and associated plumbing. Coordinate with

- 18. Existing tile to be removed from floor and face of fireplace.
- (19.) Existing wood door, frame and original wood trim to be removed and salvaged for reinstallation in this project.

- (20.) Existing janitor's sink to be removed. Relocate associated plumbing lines. Coordinate with Mechanical.
- 21.) Existing section of shelving above rad to be removed and salvaged. 22. Existing carpet and underlying vinyl tile to be removed. Refer to

- Demolition Notes for areas with asbestos containing materials. 23.) Existing door actuator and pedestal to be removed. Maintain wiring
- to be connected to new actuator in similar location. Coordinate with

- 24.) Existing concrete patio blocks to be removed back to City sidewalk,
- 25.) Existing bookshelves to be removed and reinstalled to suit other
- 26. Site removals within shaded area to suit L-102 Grading and Layout 27. Demolish mechanical equipment and surrounding fence enclosure.
