Exist 1998 Glulam Beam Repairs  
 Scale: 3/4" = 1'-0"

# SK-18

Gulam Beam Repairs  
 St Vital Arena  
 580 St. Annes Road  
 Winnipeg, MB R2M 3G4

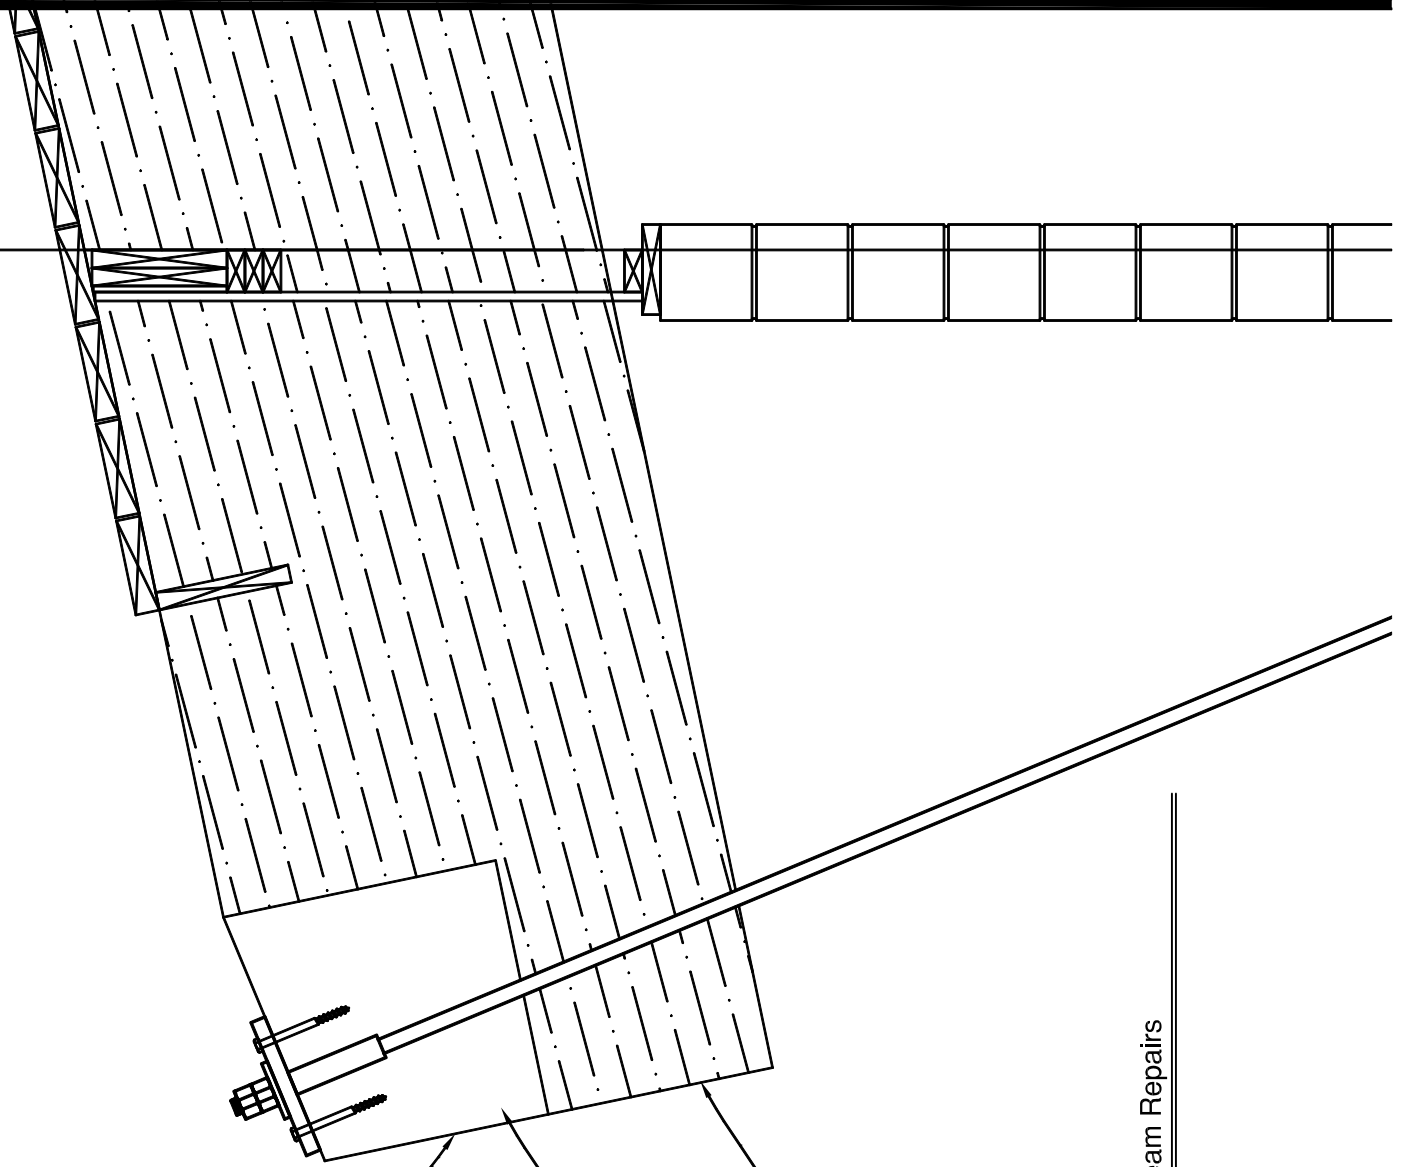
exist glulam beam repairs  
 (assumed during the 1998 repairs)  
 (new wood section for entire 11" width of beam)  
 (not typical of all beam ends)

original 1969  
 glulam beam

1998 repair to be replaced  
 (see SK-19)
