ARENA ROOF FRAMING

**SK-2**

Gulam Beam Repairs  
 St Vital Arena  
 580 St. Annes Road  
 Winnipeg, MB R2M 3G4

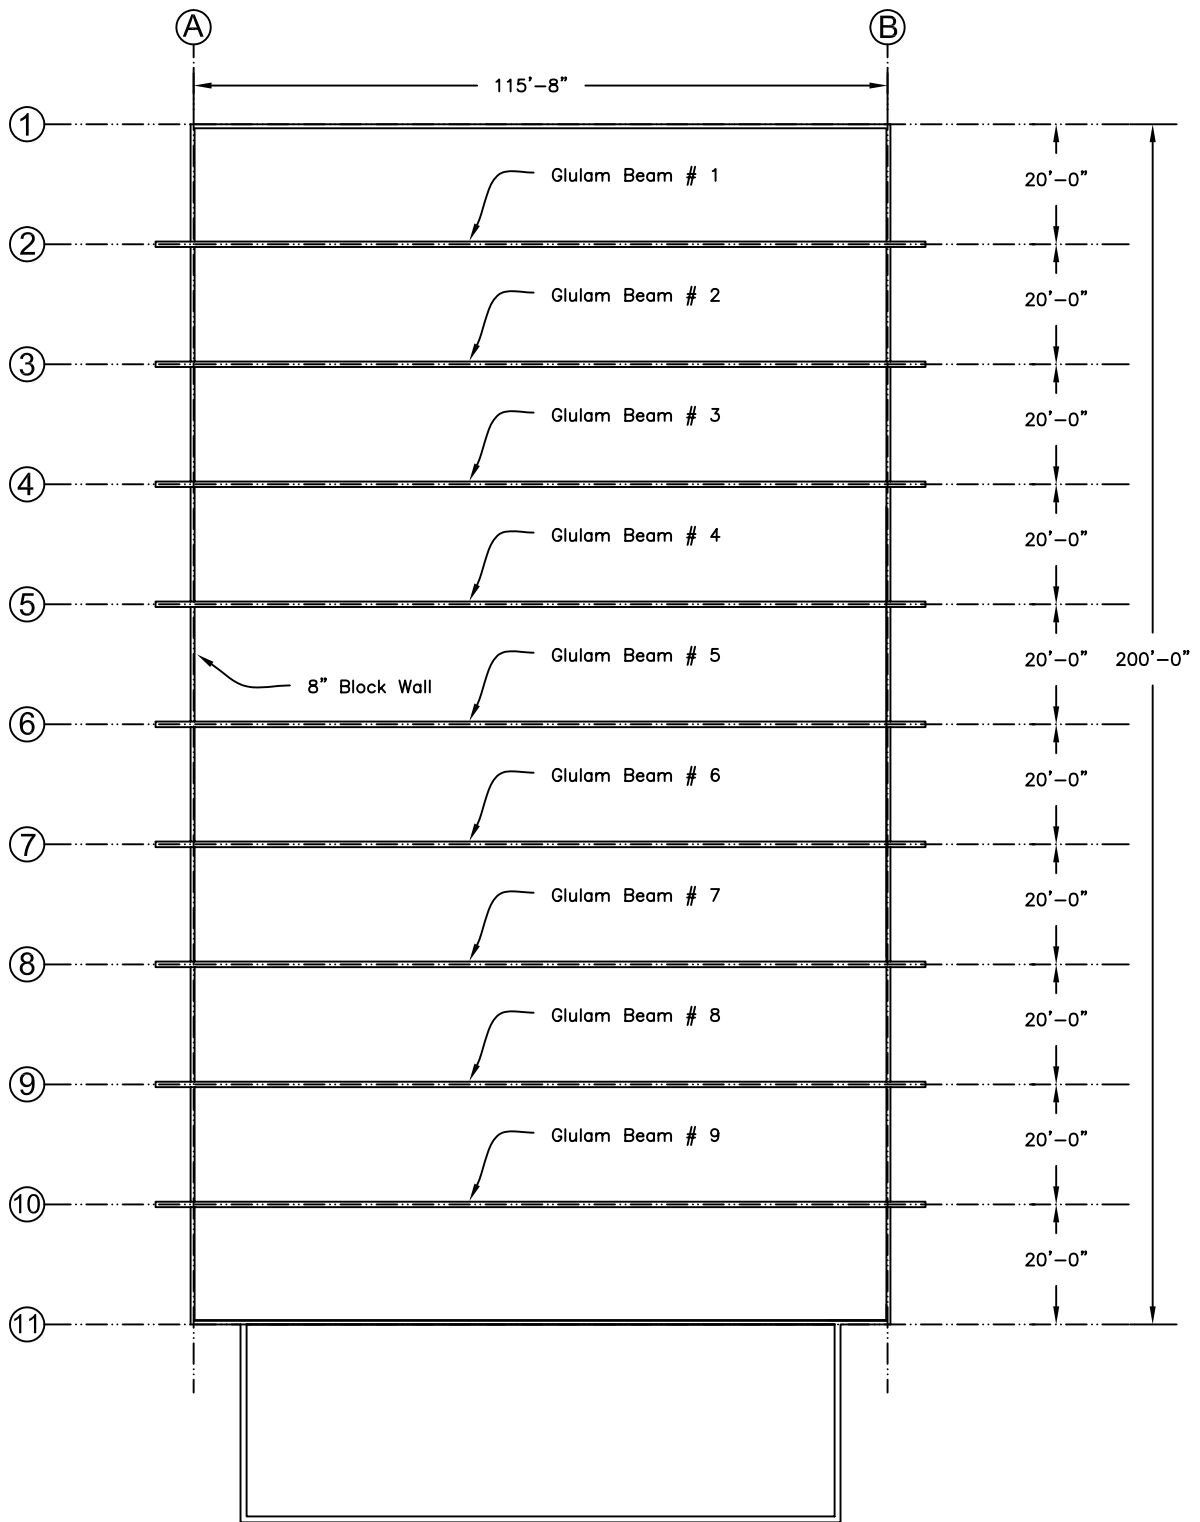
Scale: 1/32" = 1'-0"

GLULAM BEAM REPAIRS  
 FROM GL "2" to GL "10"  
 AT END BEARING CONDITIONS  
 (ALONG GL "A" & GL "B")  
 (18 GLULAM END REPAIRS)
