THE CITY OF WINNIPEG WATER AND WASTE DEPARTMENT

SHEET 18 OF 25

2007 SEWER RENEWALS AND REPAIRS
CONTRACT 16

WALLASEY STREET
MH AT LODGE AVENUE TO
1ST MH S OF LODGE AVENUE

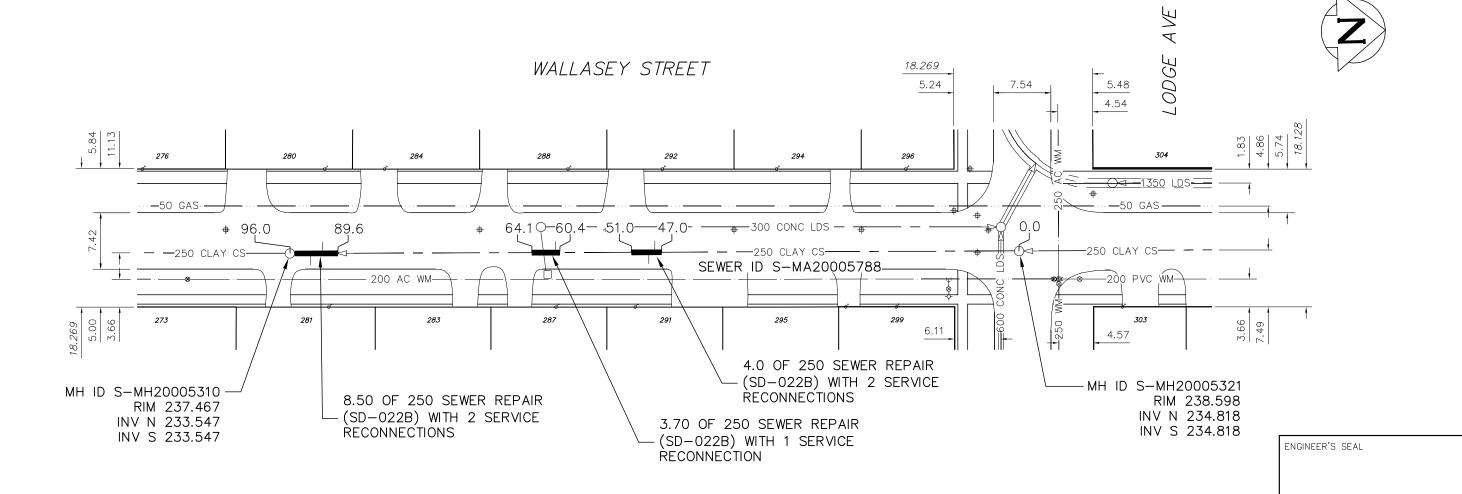
SEWER JUNCTION INFORMATION FROM SEWER VIDEO INSPECTION S-MA20005788					
	DISTA	ANCE FROM	MH S-MH2	20005321	
47.9	S	150ø	WEST	CXI	
48.7	S	150ø	EAST	CXI	
61.0	S	150ø	WEST	CXI	
91.6	S	150ø	WEST	CX	
93.2	S	150ø	EAST	CX	
				·
