2017 BRIDGE MAINTENANCE - MIDTOWN BRIDGE & ST. VITAL BRIDGE REPAIRS

MIDTOWN BARRIER REPAIR LAYOUT 2

CITY DRAWING NUMBER: B114-17-04
SHEET: 04 OF 17
CONSULTANT DRAWING NUMBER: --

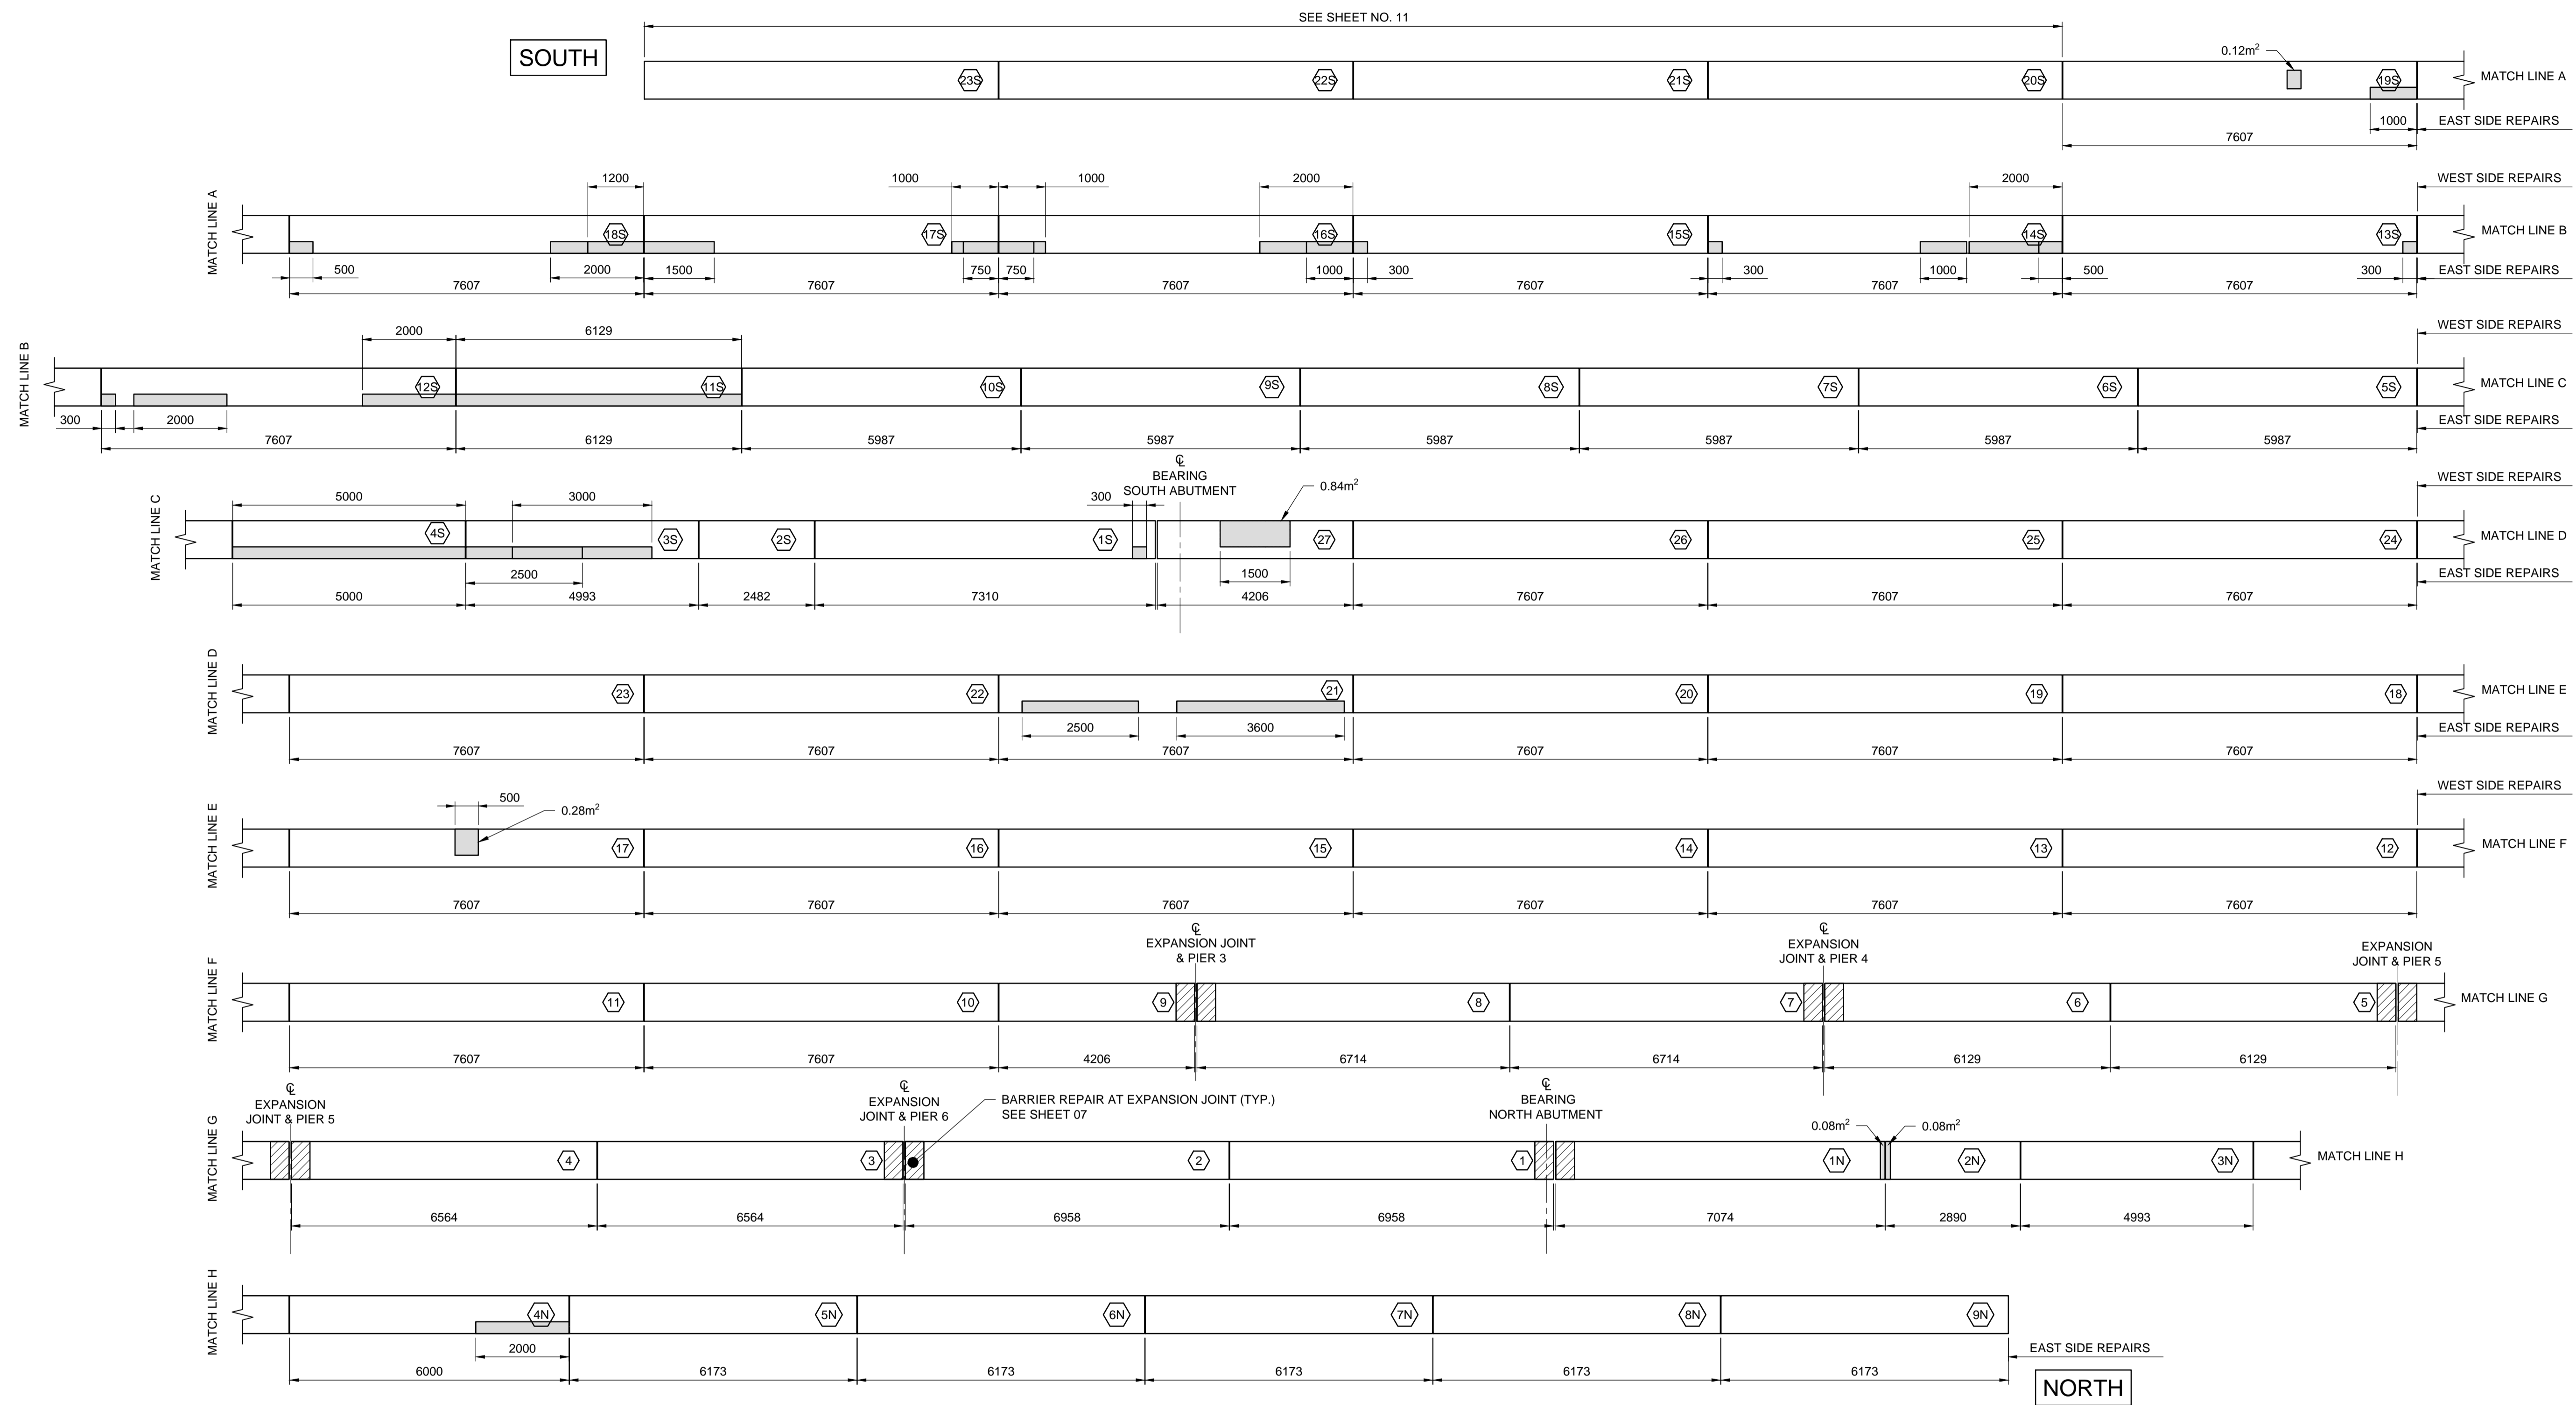
MEDIAN BARRIER ELEVATION
1:75
LOOKING WEST

- NOTES:**
- DIMENSIONS SHOWN OF EXISTING BARRIERS ARE APPROXIMATE.
 - DIMENSIONS SHOWN OF REPAIR AREAS ARE APPROXIMATE. LAYOUT ACTUAL REPAIR AREAS WITH CONTRACT ADMINISTRATOR IN FIELD.
 - SEE SPECIFICATION FOR REPAIR PREPARATION & CONCRETE REPLACEMENT DETAILS.
 - REPLACE ALL BARRIER JOINT SEALS WITH EMSEAL BE-JS-ON-A-REEL
