2017 BRIDGE MAINTENANCE - MIDTOWN BRIDGE & ST. VITAL BRIDGE REPAIRS

ST. VITAL BARRIER REPAIR LAYOUT 2

CITY DRAWING NUMBER B116-17-04
SHEET 15 OF 17
CONSULTANT DRAWING NUMBER --

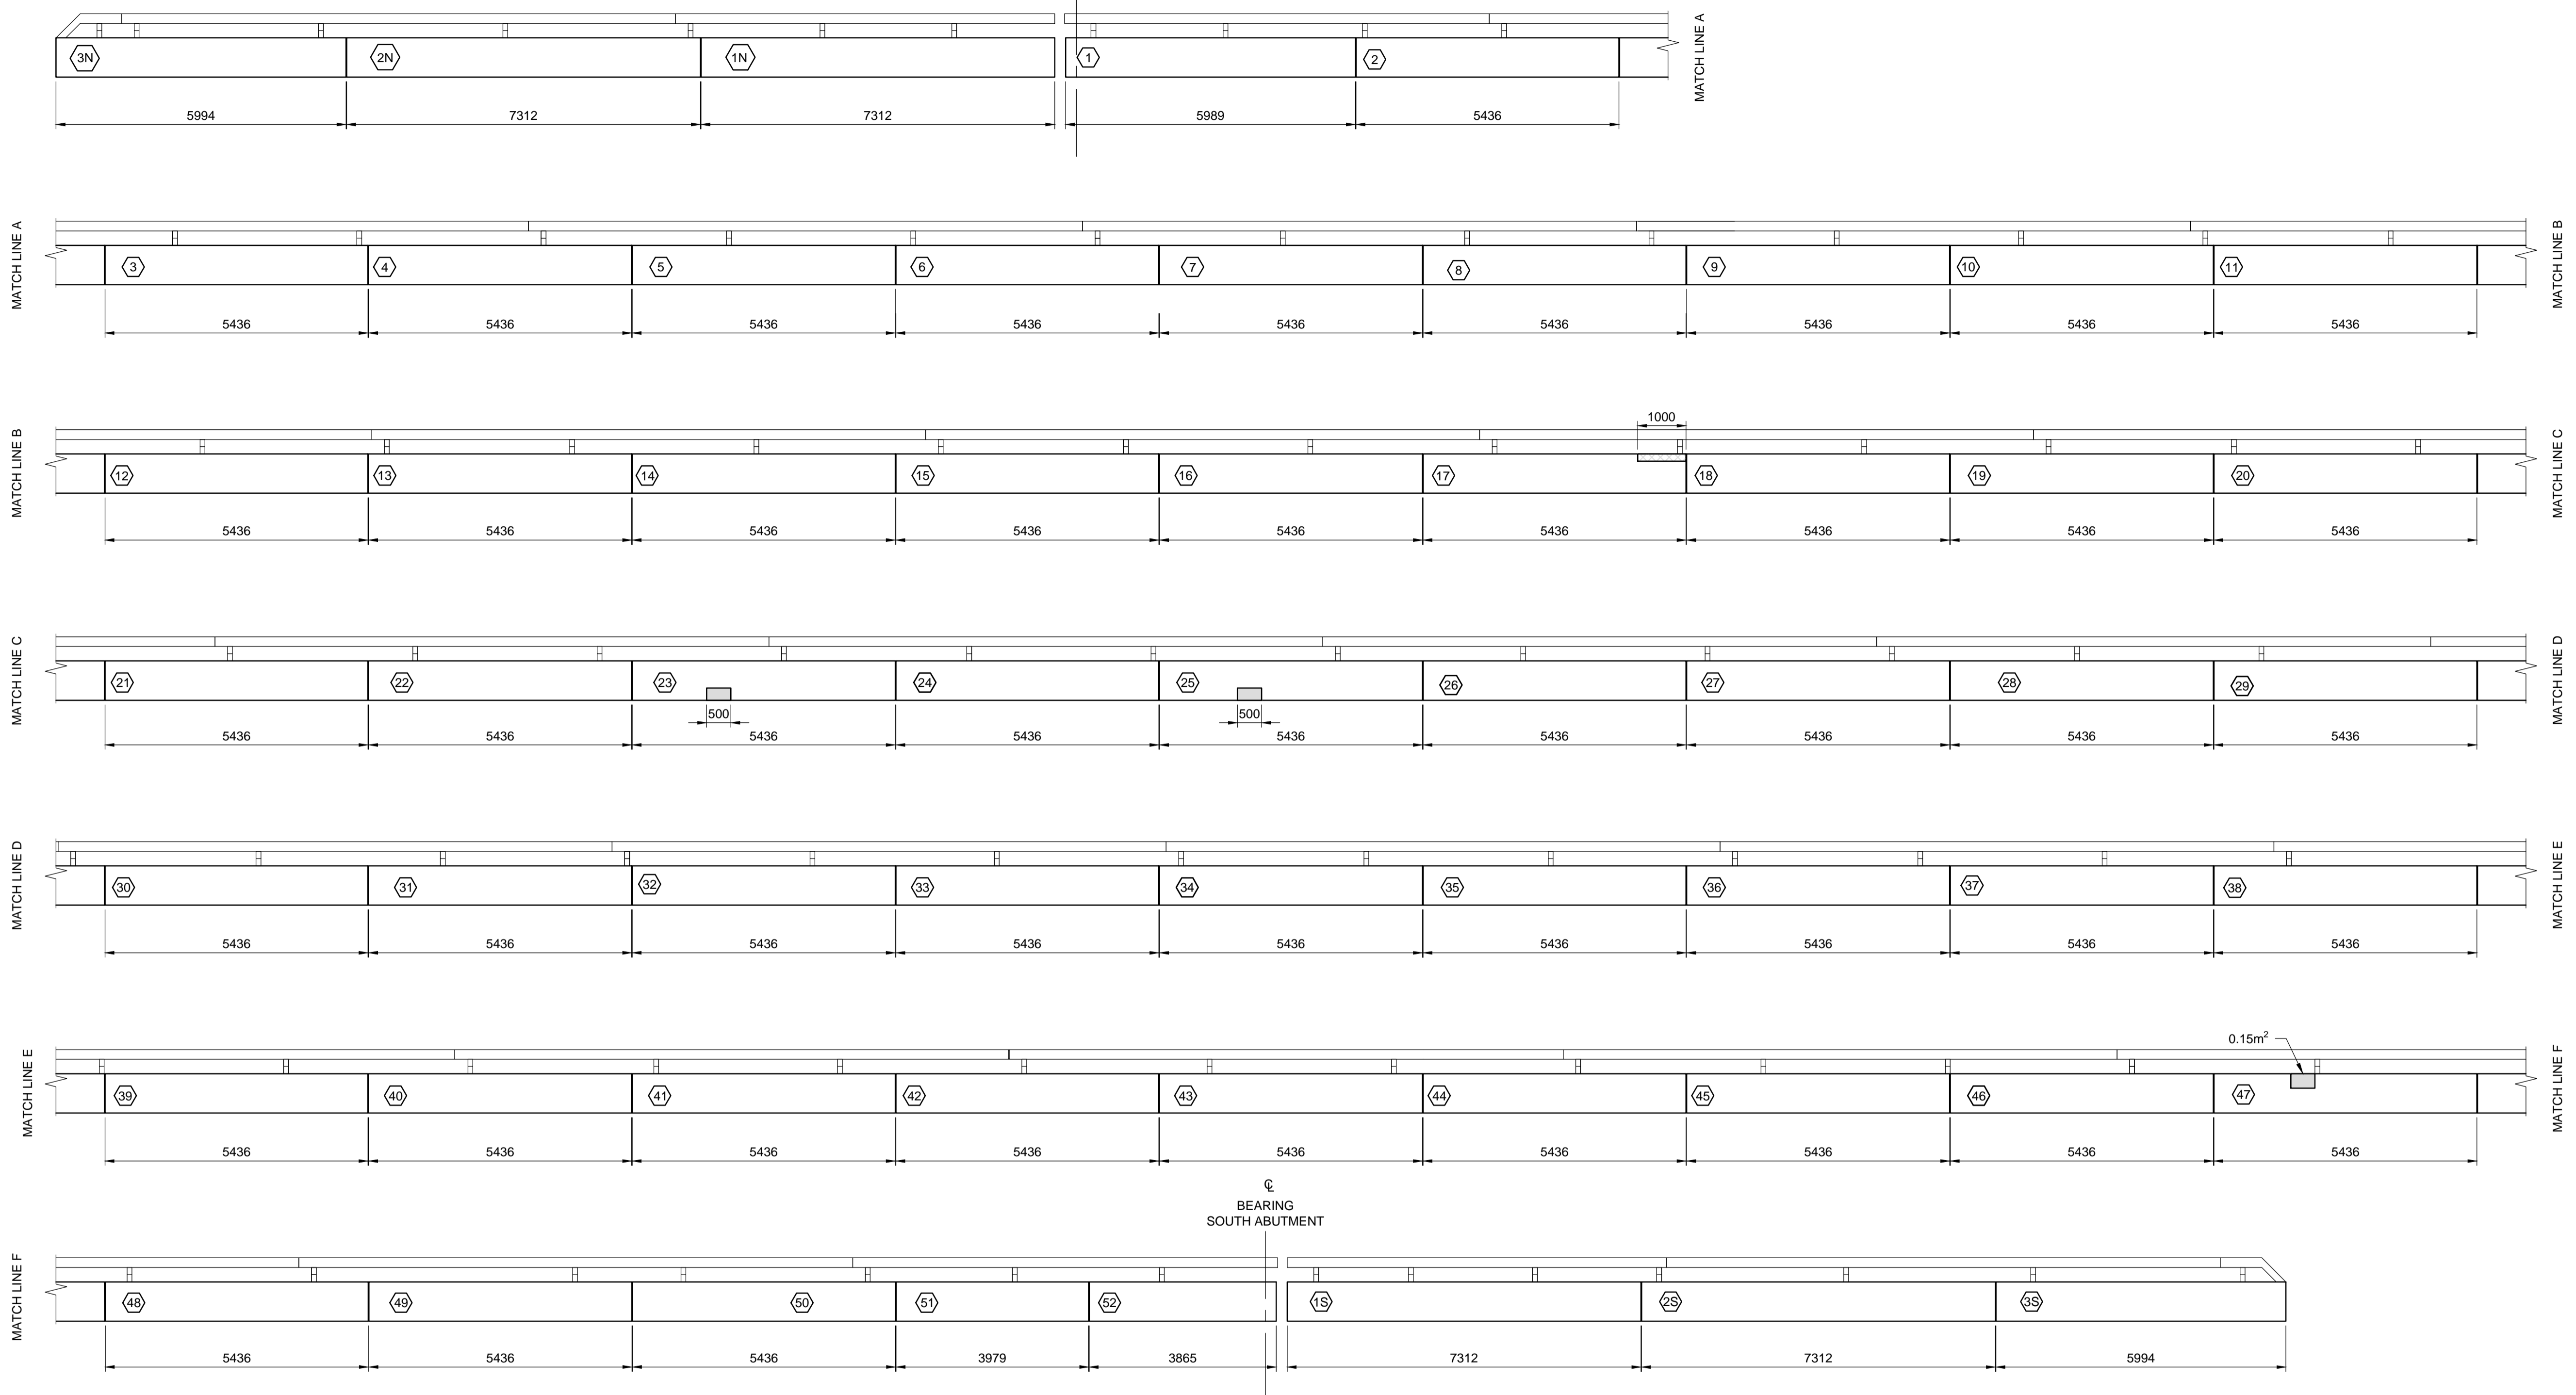
NORTH BOUND CURB LANE BARRIER ELEVATION

1:75
LOOKING EAST

TYPE 1 CONCRETE BARRIER REPAIR
-

TYPE 2 CONCRETE BARRIER REPAIR
-

- 1.0 m
- 0.41 m²
