FINAL GEOTECHNICAL REPORT

CITY OF WINNIPEG STREET INVESTIGATION PROGRAM
MCPHILLIPS STREET, SALTER STREET AND SELKIRK
AVENUE
WINNIPEG, MANITOBA

STANTEC
PROJECT WX19714
JANUARY 2023

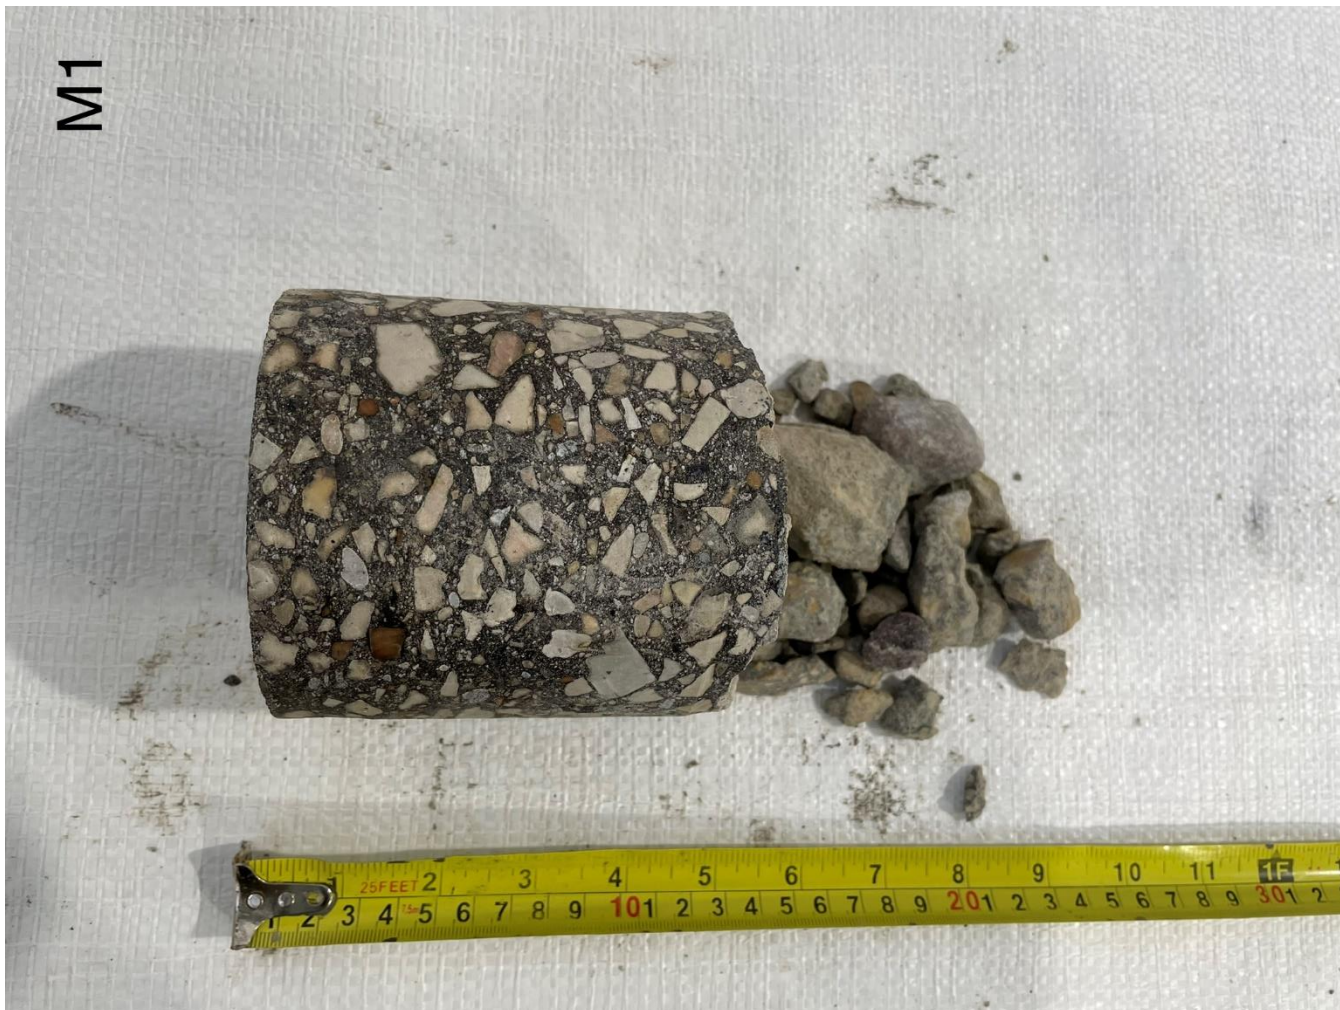
Core Photographs Pavement Core Sample – McPhillips, Winnipeg, MB		Hole ID: M01
			Page: 1 of 6

Asphalt: 105mm	Concrete: 95mm	Core Date: 25 Oct. 2022
	Project #: WX19714		Logger: AJ

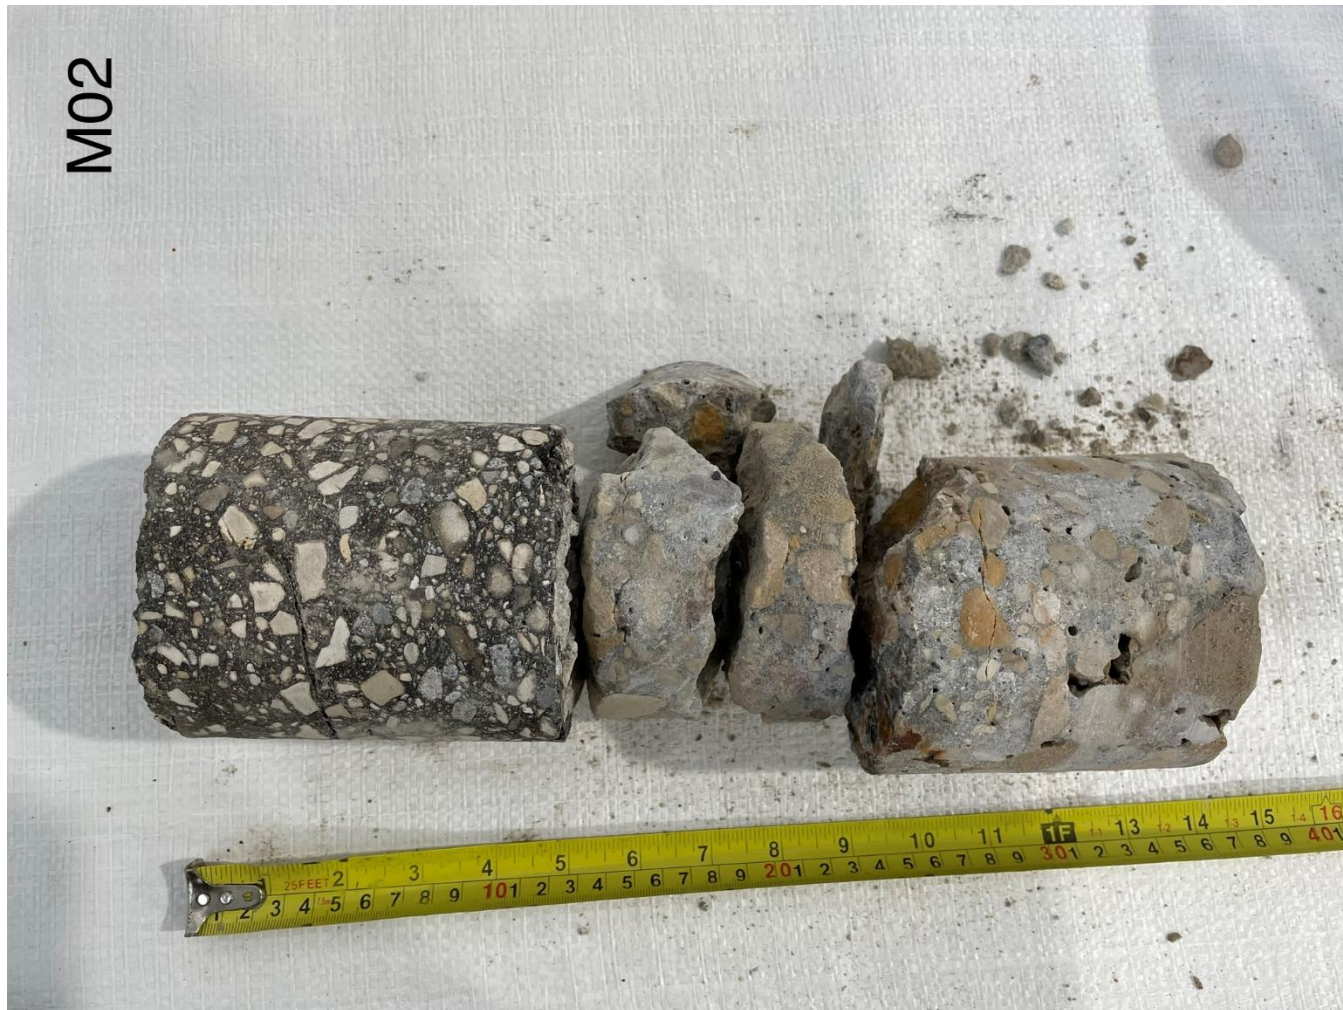
M02

Asphalt: 105mm	Concrete: 240mm	Core Date: 25 Oct. 2022
	Project #: WX19714		Logger: AJ

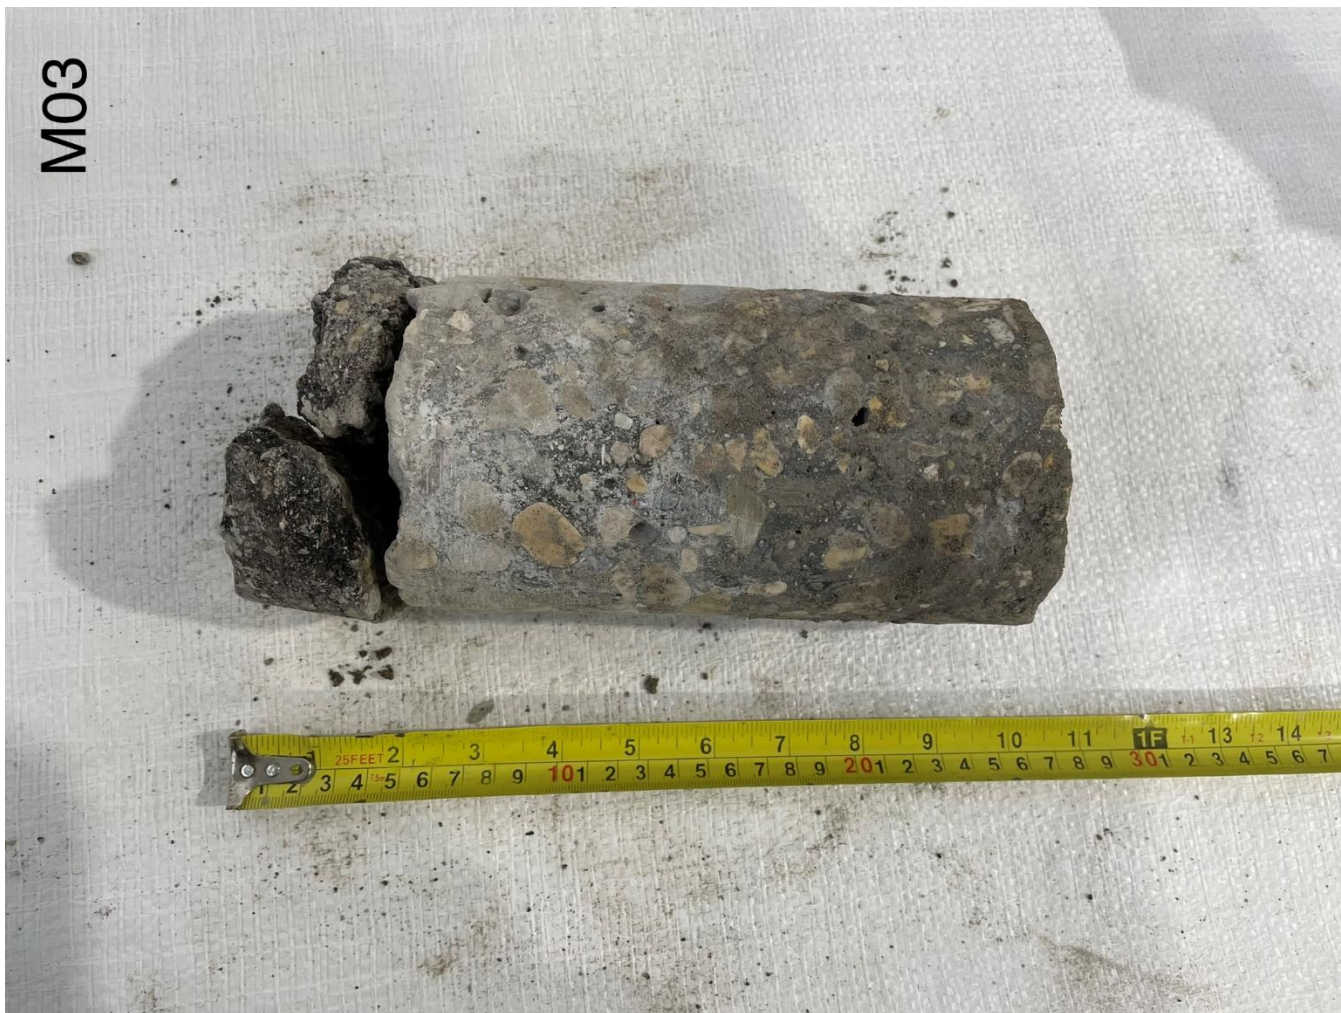
Core Photographs Pavement Core Sample – McPhillips, Winnipeg, MB		Hole ID: M03
			Page: 3 of 6

Asphalt: 190mm	Concrete: 60mm (rubble – no recovery)	Core Date: 25 Oct. 2022
	Project #: WX19714		Logger: AJ

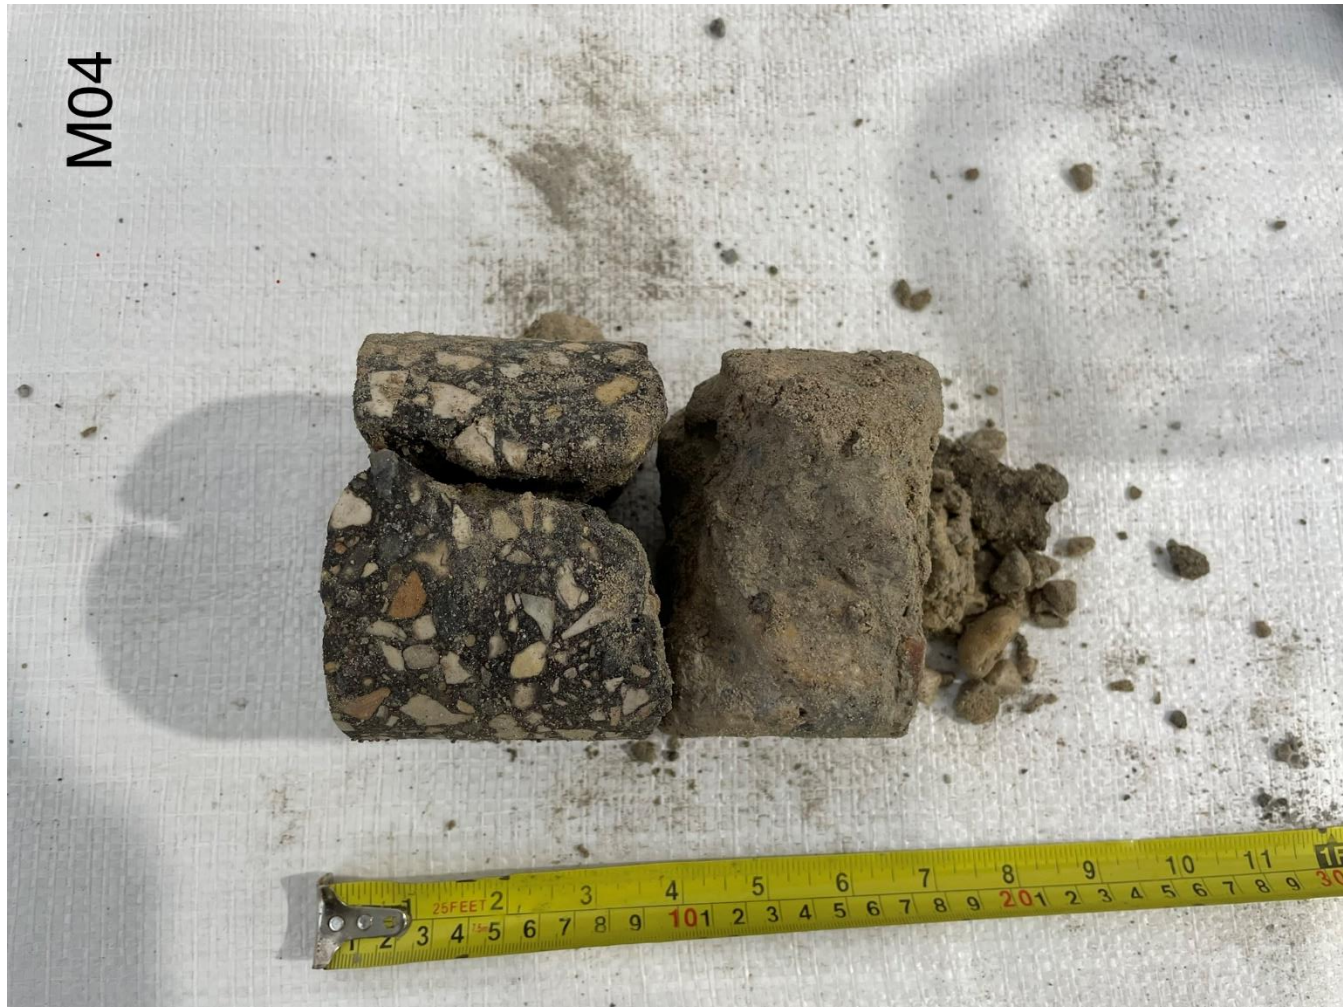
Core Photographs Pavement Core Sample – McPhillips, Winnipeg, MB		Hole ID: M04
			Page: 4 of 6

Asphalt: 75mm	Concrete: 200mm (Partial rubble)	Core Date: 25 Oct. 2022
	Project #: WX19714		Logger: AJ

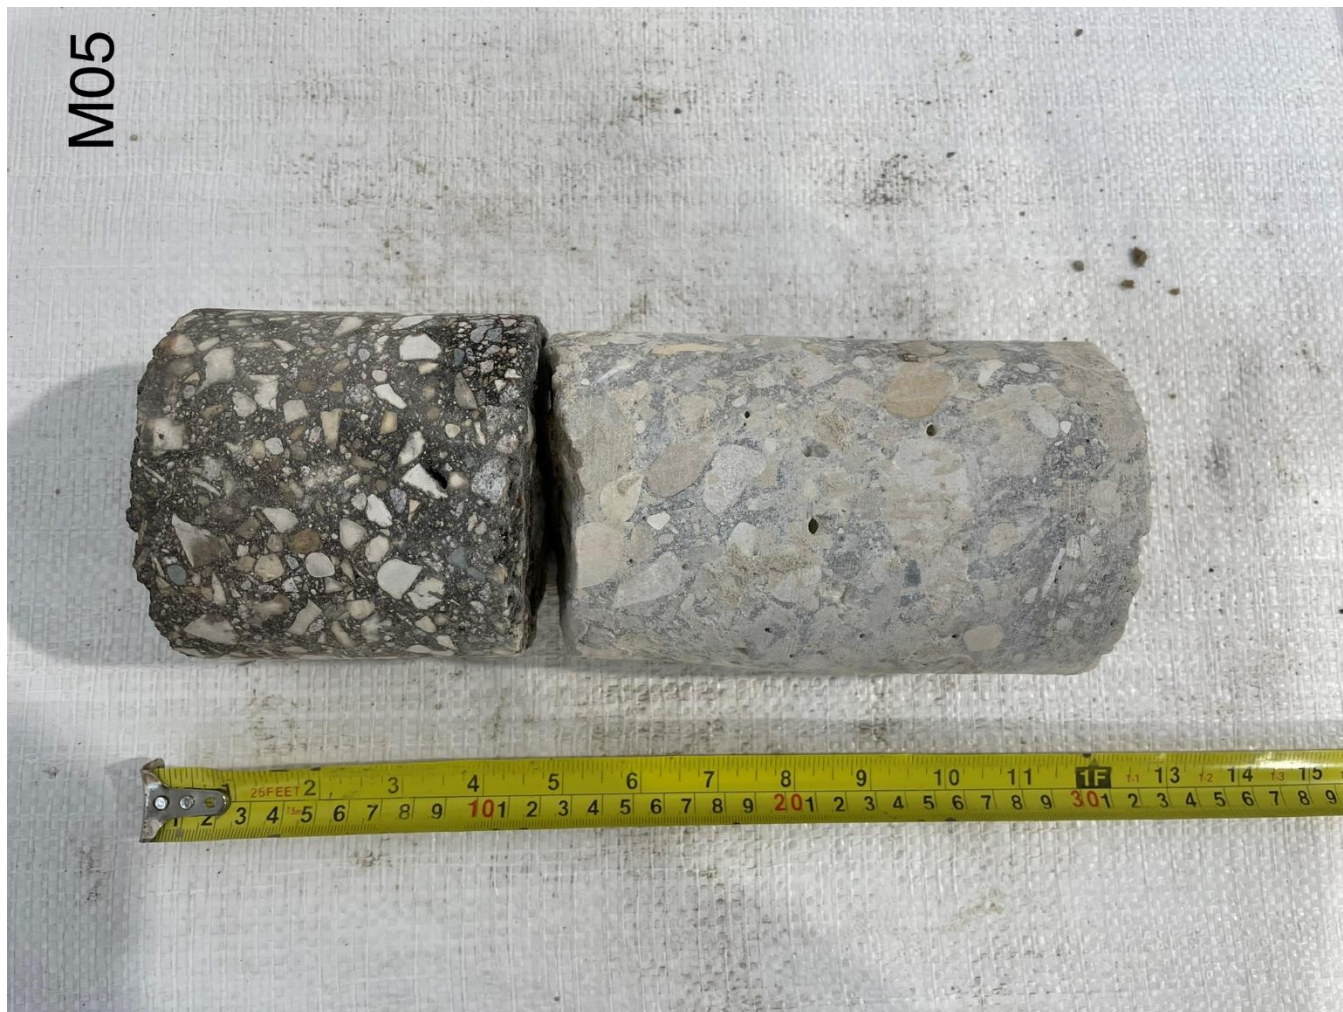
Core Photographs Pavement Core Sample – McPhillips, Winnipeg, MB		Hole ID: M05
			Page: 5 of 6

Asphalt: 100mm	Concrete: 165mm	Core Date: 25 Oct. 2022
	Project #: WX19714		Logger: AJ

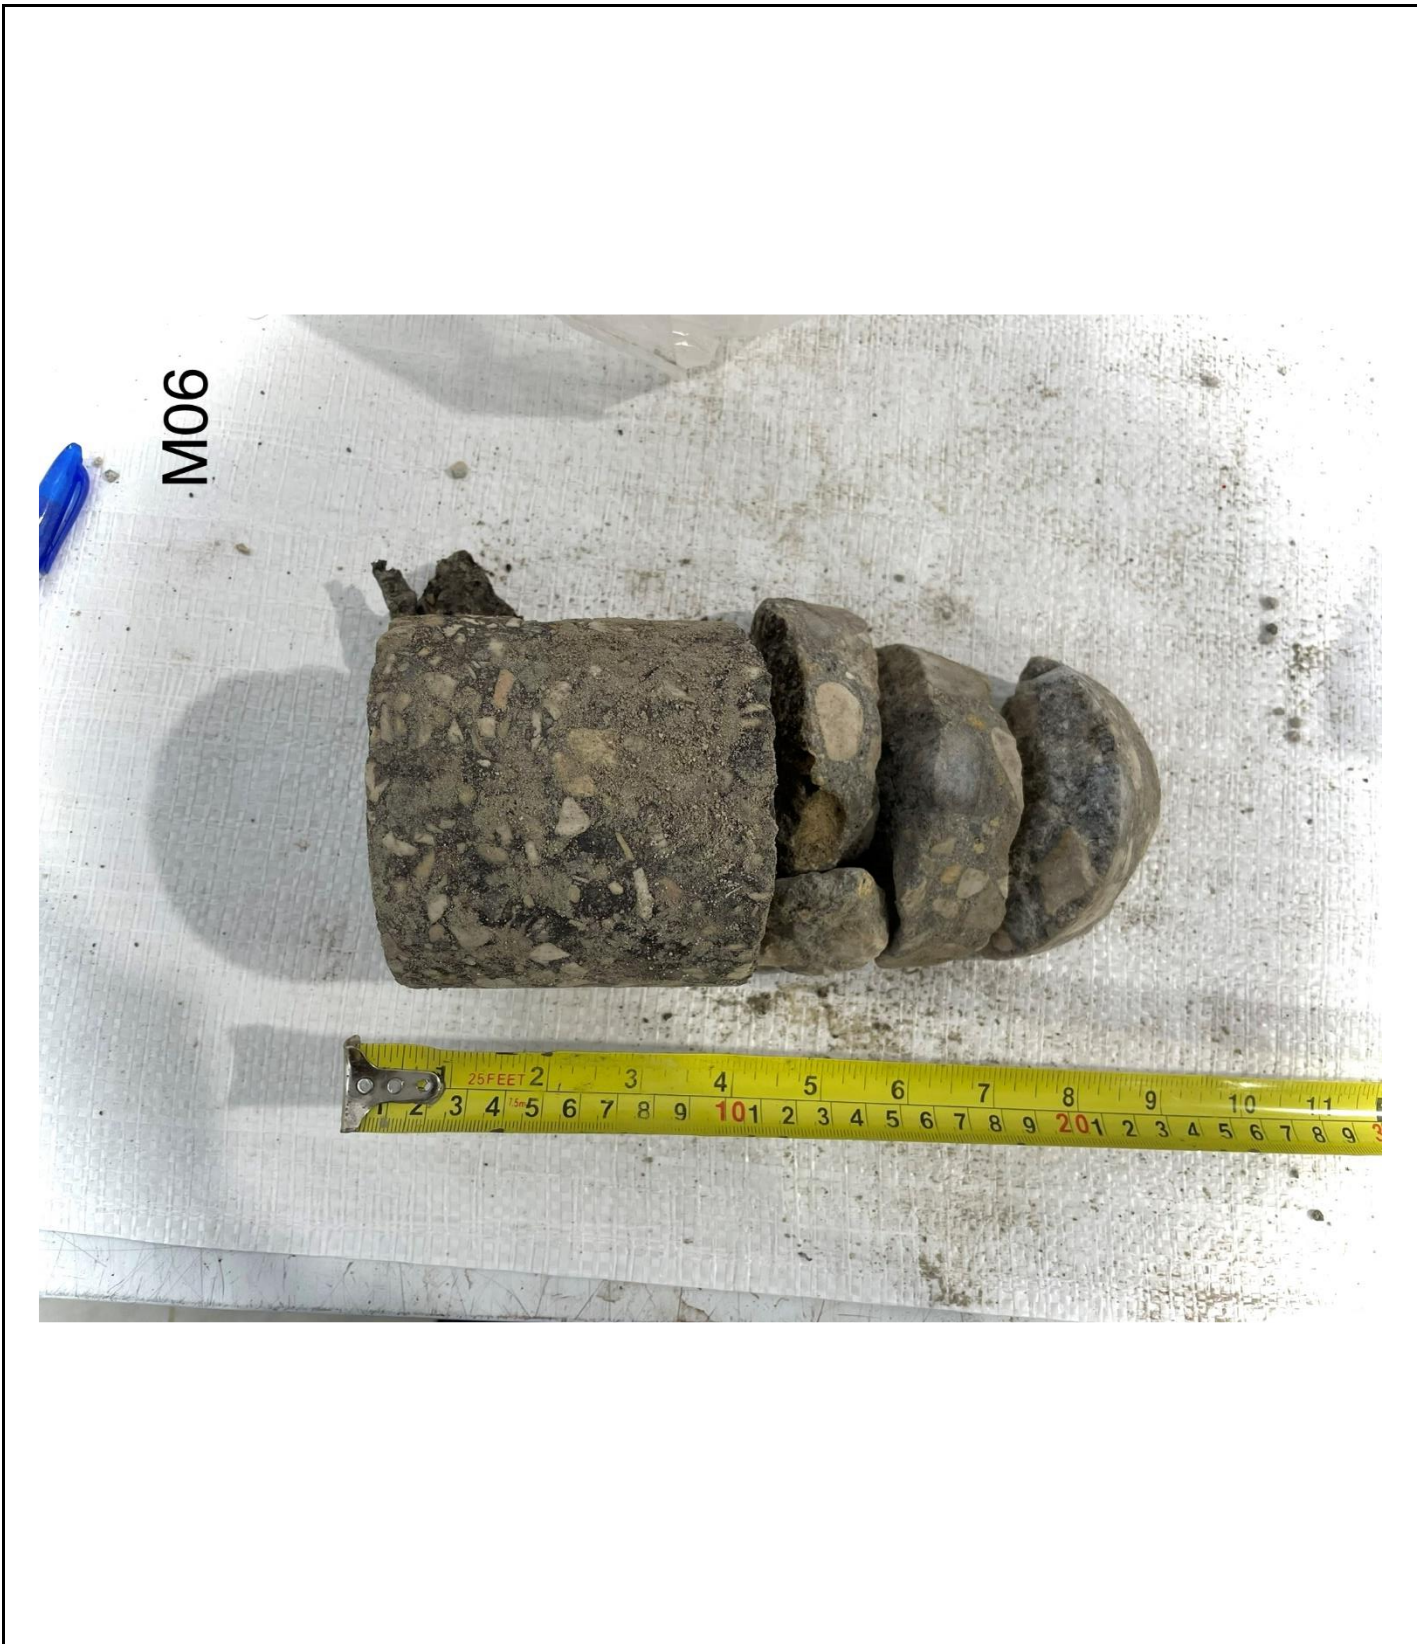
Core Photographs Pavement Core Sample – McPhillips, Winnipeg, MB		Hole ID: M06
			Page: 6 of 6

Asphalt: 100mm	Concrete: 225mm (rubble below 100mm)	Core Date: 25 Oct 2022
	Project #: WX19714		Logger: AJ

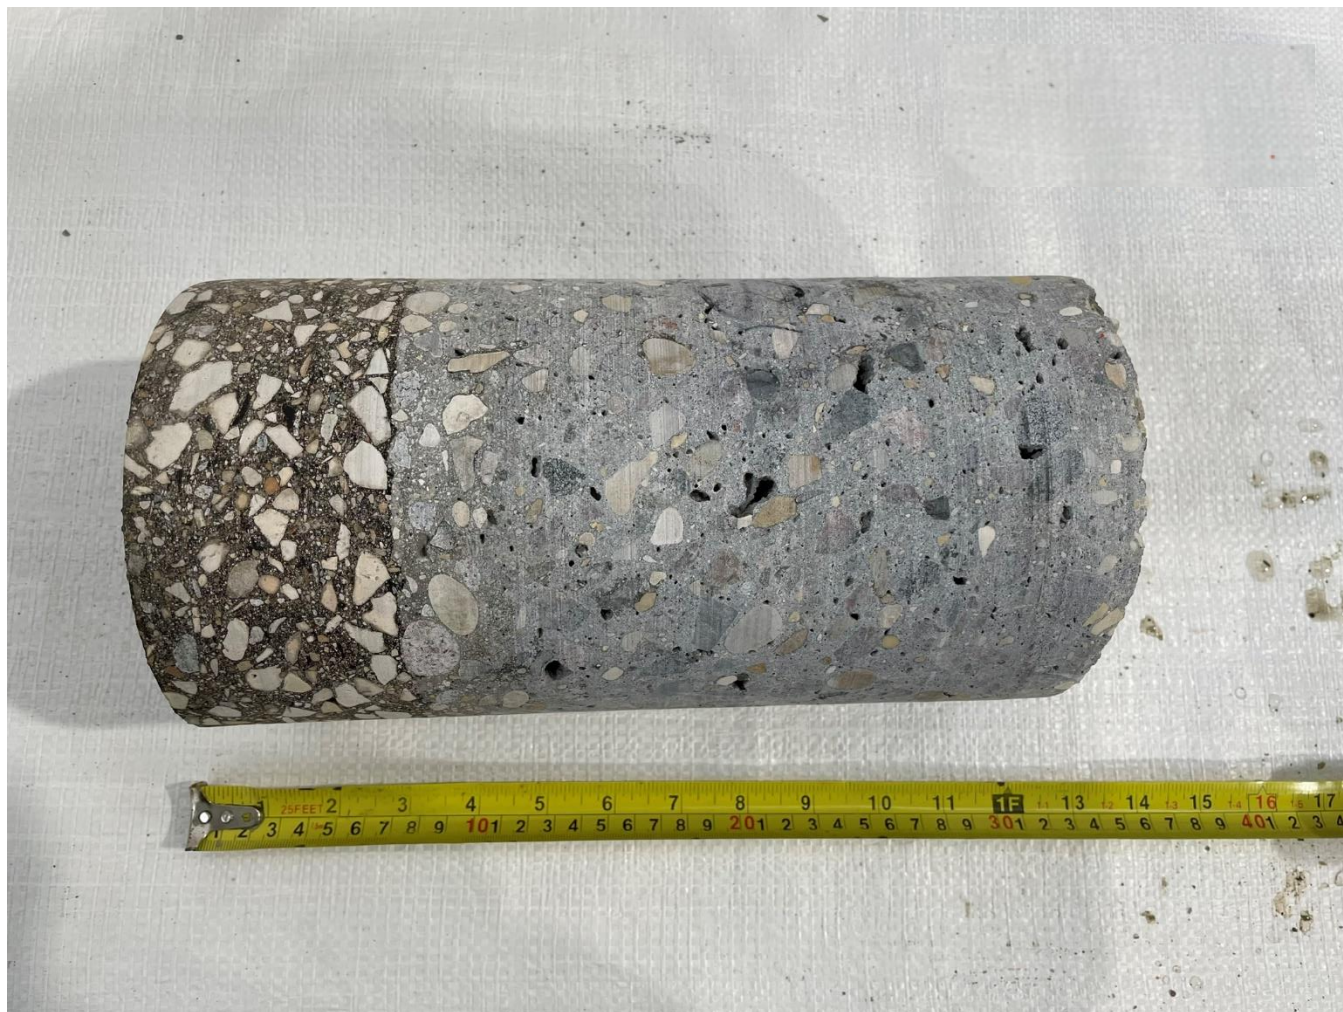
Core Photographs Pavement Core Sample – Salter, Winnipeg, MB		Hole ID: SA01
			Page: 1 of 9

Asphalt:75mm	Concrete:300mm	Core Date: 7 Nov. 2022
	Project #: WX19714		Logger: AJ

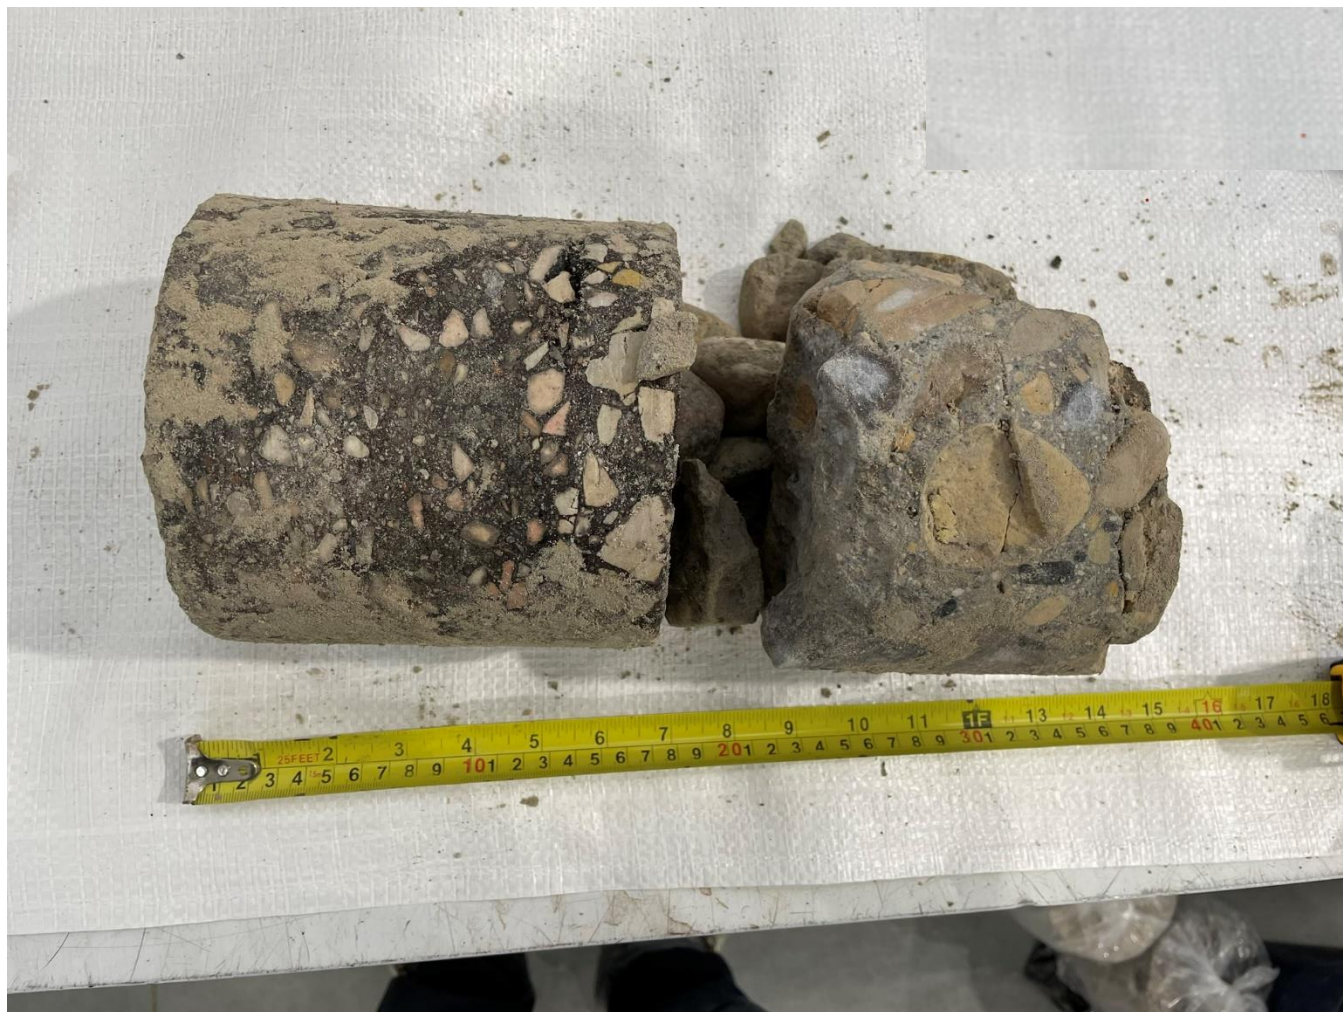
Core Photographs Pavement Core Sample – Salter, Winnipeg, MB		Hole ID: SA02
			Page: 2 of 9

Asphalt: 150mm	Concrete: 175mm	Core Date: 7 Nov. 2022
	Project #: WX19714		Logger: AJ

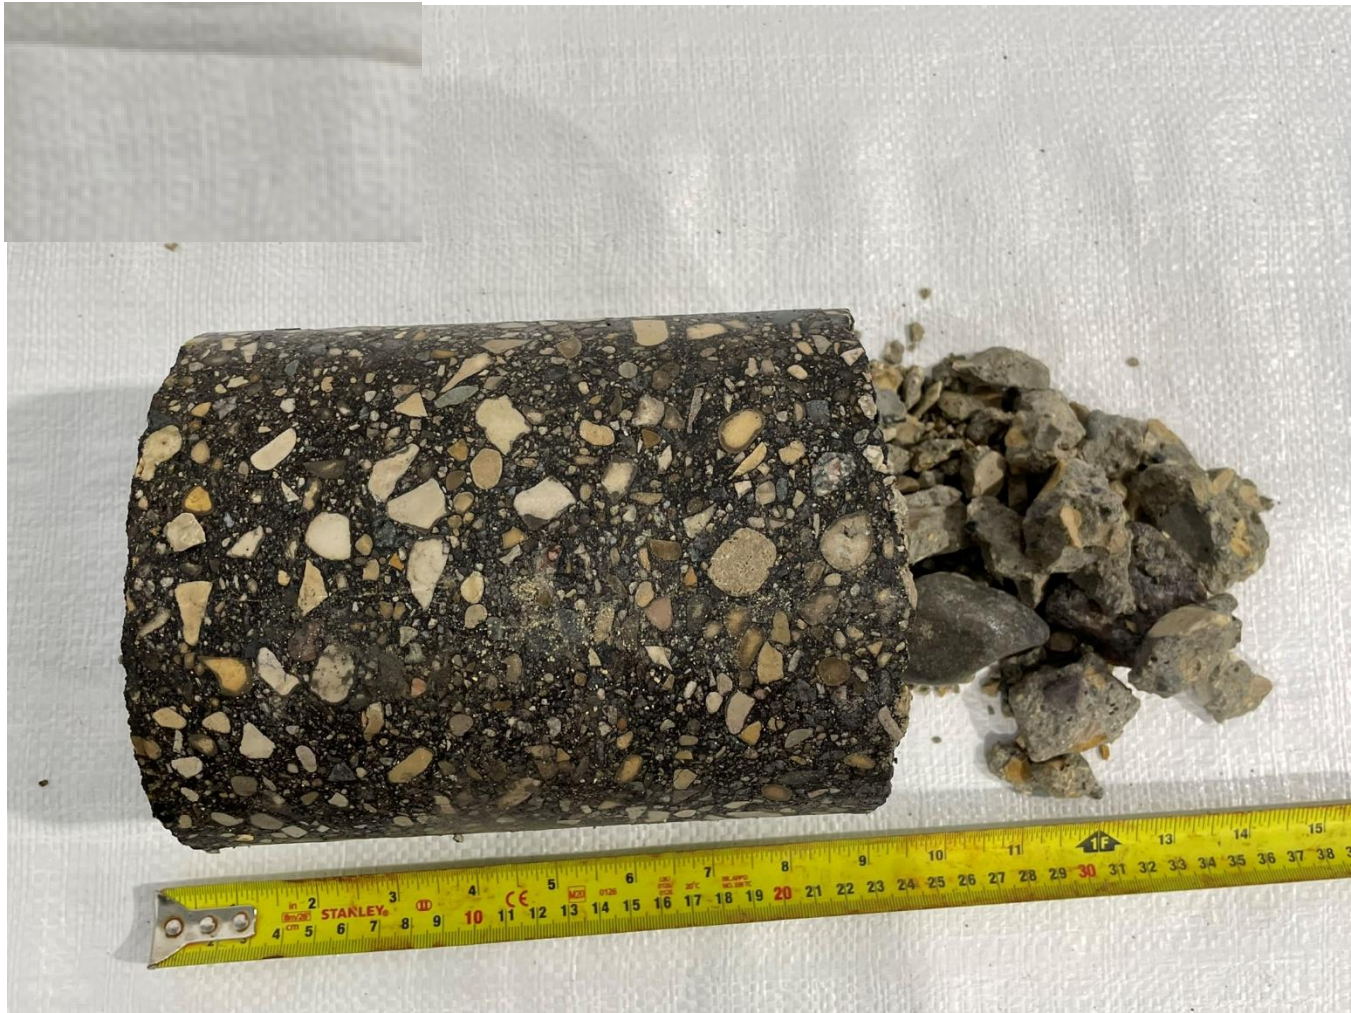
Core Photographs Pavement Core Sample – Salter, Winnipeg, MB		Hole ID: SA04
			Page: 4 of 9

Asphalt: 175mm	Concrete: 25mm (rubble)	Core Date: 28 Nov. 2022
	Project #: WX19714		Logger: AJ

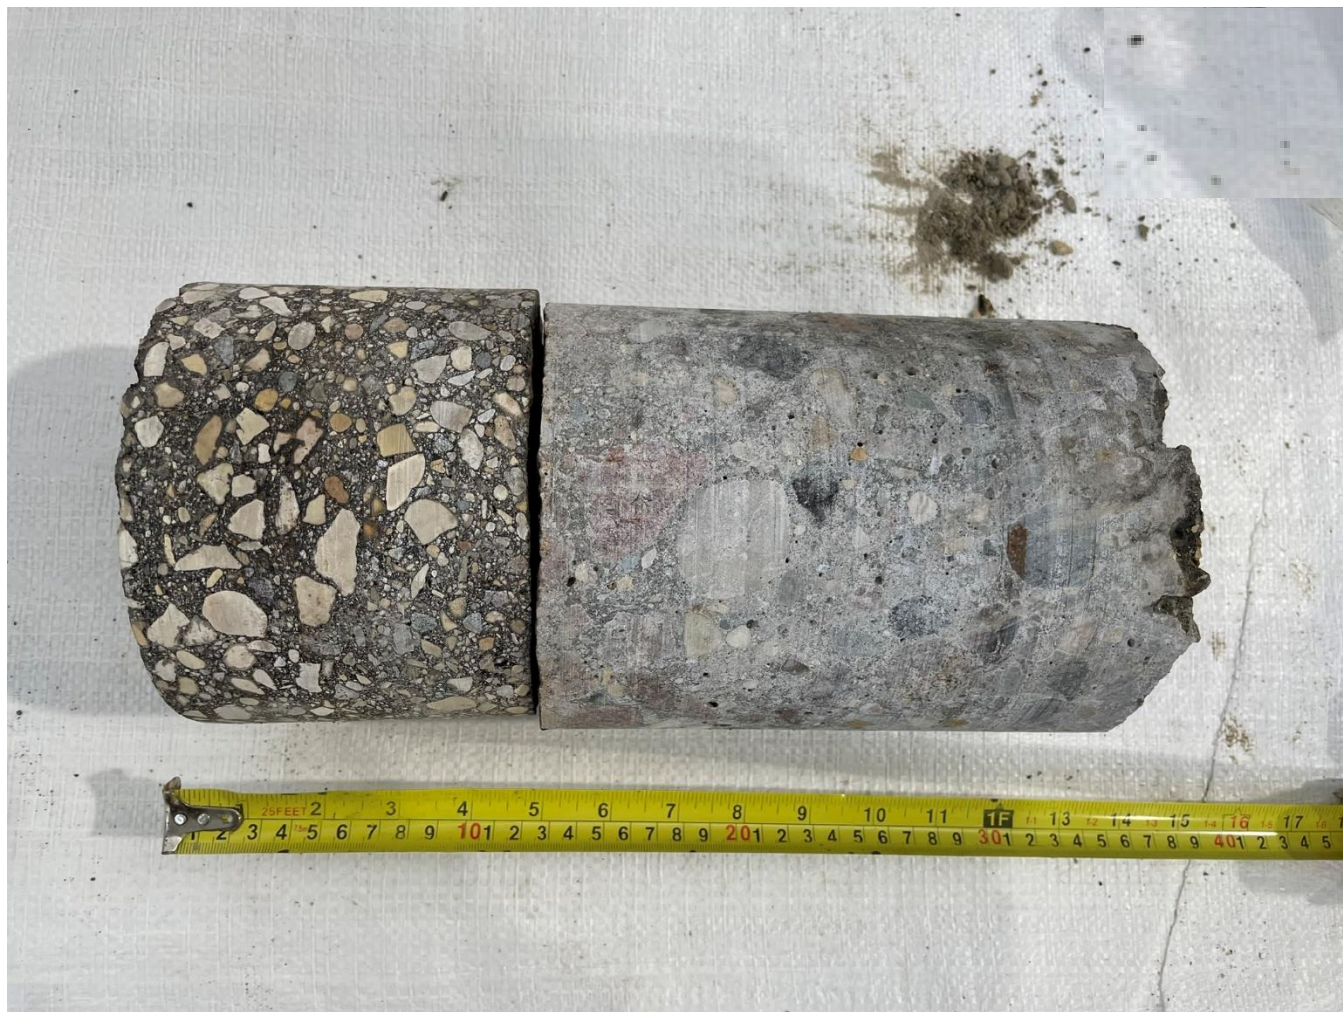
Core Photographs Pavement Core Sample – Salter, Winnipeg, MB		Hole ID: SA05
			Page: 5 of 9

Asphalt: 75mm	Concrete: 300mm	Core Date: 7 Nov. 2022
	Project #: WX19714		Logger: AJ

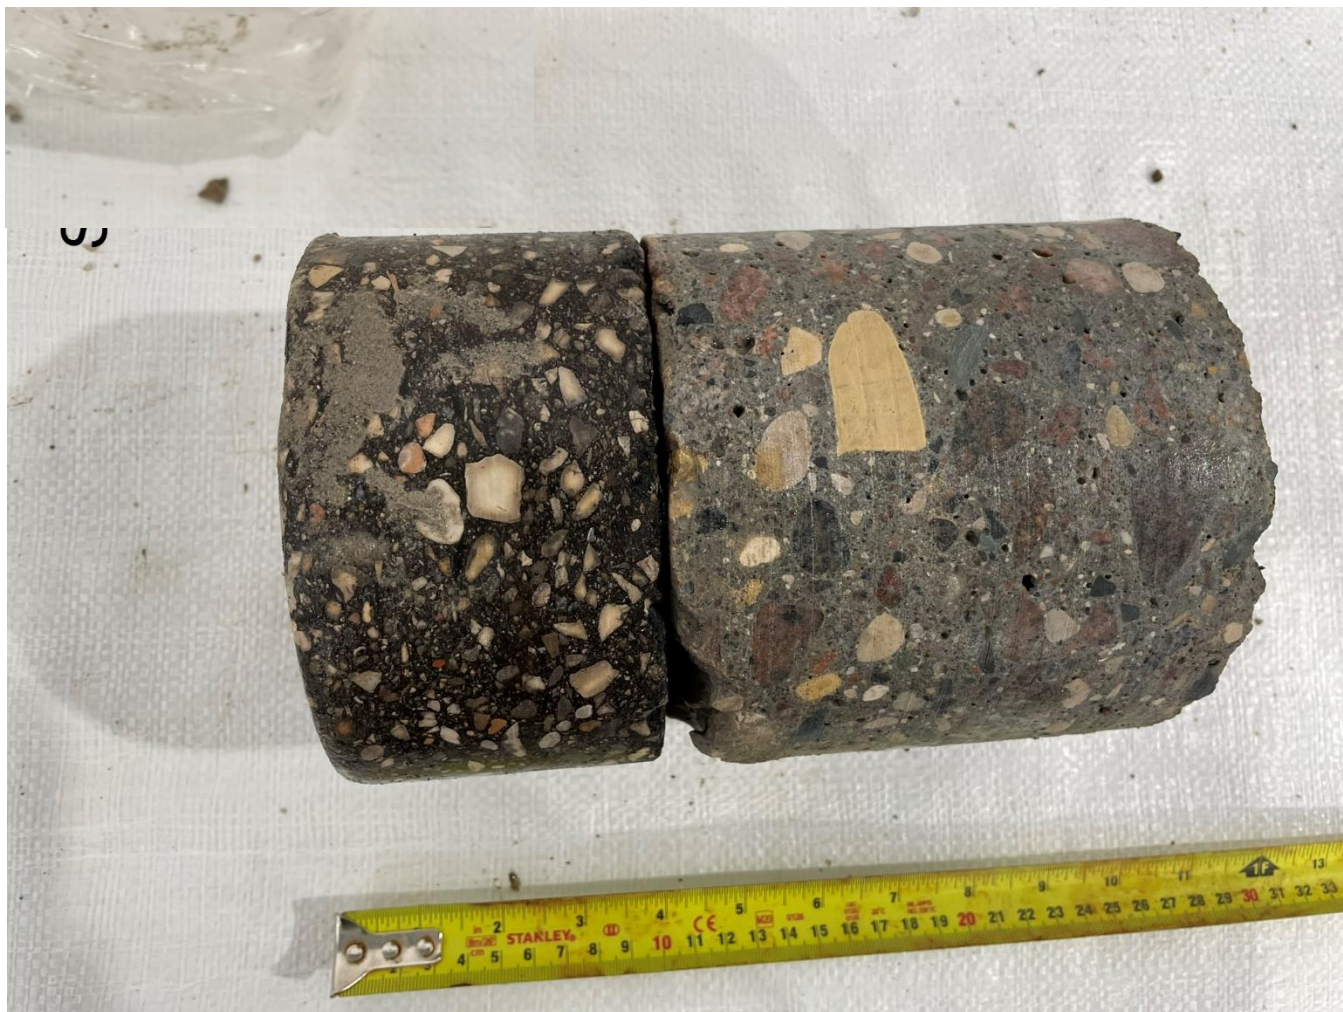
Core Photographs Pavement Core Sample – Salter, Winnipeg, MB		Hole ID: SA06
			Page: 6 of 9

Asphalt: 75mm	Concrete: 135mm	Core Date: 28 Nov. 2022
	Project #: WX19714		Logger: AJ

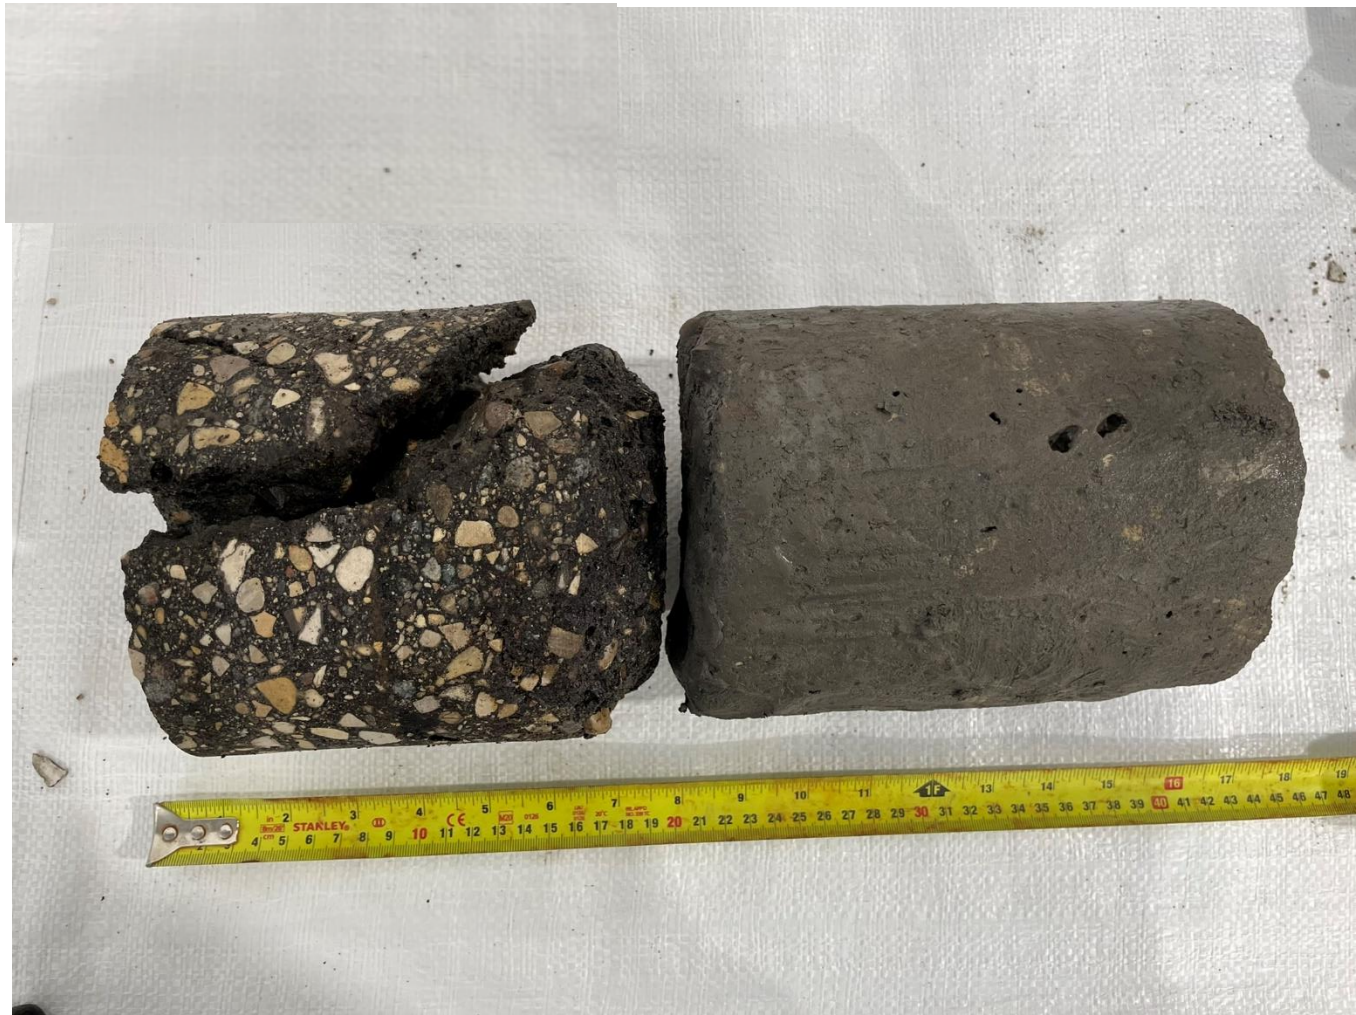
Core Photographs Pavement Core Sample – Salter, Winnipeg, MB		Hole ID: SA07
			Page: 7 of 9

Asphalt: 150mm	Concrete: 190mm	Core Date: 28 Nov. 2022
	Project #: WX19714		Logger: AJ

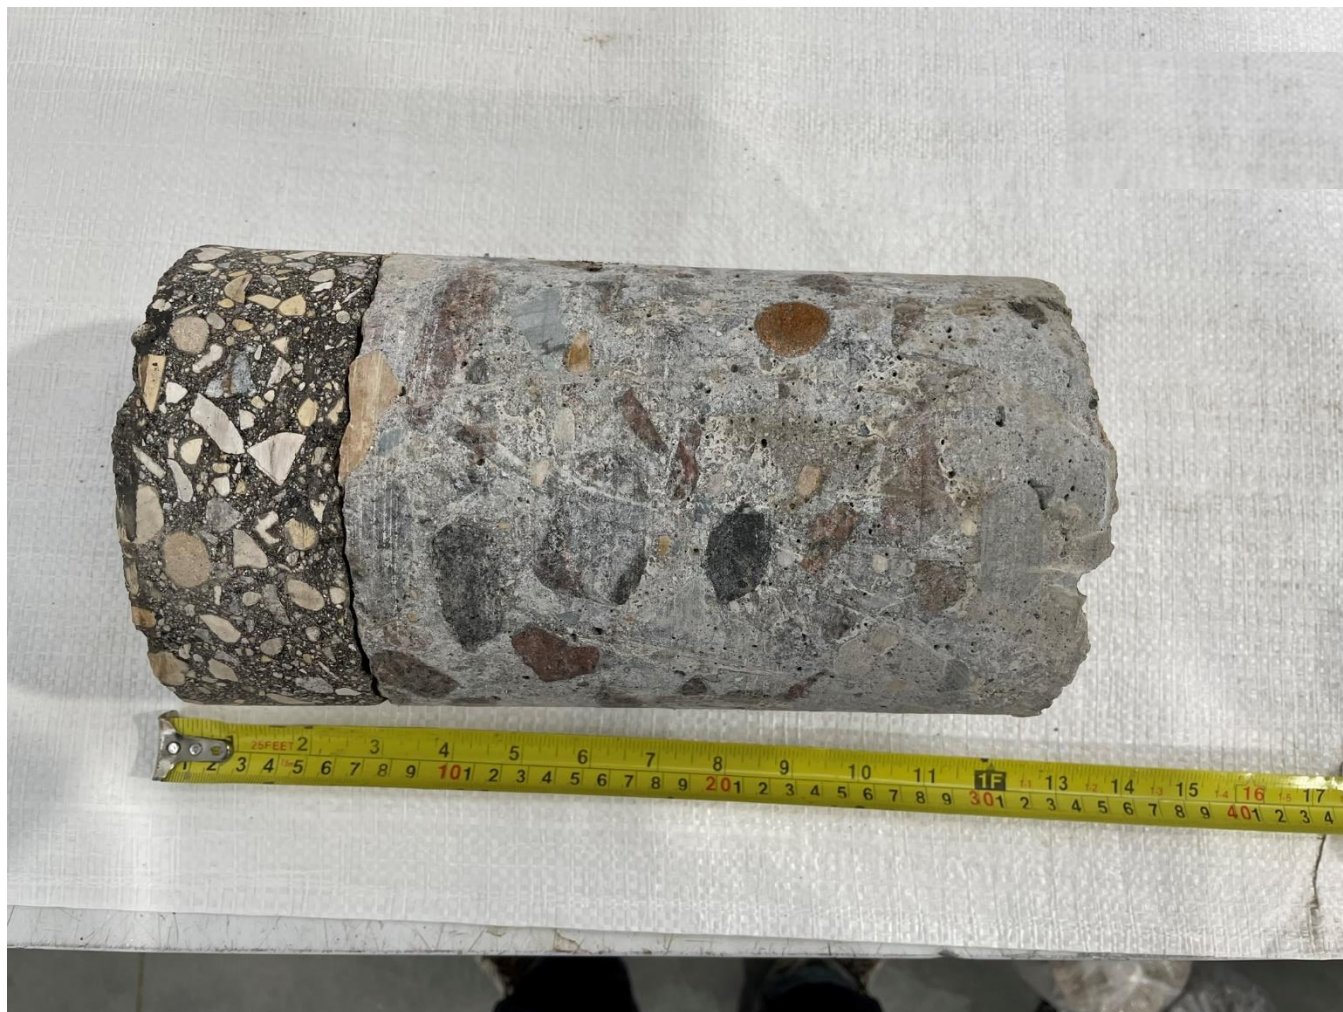
Core Photographs Pavement Core Sample – Salter, Winnipeg, MB		Hole ID: SA08
			Page: 8 of 9

Asphalt: 50mm	Concrete: 250mm	Core Date: 7 Nov. 2022
	Project #: WX19714		Logger: AJ

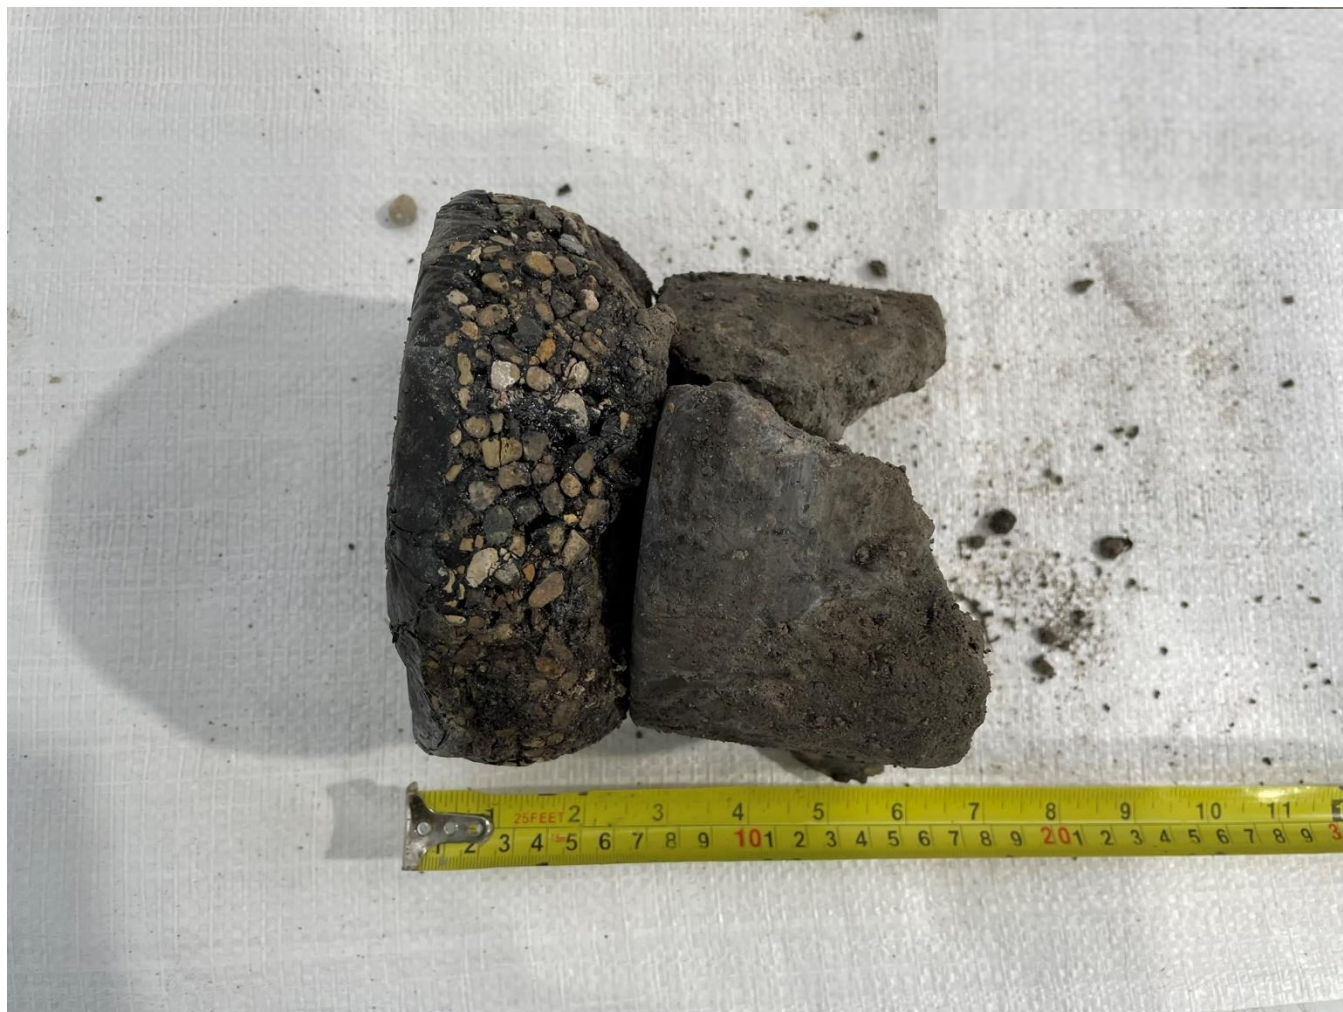
Core Photographs Pavement Core Sample – Salter, Winnipeg, MB		Hole ID: SA09
			Page: 9 of 9

Asphalt: 75mm	Concrete: 0mm	Core Date: 7 Nov. 2022
	Project #: WX19714		Logger: AJ

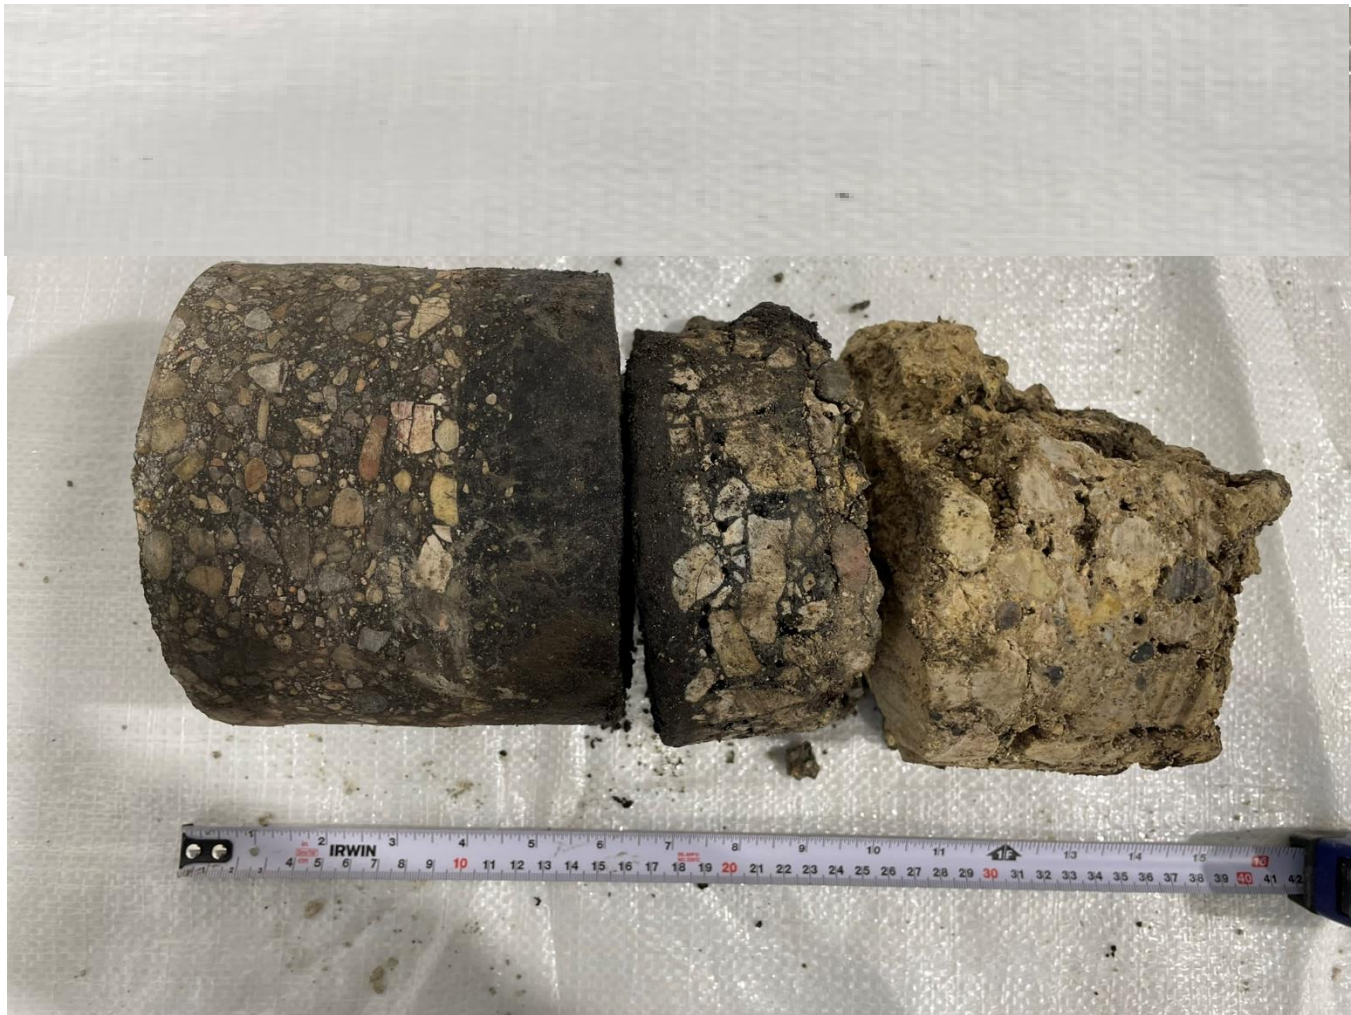
Core Photographs Pavement Core Sample – Selkirk, Winnipeg, MB		Hole ID: SE01
			Page: 1 of 9

Asphalt: 175mm	Concrete: 75mm	Core Date: 2 Dec. 2022
	Project #: WX19714		Logger: AJ
