FINAL GEOTECHNICAL REPORT

CITY OF WINNIPEG STREET INVESTIGATION PROGRAM
MCPHILLIPS STREET, SALTER STREET AND SELKIRK
AVENUE
WINNIPEG, MANITOBA

STANTEC
PROJECT WX19714
JANUARY 2023

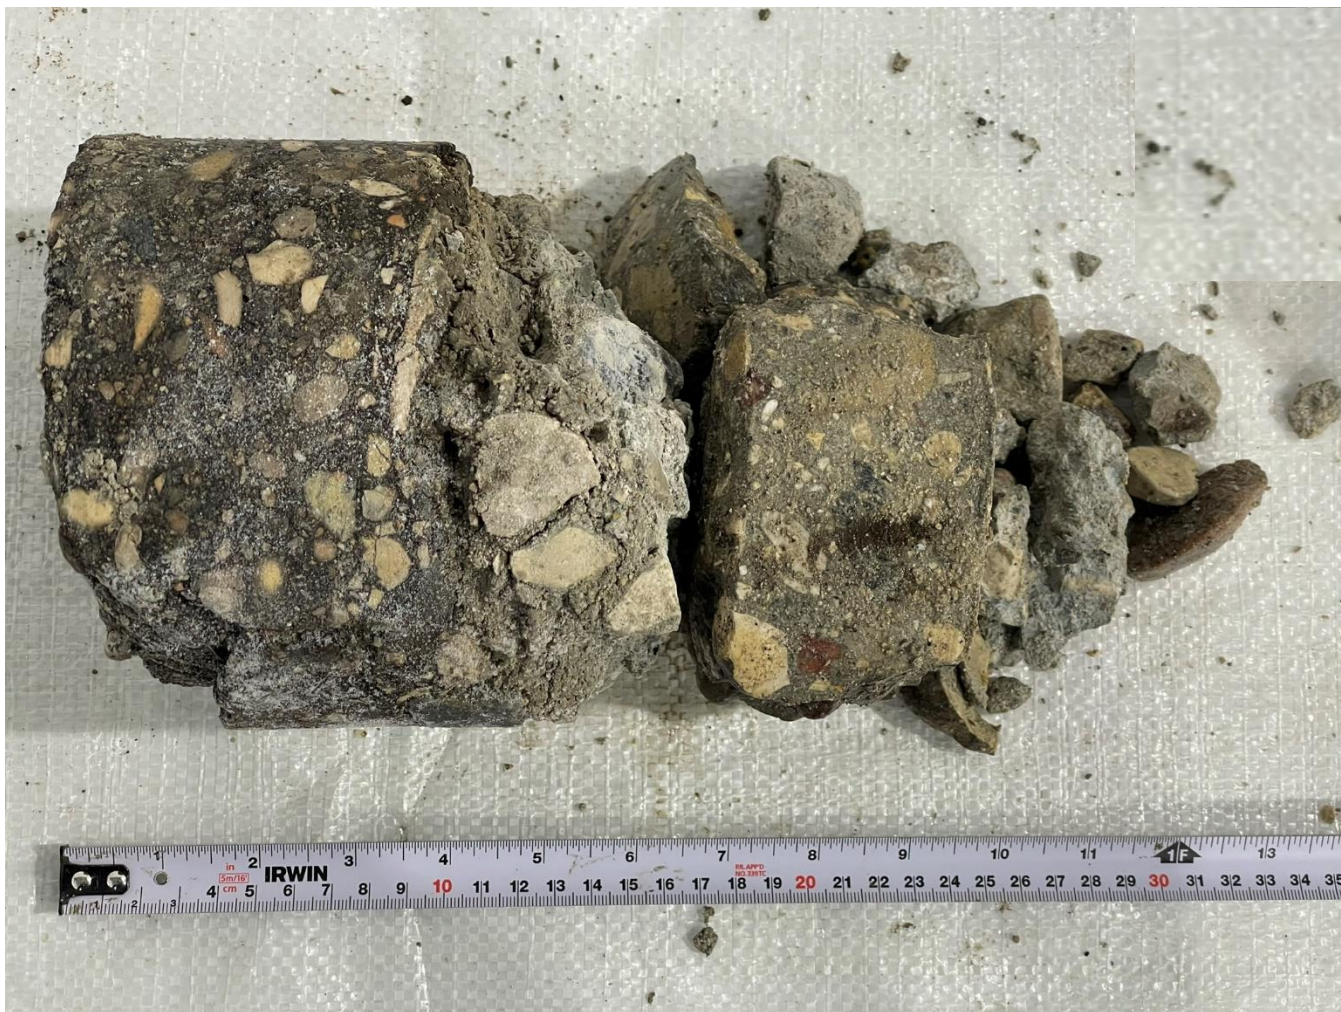
Core Photographs Pavement Core Sample – Selkirk, Winnipeg, MB		Hole ID: SE02
			Page: 2 of 9

Asphalt: 90mm	Concrete: 210mm	Core Date: 2 Dec. 2022
	Project #: WX19714		Logger: AJ

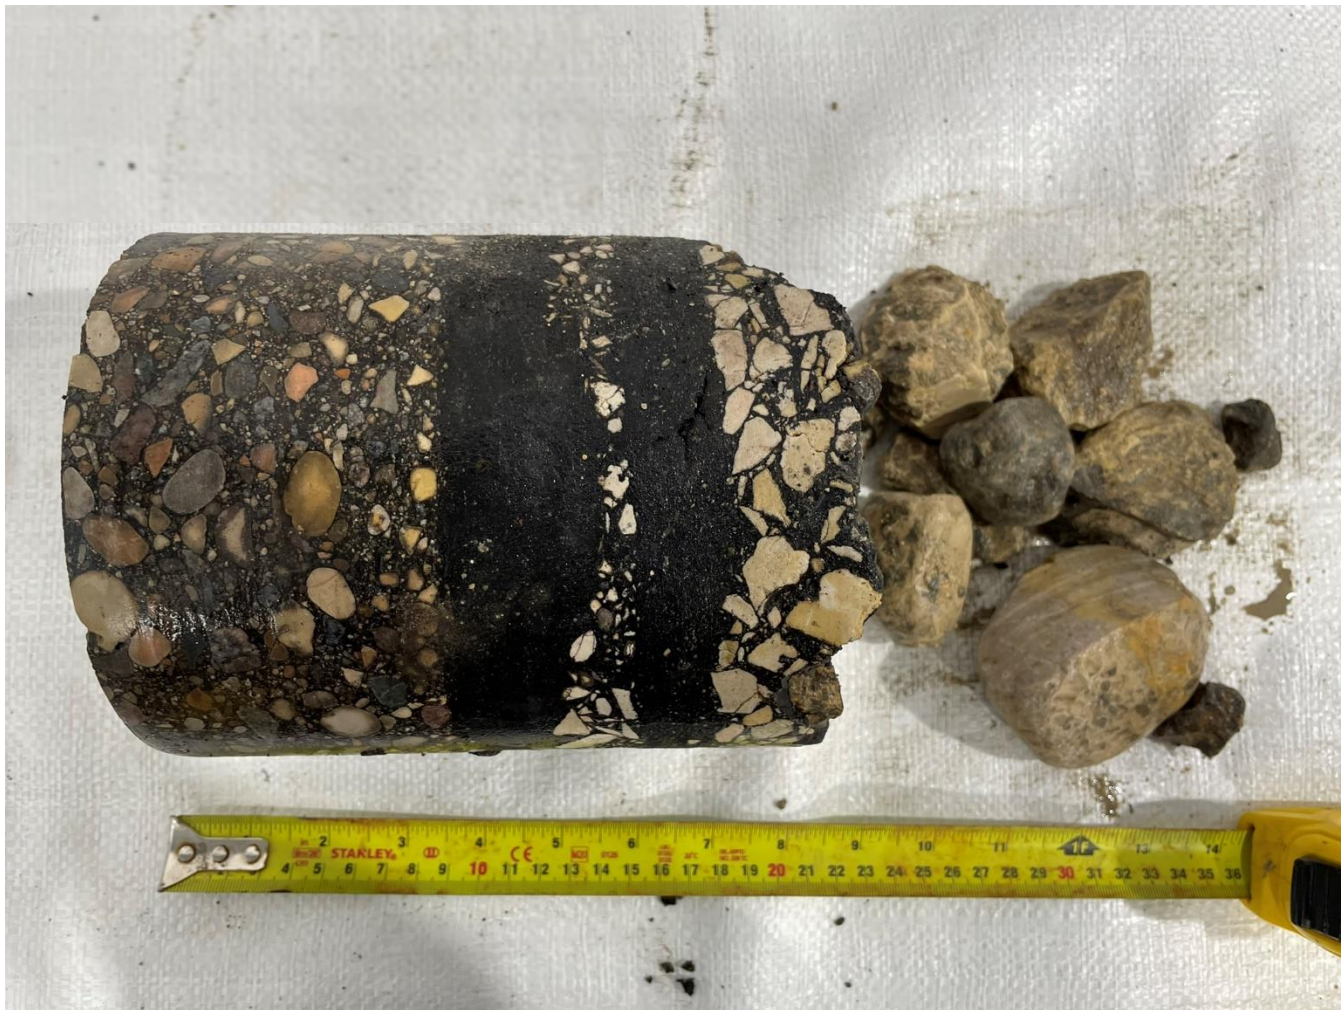
Core Photographs Pavement Core Sample – Selkirk, Winnipeg, MB		Hole ID: SE03
			Page: 3 of 9

Asphalt: 175mm	Concrete:125mm (rubble)	Core Date: 28 Nov.2022
	Project #: WX19714		Logger: AJ

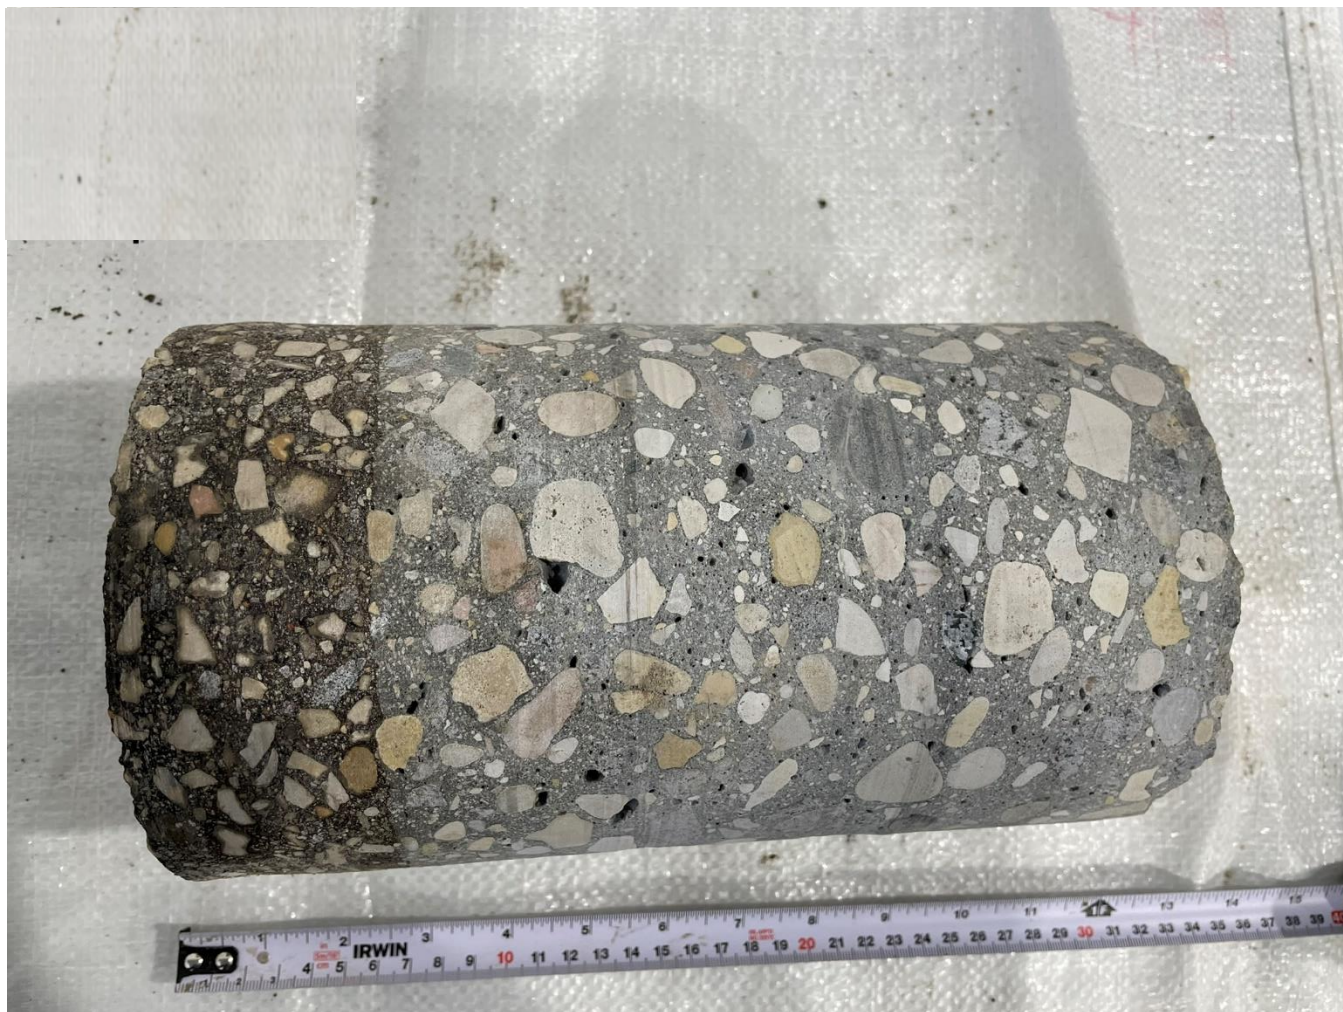
Core Photographs Pavement Core Sample – Selkirk, Winnipeg, MB		Hole ID: SE04
			Page: 4 of 9

Asphalt:50mm	Concrete:275mm	Core Date: 30 Nov. 2022
	Project #: WX19714		Logger: AJ

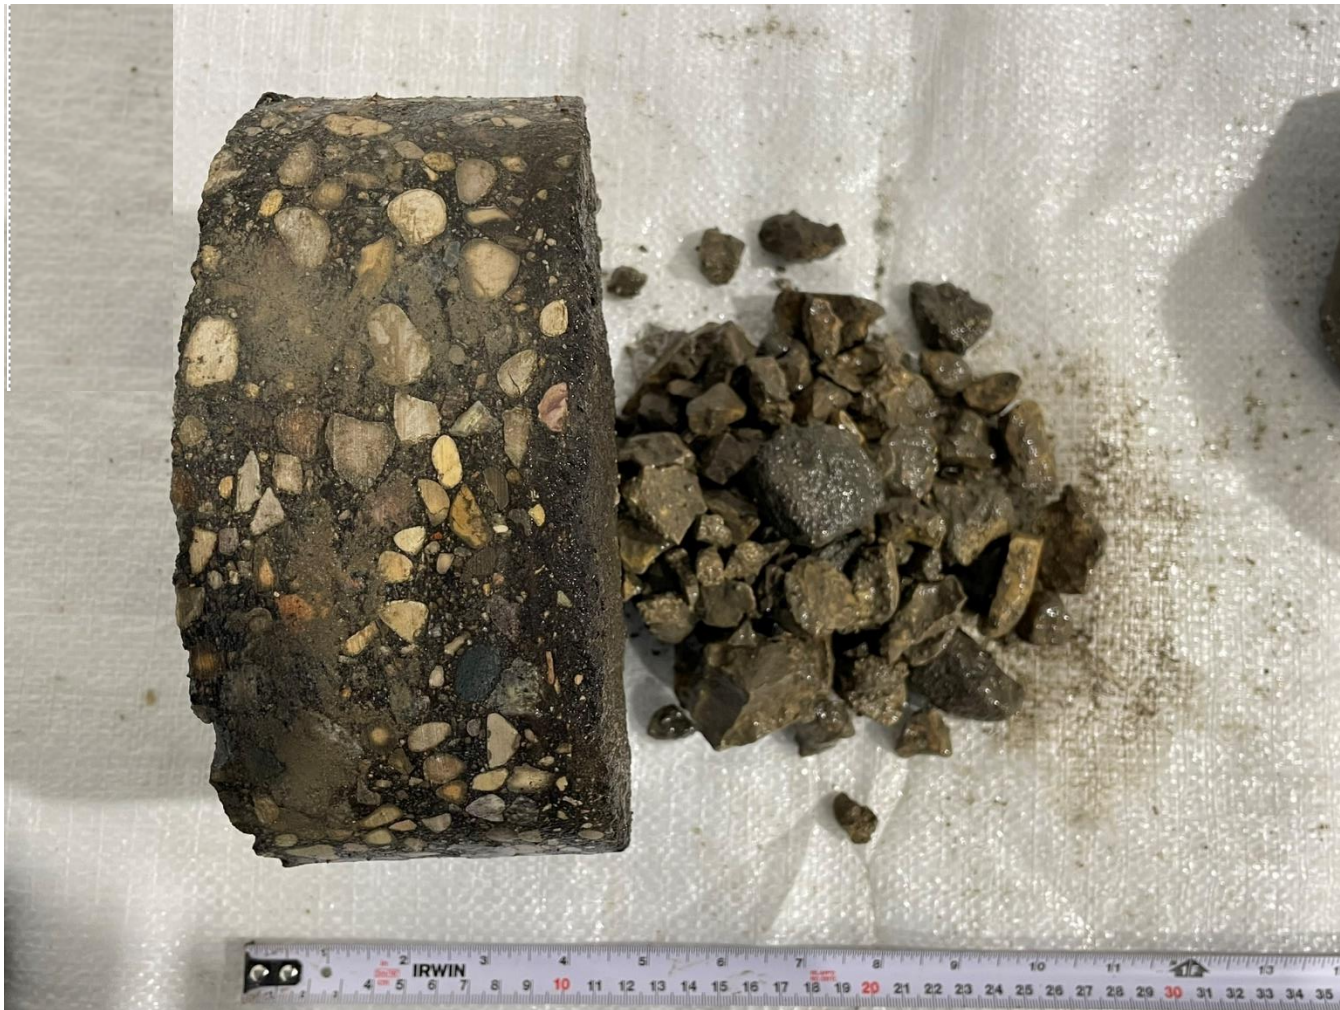
Core Photographs Pavement Core Sample – Selkirk, Winnipeg, MB		Hole ID: SE05
			Page: 5 of 9

Asphalt:100mm	Concrete:500mm (rubble – no recovery)	Core Date: 29 Nov. 2022
	Project #: WX19714		Logger: AJ

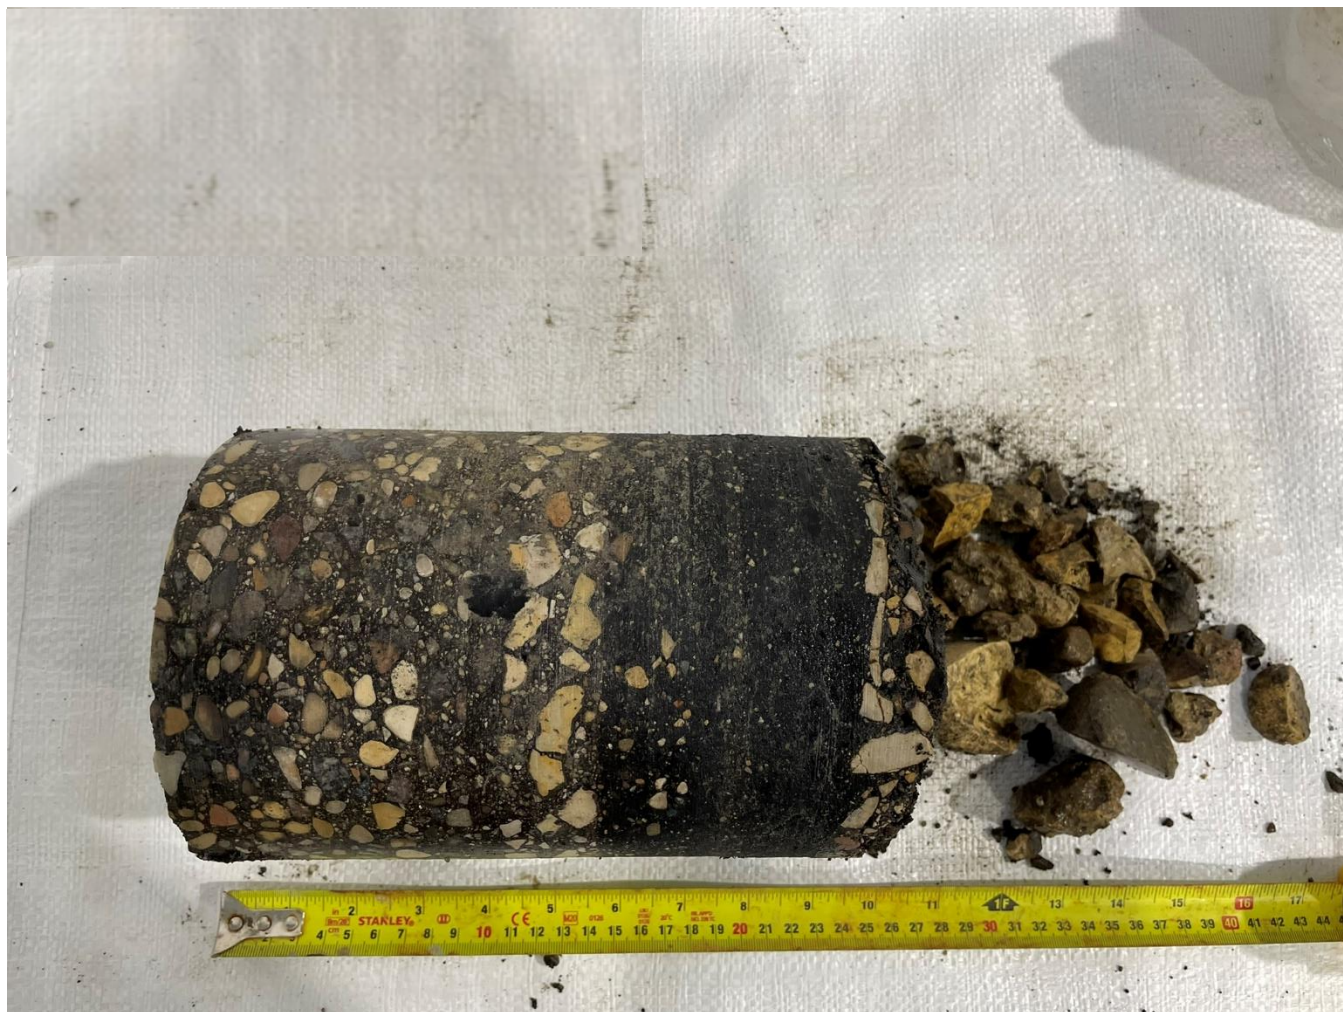
Core Photographs Pavement Core Sample – Selkirk, Winnipeg, MB		Hole ID: SE06
			Page: 6 of 9

Asphalt: 215mm	Concrete: 25mm	Core Date: 29 Nov. 2022
	Project #: WX19714		Logger: AJ

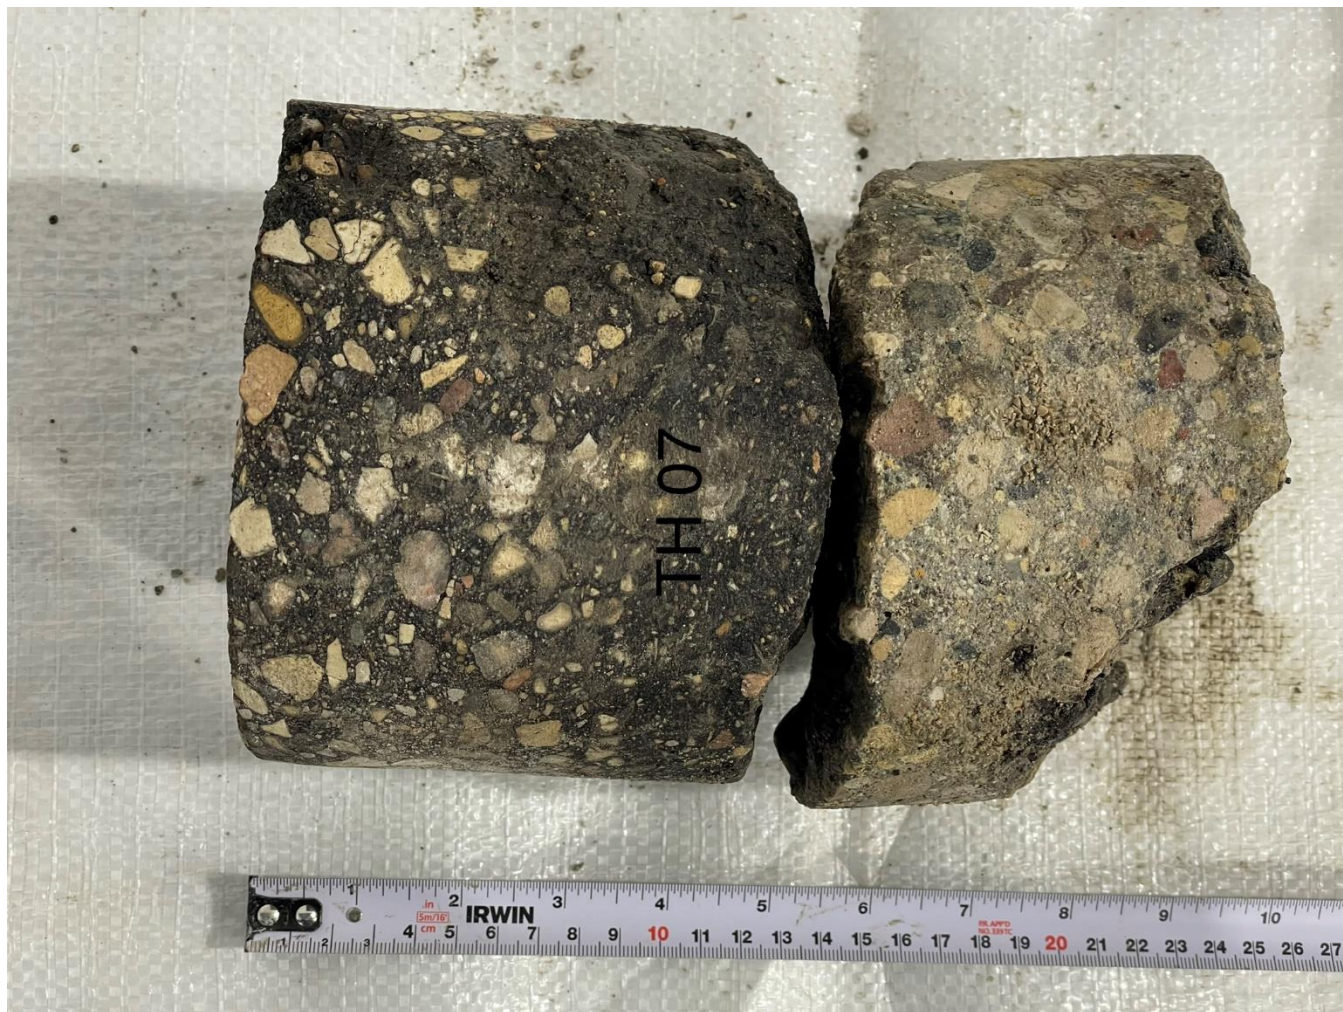
Core Photographs Pavement Core Sample – Selkirk, Winnipeg, MB		Hole ID: SE07
			Page: 7 of 9

Asphalt: 100mm	Concrete:90mm	Core Date: 29 Nov. 2022
	Project #: WX19714		Logger: AJ

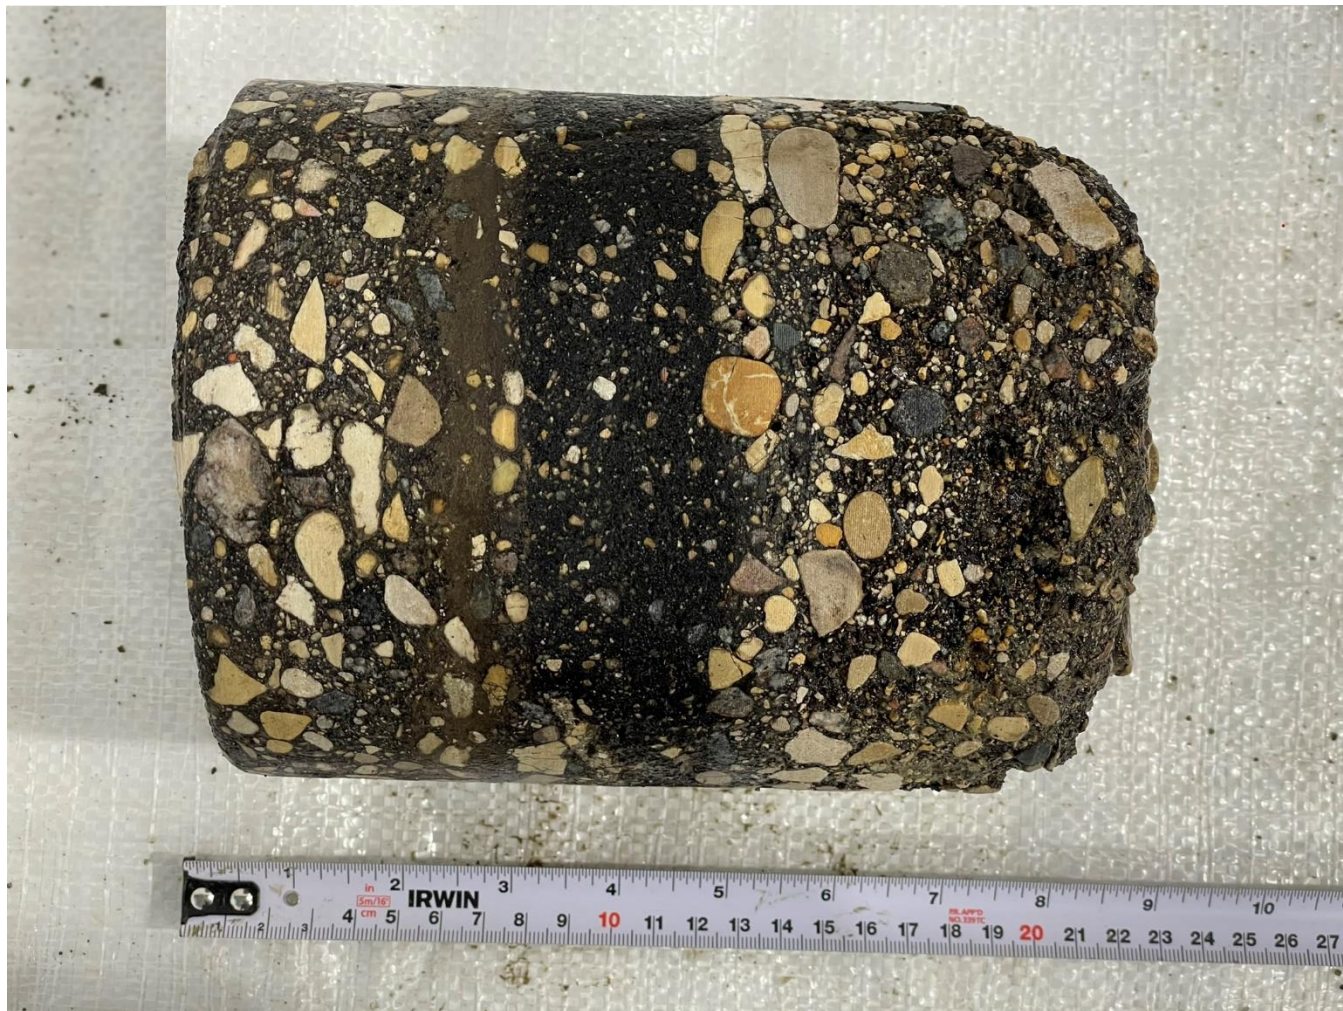
Core Photographs Pavement Core Sample – Selkirk, Winnipeg, MB		Hole ID: SE08
			Page: 8 of 9

Asphalt: 175mm	Concrete: 425mm (rubble – no recovery)	Core Date: 30 Nov. 2022
	Project #: WX19714		Logger: AJ

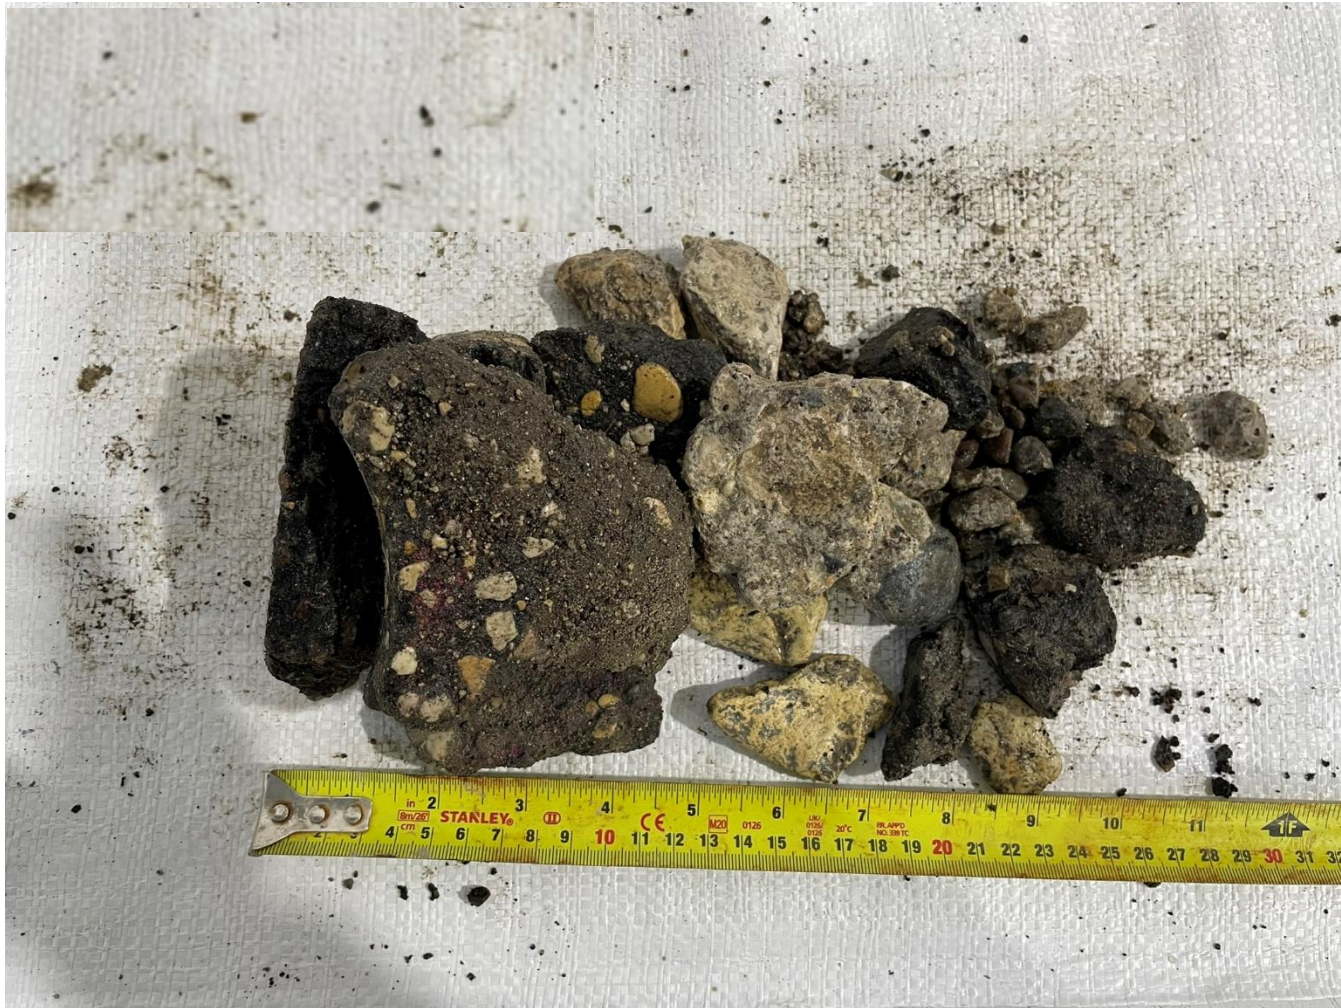
Core Photographs Pavement Core Sample – Selkirk, Winnipeg, MB		Hole ID: SE09
			Page: 9 of 9

Asphalt: 75mm	Concrete: 75mm (rubble – no recovery)	Core Date: 30 Nov. 2022
	Project #: WX19714		Logger: AJ
