Facility Renewal and Redevelopment Strategy
for the
City of Winnipeg Archives and Records Control
Location: 380 William Avenue

December 22, 2010

Produced by Cibinel Architects Ltd.

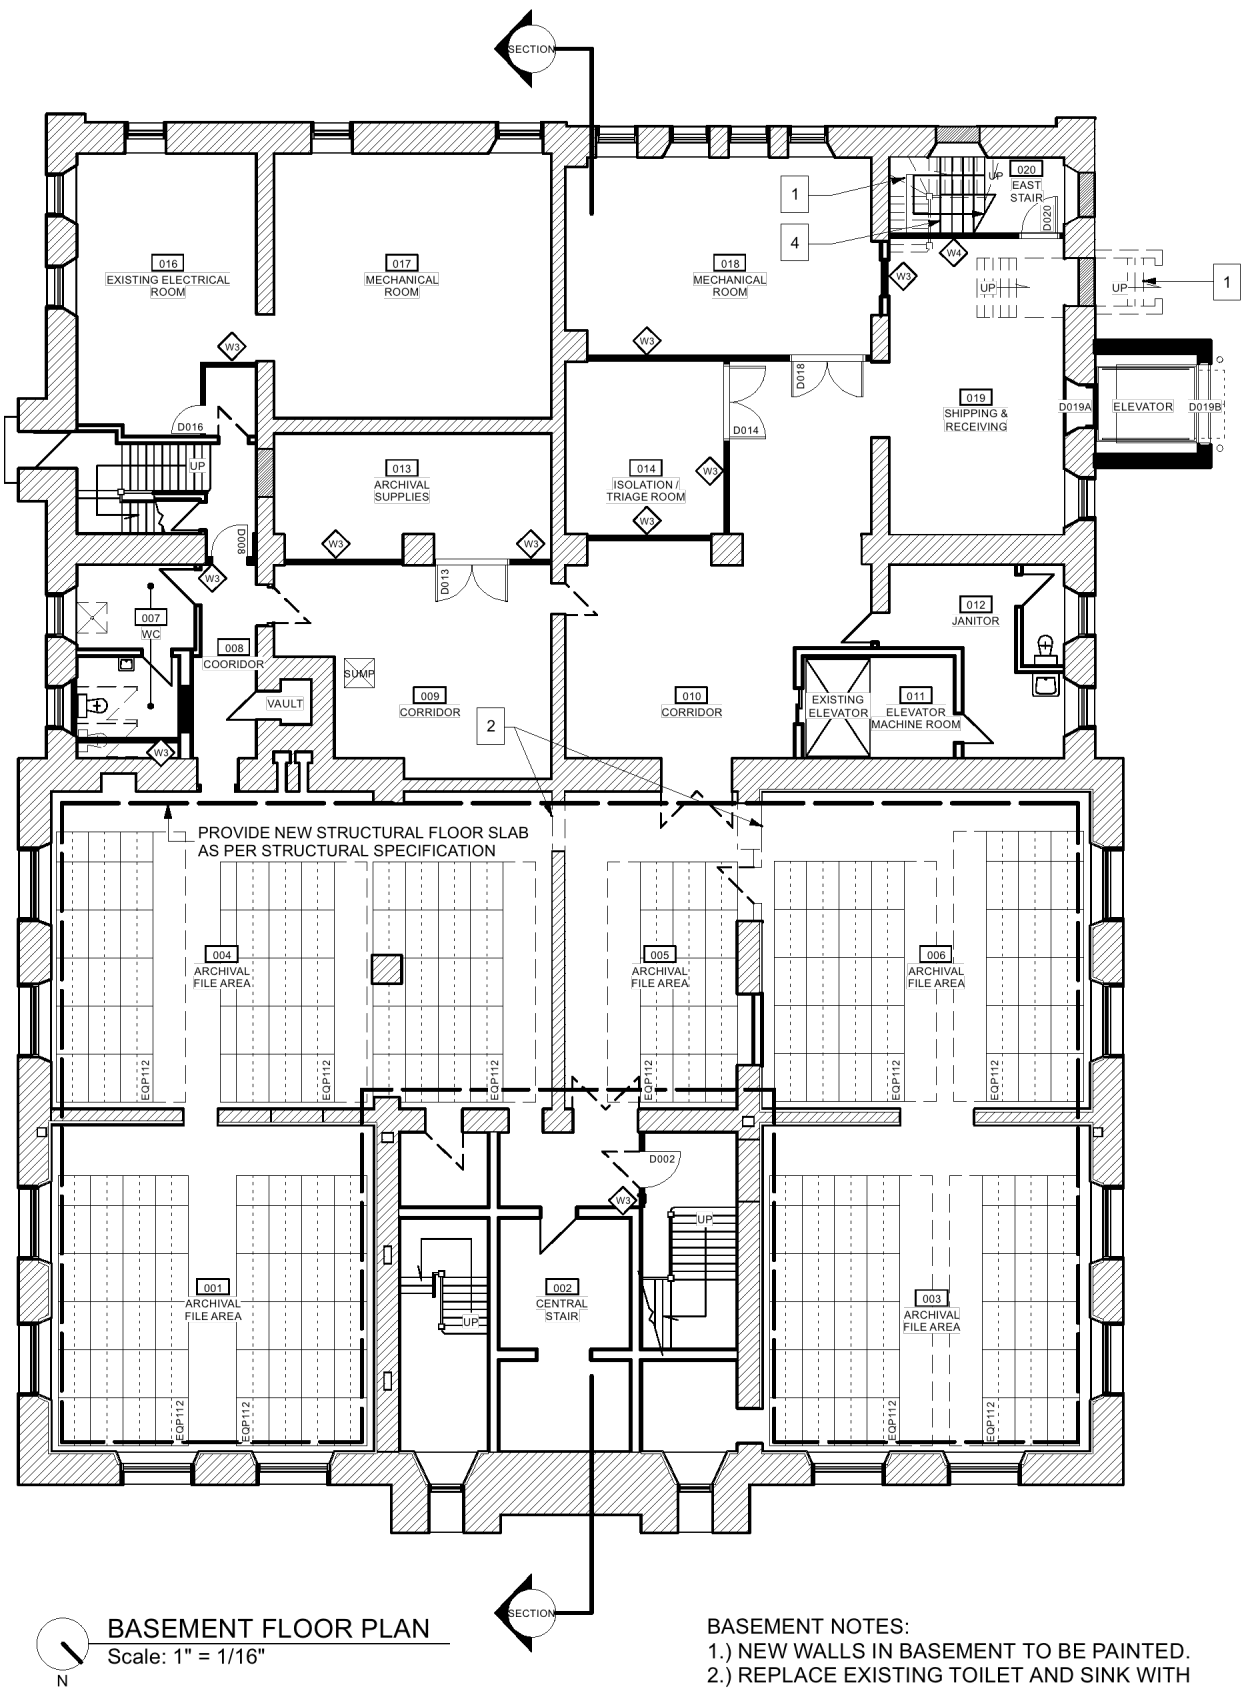
BASEMENT FLOOR PLAN

- 1.) NEW WALLS IN BASEMENT TO BE PAINTED.
- 2.) REPLACE EXISTING TOILET AND SINK WITH NEW FIXTURES AS SHOWN ROOM WC 007 - PROVIDE SHEET VINYL FLOOR FINISH W/ COVED BASE AND A.C.T CEILING.

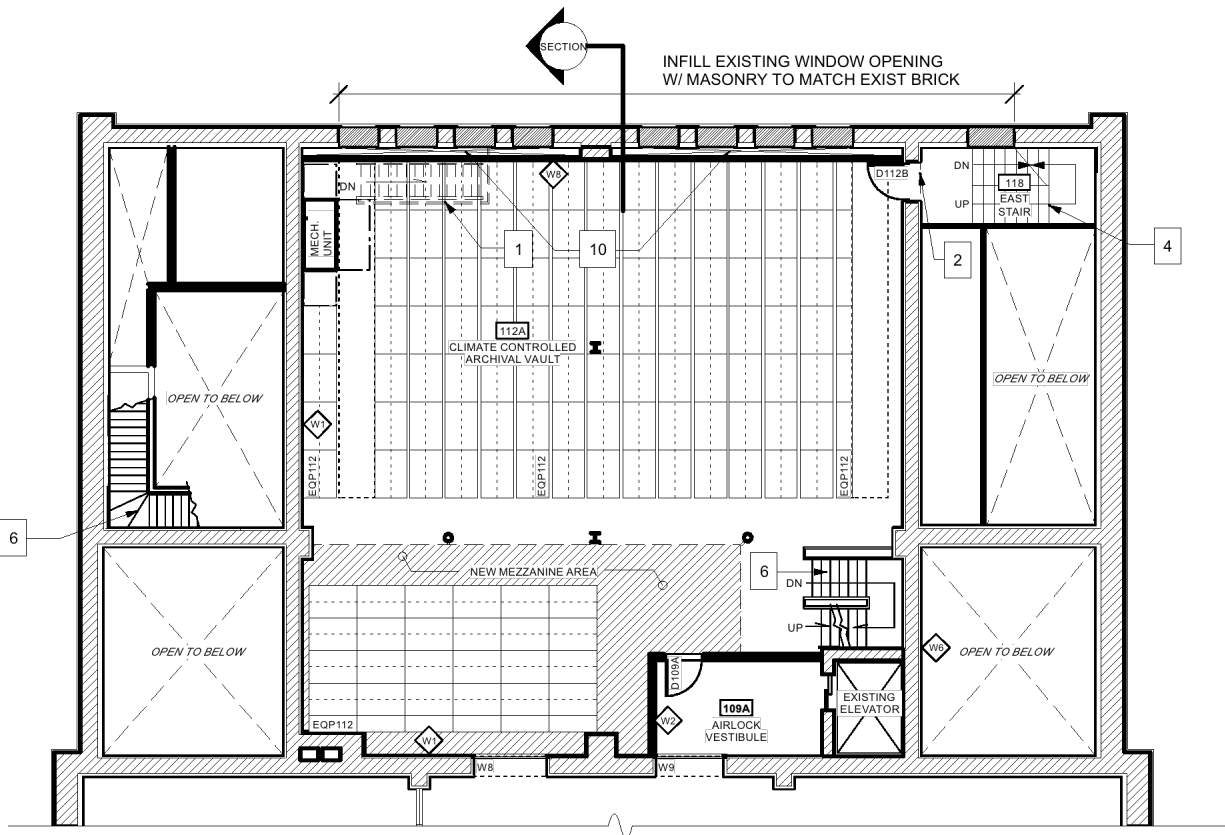
MAIN FLOOR MEZZANINE
 Scale: 1" = 1/16"

1. DEMOLISH STAIR (INFILL FLOOR ASSEMBLY AS REQUIRED)
2. PROVIDE LINTEL FOR NEW OPENING IN MASONRY
3. DEMOLISH VAULT
4. NEW STEEL STAIR, HANDRAIL & GAURDS
5. DEMOLISH WOOD FRAME GWB PARTITION (±12'-0" HIGH)
6. EXISTING STAIR
7. INFILL EXISTING DOOR OPENING WITH MASONRY
8. NEW WOOD AND GLASS PARTITION (SEE BLDG. SECTION DRAWING FOR INTERIOR ELEVATION)
9. NEW 9' HIGH WOOD AND GLASS PARTITION - CEILING TO BE WOOD FRAME W/ PLYWOOD BOTH SIDES - WAINSCOTTING TO 36", GLASS ABOVE ±8" CAVITY TO BE HEATED AND COOLED SEPARATLY FROM ARCHIVAL VAULT - SEE MECH. SPEC.
- 10.

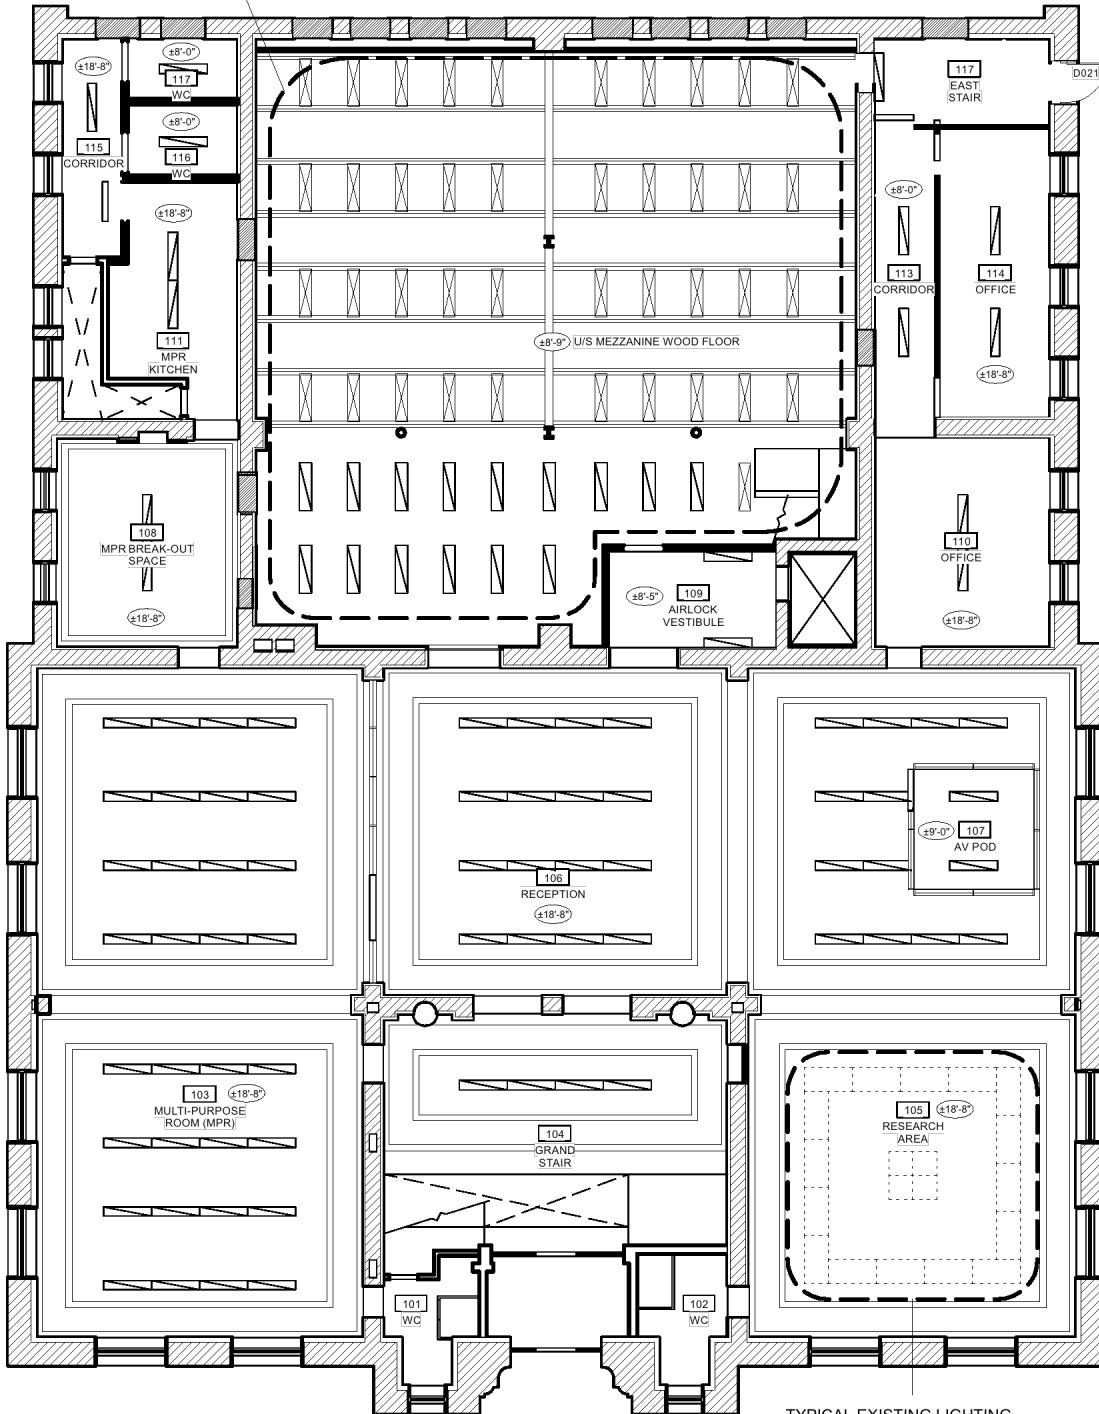
MAIN FLOOR REFLECTED CEILING PLAN
 Scale: 1" = 1/16"
 N

TYPICAL EXISTING LIGHTING LAYOUT IN ROOMS 103, 105 & 106 TO BE DEMOLISHED - PATCH AND REPAIR PLASTER CEILING AS REQUIRED. NEW LIGHTING LAYOUT TO MATCH RM106 RECEPTION

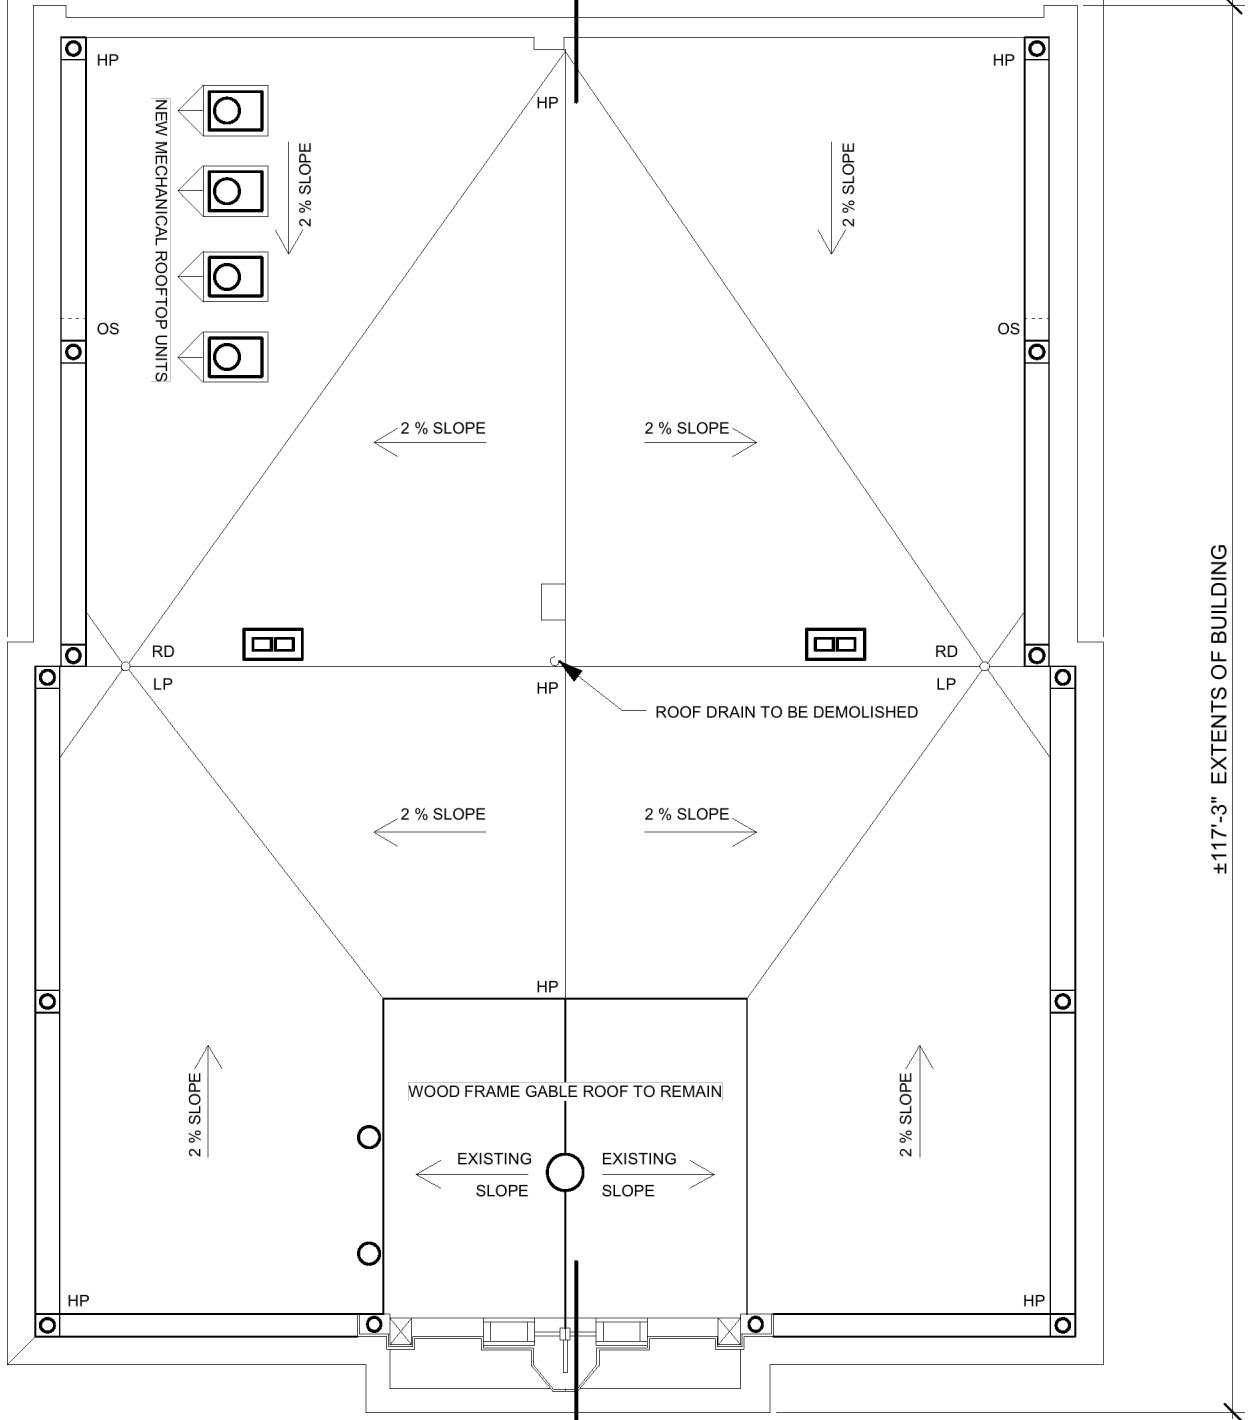
ROOF PLAN
1":1/16"
N

PROVIDE NEW FLAT STEEL FRAME ROOF
STRUCTURE W/ LIGHT COLOURED 2 PLY
SBS ROOF MEMBRANE SYSTEM ON
SLOPED EPS INSULATION

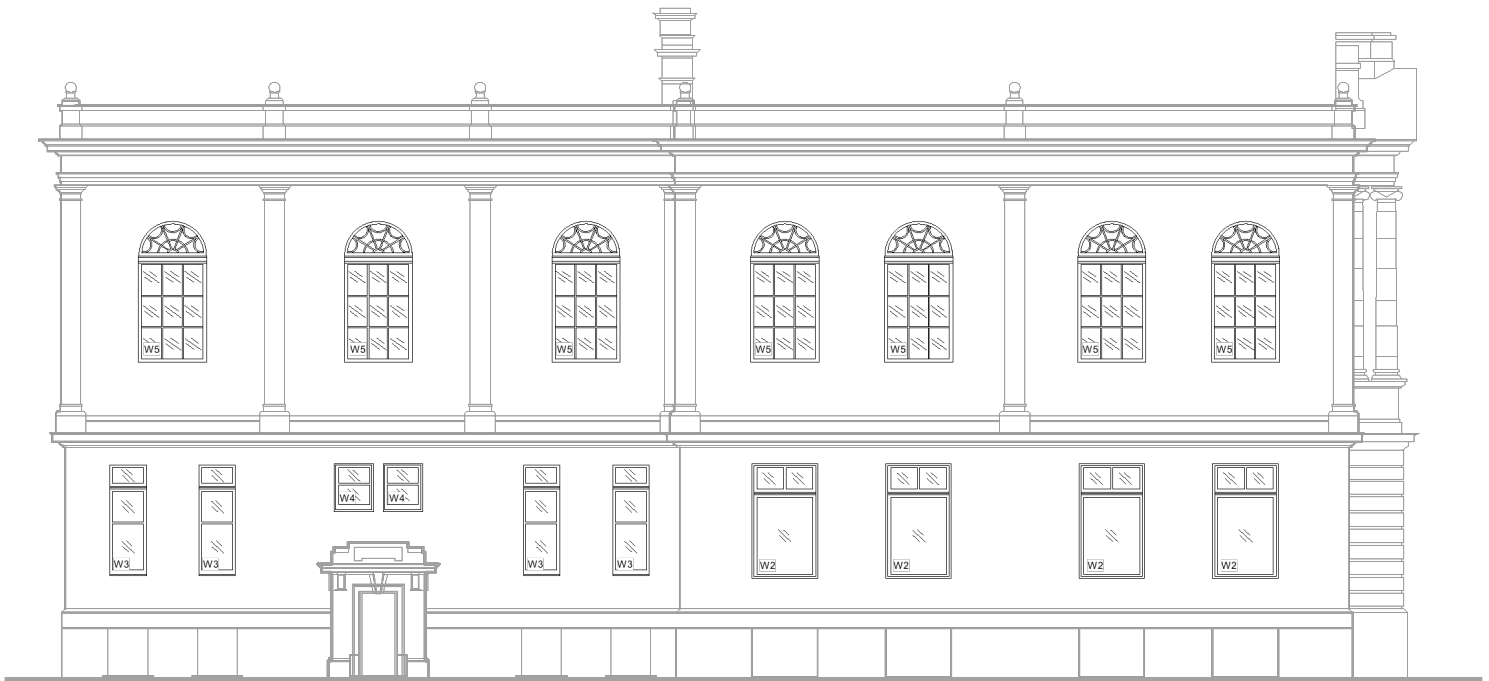
EAST ELEVATION

*NOTE:
REFURBISH WINDOWS AS PER WINDOW SCHEDULE

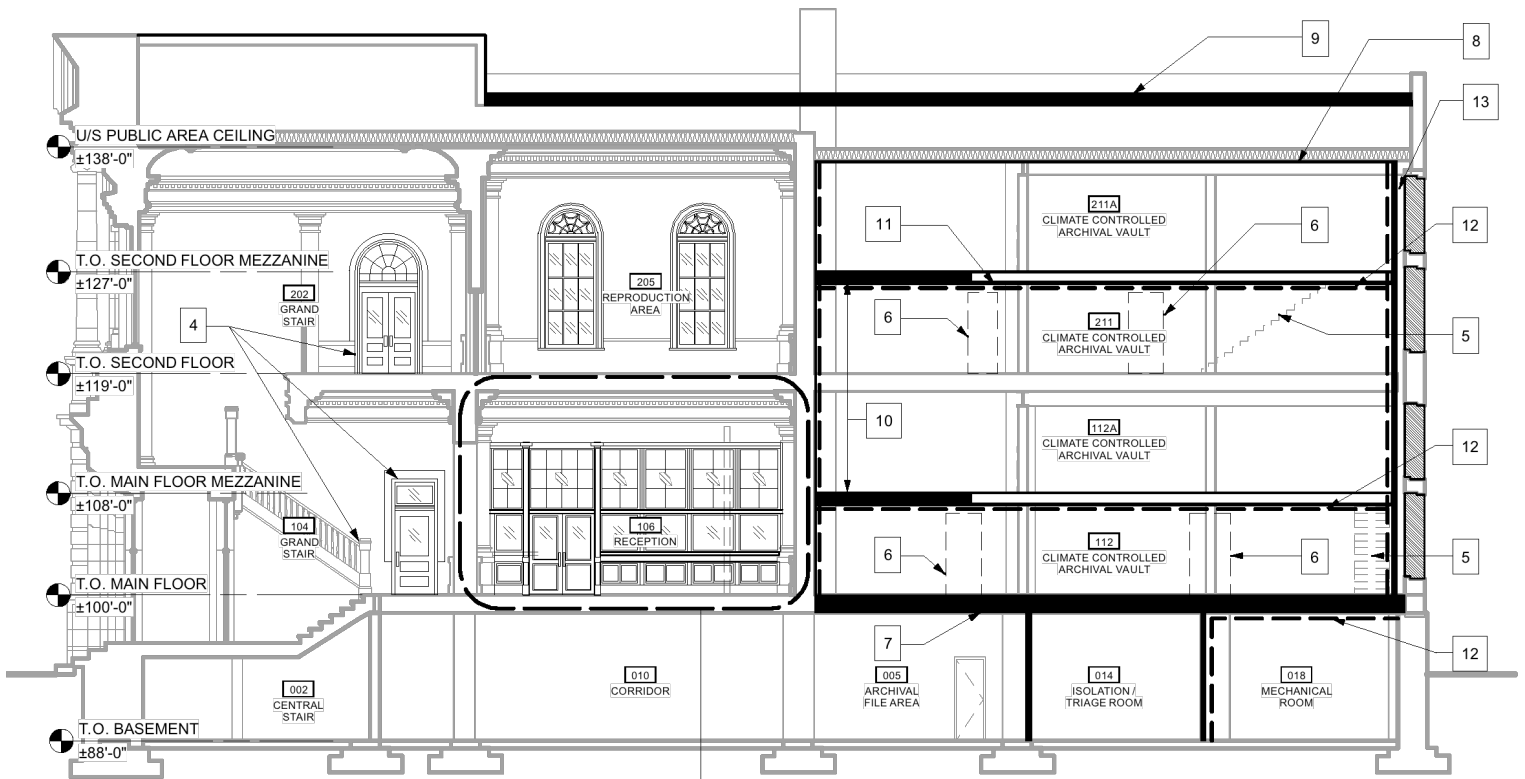
BUILDING SECTION

SEE INTERIOR ELEVATION FOR GREATER DETAIL OF
NEW WOOD WALL & GLAZING

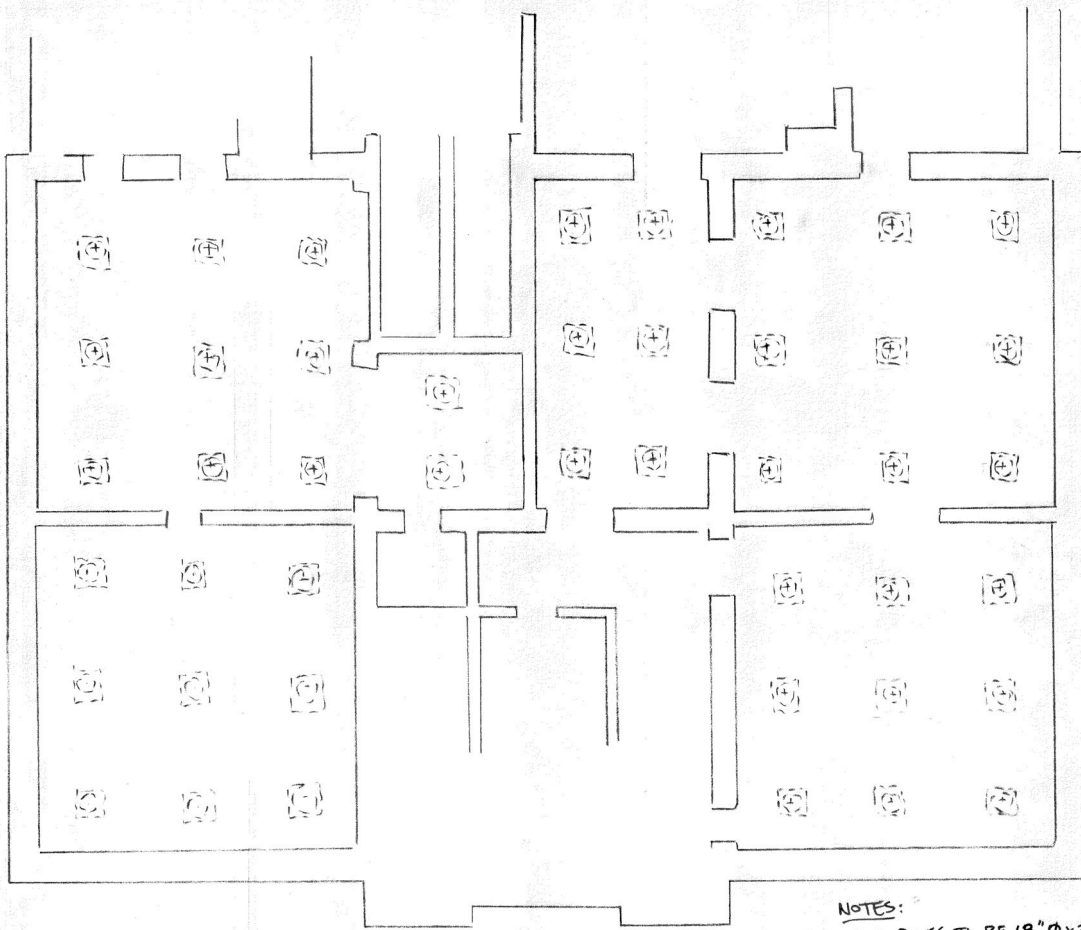
BASEMENT FLOOR FRAMING PLAN

- ALL PILES TO BE 18" ϕ x 35'-0" LONG
- ALL NEW SLAB TO BE 8" THICK
- R/W 15 M @ 16" o.c. E.W. TOP & BOT.
- 6" VOID FORM UNDER ALL SLAB AREAS

DESIGN LIVE LOAD = 200 PSF
