**APPENDIX B - FALCON RIVER DIVERSION AND SHOAL LAKE AQUEDUCT BRIDGES  
GEOTECHNICAL REPORT, MARCH 25, 2013**

## **Falcon River Diversion and Shoal Lake Aqueduct Bridges – Geotechnical Report**

**RE: Falcon River Diversion and Shoal Lake Aqueduct Bridges – Geotechnical Report**

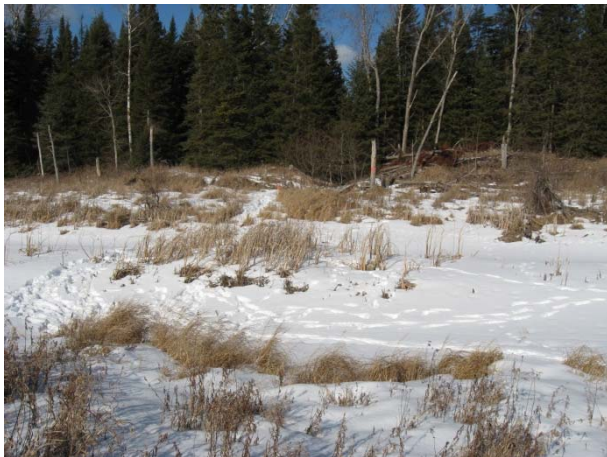
Figure 03 View N at N Abutment Location

The ground elevation on the north and south sides of the Aqueduct are at approximately Elev. 325.5 and 324.5 m respectively with the higher north side elevation resulting in part from spoil material (Figures 03 and 04). The ditch invert is at approximately Elev. 322.5 m and 2 to 3 m wide. The berm above the Aqueduct slopes at about 2H:1V and cresting at about Elev. 323.5 m. A cross section of the proposed crossing at Mile 93 is shown on Drawing 02.

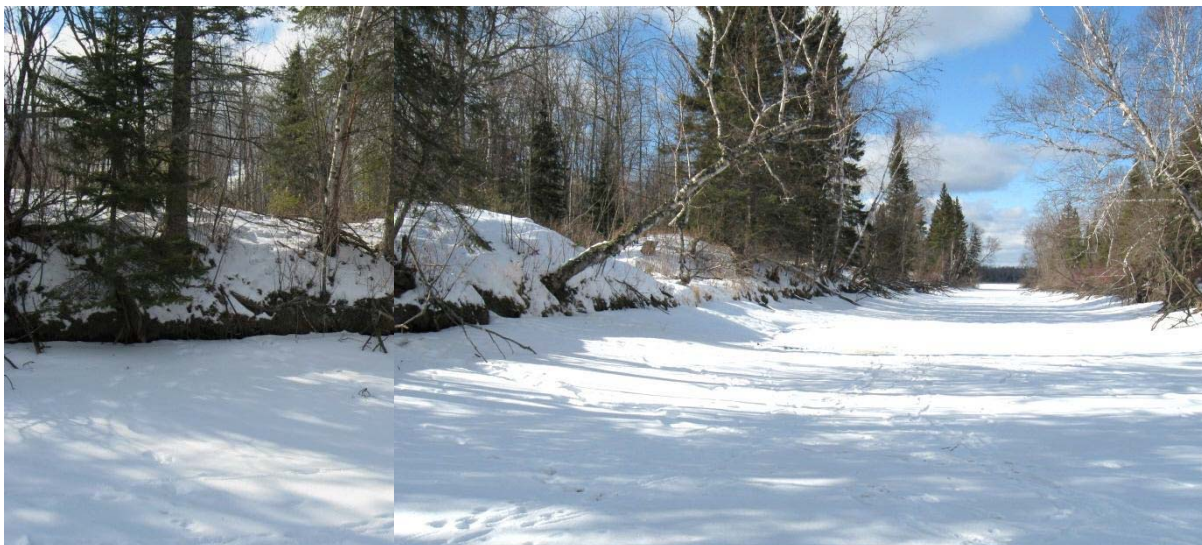
Figure 06 View NW at W Side of Crossing (IMG\_4399&4400)

The surveyed water level of the channel was Elev. 322.22 m on October 12, 2012. Historical records obtained from Dillon show that the lowest water level to date in the FRD channel was Elev. 321.87 m recorded on March 28, 1930. Between 2000 and 2011, the lowest water Elev. was 322.26 m. At ice level, the channel is about 17 m wide with banks in the order of 2 m high. Spoil material from the original excavation has been piled on the tops of both banks ranging in height from about 2 m on the west side to about 1.5 m on the east bank. The channel spoil banks show evidence of undercutting although no instabilities of the banks were visible. A cross section and site plan of the existing ground profile is presented on Drawing 03. A cross section of the proposed crossing at the Falcon River Diversion is shown on Drawing 04.

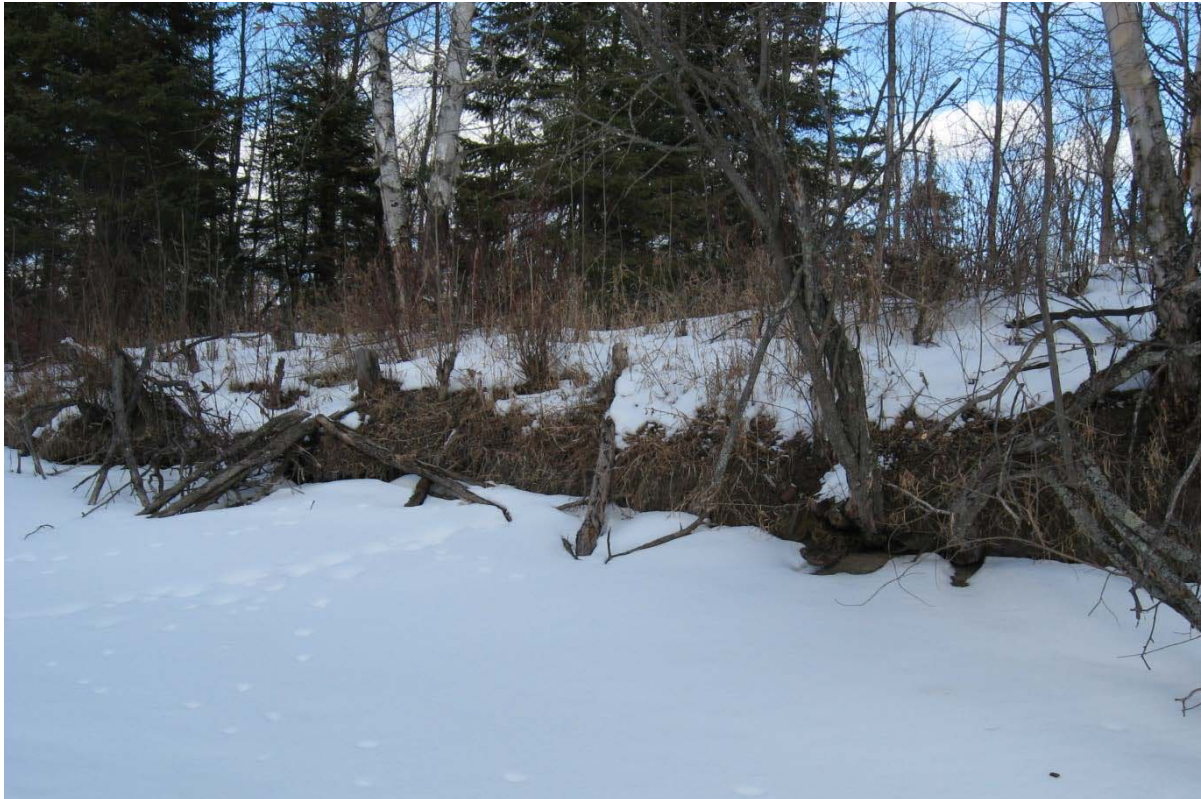
Figure 07 View NE at E Side of Crossing (IMG\_4414)

The proposed bridge will cross the Falcon River Diversion (FRD) channel approximately 3.5 km west of the community at Shoal Lake No. 40. A location plan of the crossing is shown on Drawing 03. The Falcon River Diversion channel was excavated across the peninsula separating Indian Bay and Snowshoe Bay during construction of the Shoal lake Aqueduct between 1914 and 1915 to divert Falcon River water away from the Intake. The originally proposed channel crossing is situated in a relatively flat, heavily treed area immediately northwest of a horizontal bend in the channel where a large area on the west side of the channel has been cleared at the termination of a recently constructed winter road (Figure 06). On the east side, a road connects the Community to the channel crossing location (Figure 07). It is our understanding that the proposed crossing is to be relocated about 100 m farther southeast, along a straight portion of the channel; however, our investigation was carried out at the originally proposed location.

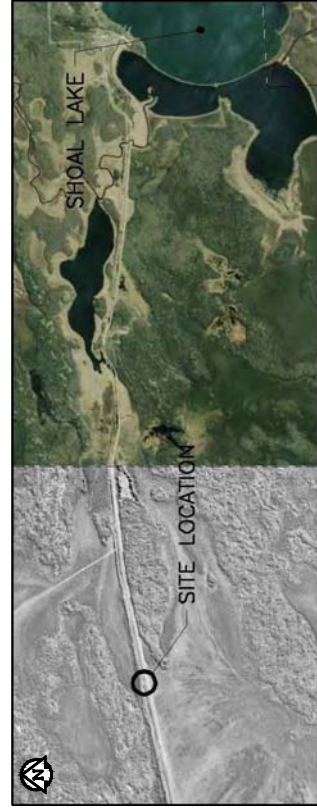
1. TH12-01 OFFSET 4.3m EAST OF CROSS-SECTION.
2. CROSS-SECTION GEOMETRY BASED OFF OF DILLON OCTOBER 12, 2012 SURVEY.
3. CHANNEL GEOMETRY BELOW WATER LEVEL NOT SURVEYED.

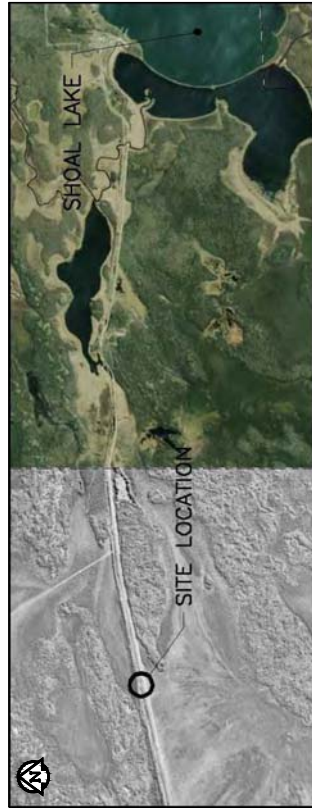
**LOCATION PLAN**  
SCALE: N.T.S.

1. TH12-01 OFFSET 4.3m EAST OF CROSS-SECTION.
2. CROSS-SECTION GEOMETRY BASED OFF OF DILLON OCTOBER 12, 2012 SURVEY.
3. CHANNEL GEOMETRY BELOW WATER LEVEL NOT SURVEYED.

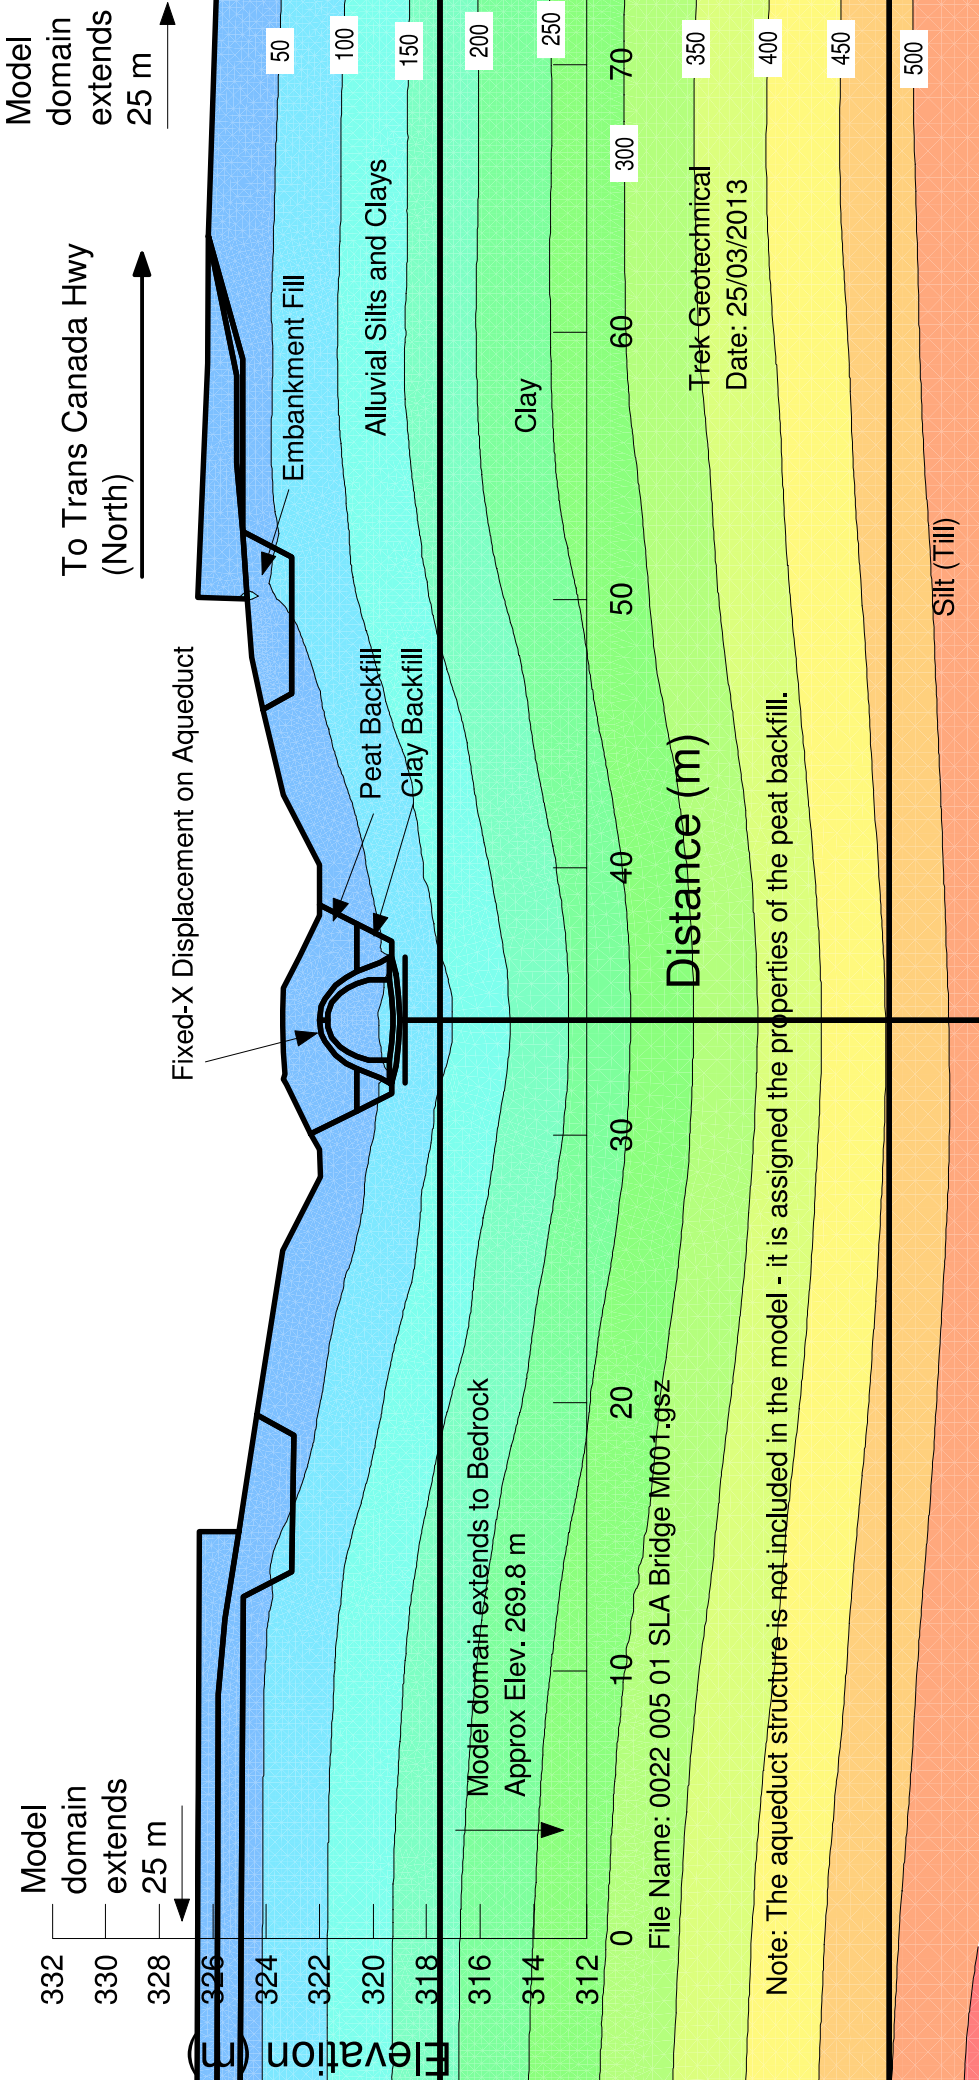
Name: Clay Effective Young's Modulus (E): 5000 kPa Poisson's Ratio: 0.4 Unit Weight: 19 kN/m<sup>3</sup>  
Name: Peat Backfill Effective Young's Modulus (E): 200 kPa Poisson's Ratio: 0.4 Unit Weight: 14 kN/m<sup>3</sup>  
Name: Clay Backfill Effective Young's Modulus (E): 5000 kPa Poisson's Ratio: 0.4 Unit Weight: 19 kN/m<sup>3</sup>  
Name: Embankment Fill Effective Young's Modulus (E): 40000 kPa Poisson's Ratio: 0.3 Unit Weight: 21 kN/m<sup>3</sup>  
Name: Alluvial Silts and Clays Effective Young's Modulus (E): 15000 kPa Poisson's Ratio: 0.4 Unit Weight: 20.5 kN/m<sup>3</sup>  
Name: Silt (Till) Effective Young's Modulus (E): 100000 kPa Poisson's Ratio: 0.4 Unit Weight: 19 kN/m<sup>3</sup>

Type: Y-Effective Stress kPa  
Starting Contour Value: 0kPa  
Increment by: 50kPa

**0022 005 01**  
**Dillon Consulting Ltd.**  
**City of Winnipeg Shoal Lake Aqueduct**  
**Proposed Bridge Crossing at Mile 93**  
**Load/Deformation**

Aqueduct crossing and Falcon River Diversion crossing based on the proposed bridge configuration. Stress-deformation analysis was also carried out at the Mile 93 crossing to quantify any associated stress changes and/or settlement at the Aqueduct structure.
