Project: **Windsor Park Golf Course**
 10 Des Meurons St., Winnipeg, MB.
 Drawing Title: **Renovation Plan - Holes No. 2, 4 & 5**

Notes: **Bid Opportunity 511-2016**

Drawing No.: **L1**

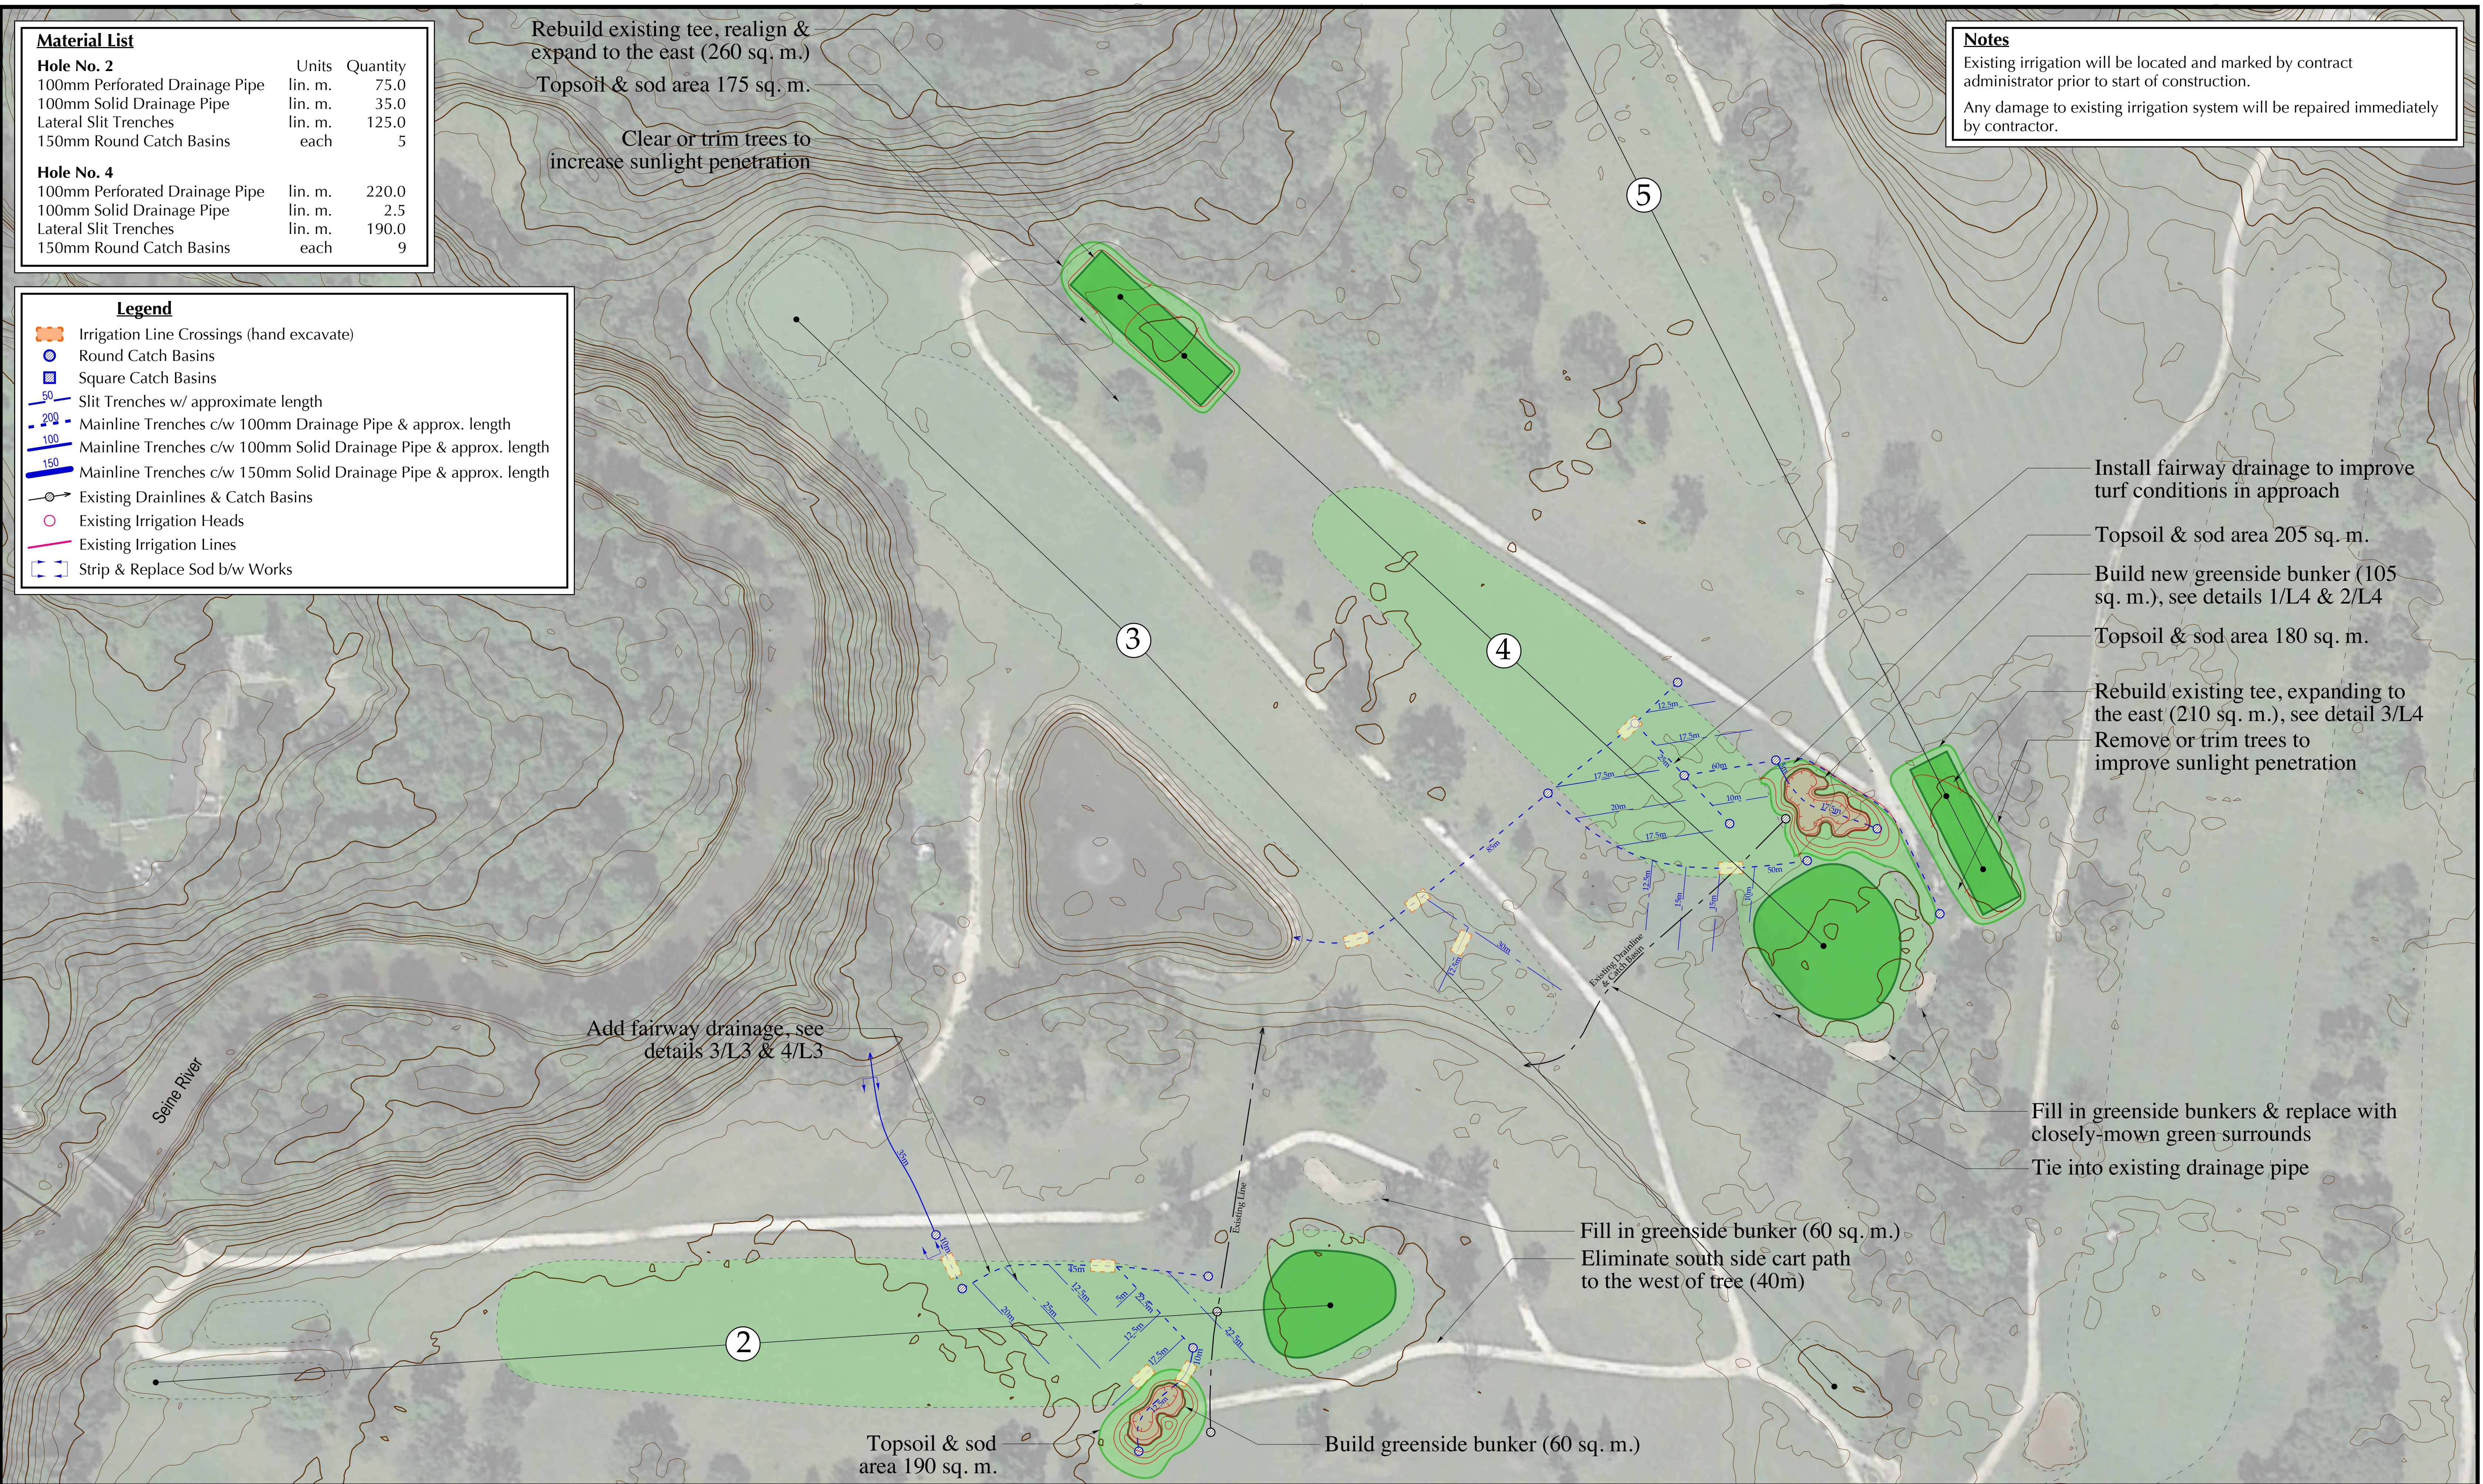
Material List		
Hole No.	Units	Quantity
Hole No. 2	100mm Perforated Drainage Pipe	lin. m. 75.0
	100mm Solid Drainage Pipe	lin. m. 35.0
	Lateral Slit Trenches	lin. m. 125.0
	150mm Round Catch Basins	each 5
Hole No. 4	100mm Perforated Drainage Pipe	lin. m. 220.0
	100mm Solid Drainage Pipe	lin. m. 2.5
	Lateral Slit Trenches	lin. m. 190.0
	150mm Round Catch Basins	each 9

Rebuild existing tee, realign & expand to the east (260 sq. m.)
 Topsoil & sod area 175 sq. m.
 Clear or trim trees to increase sunlight penetration
