Project: **Windsor Park Golf Course**
 10 Des Meurons St., Winnipeg, MB.
 Drawing Title: **Renovation Plan - Holes No. 14 & 15**

Notes: **Bid Opportunity 511-2016**

Drawing No.: **L2**

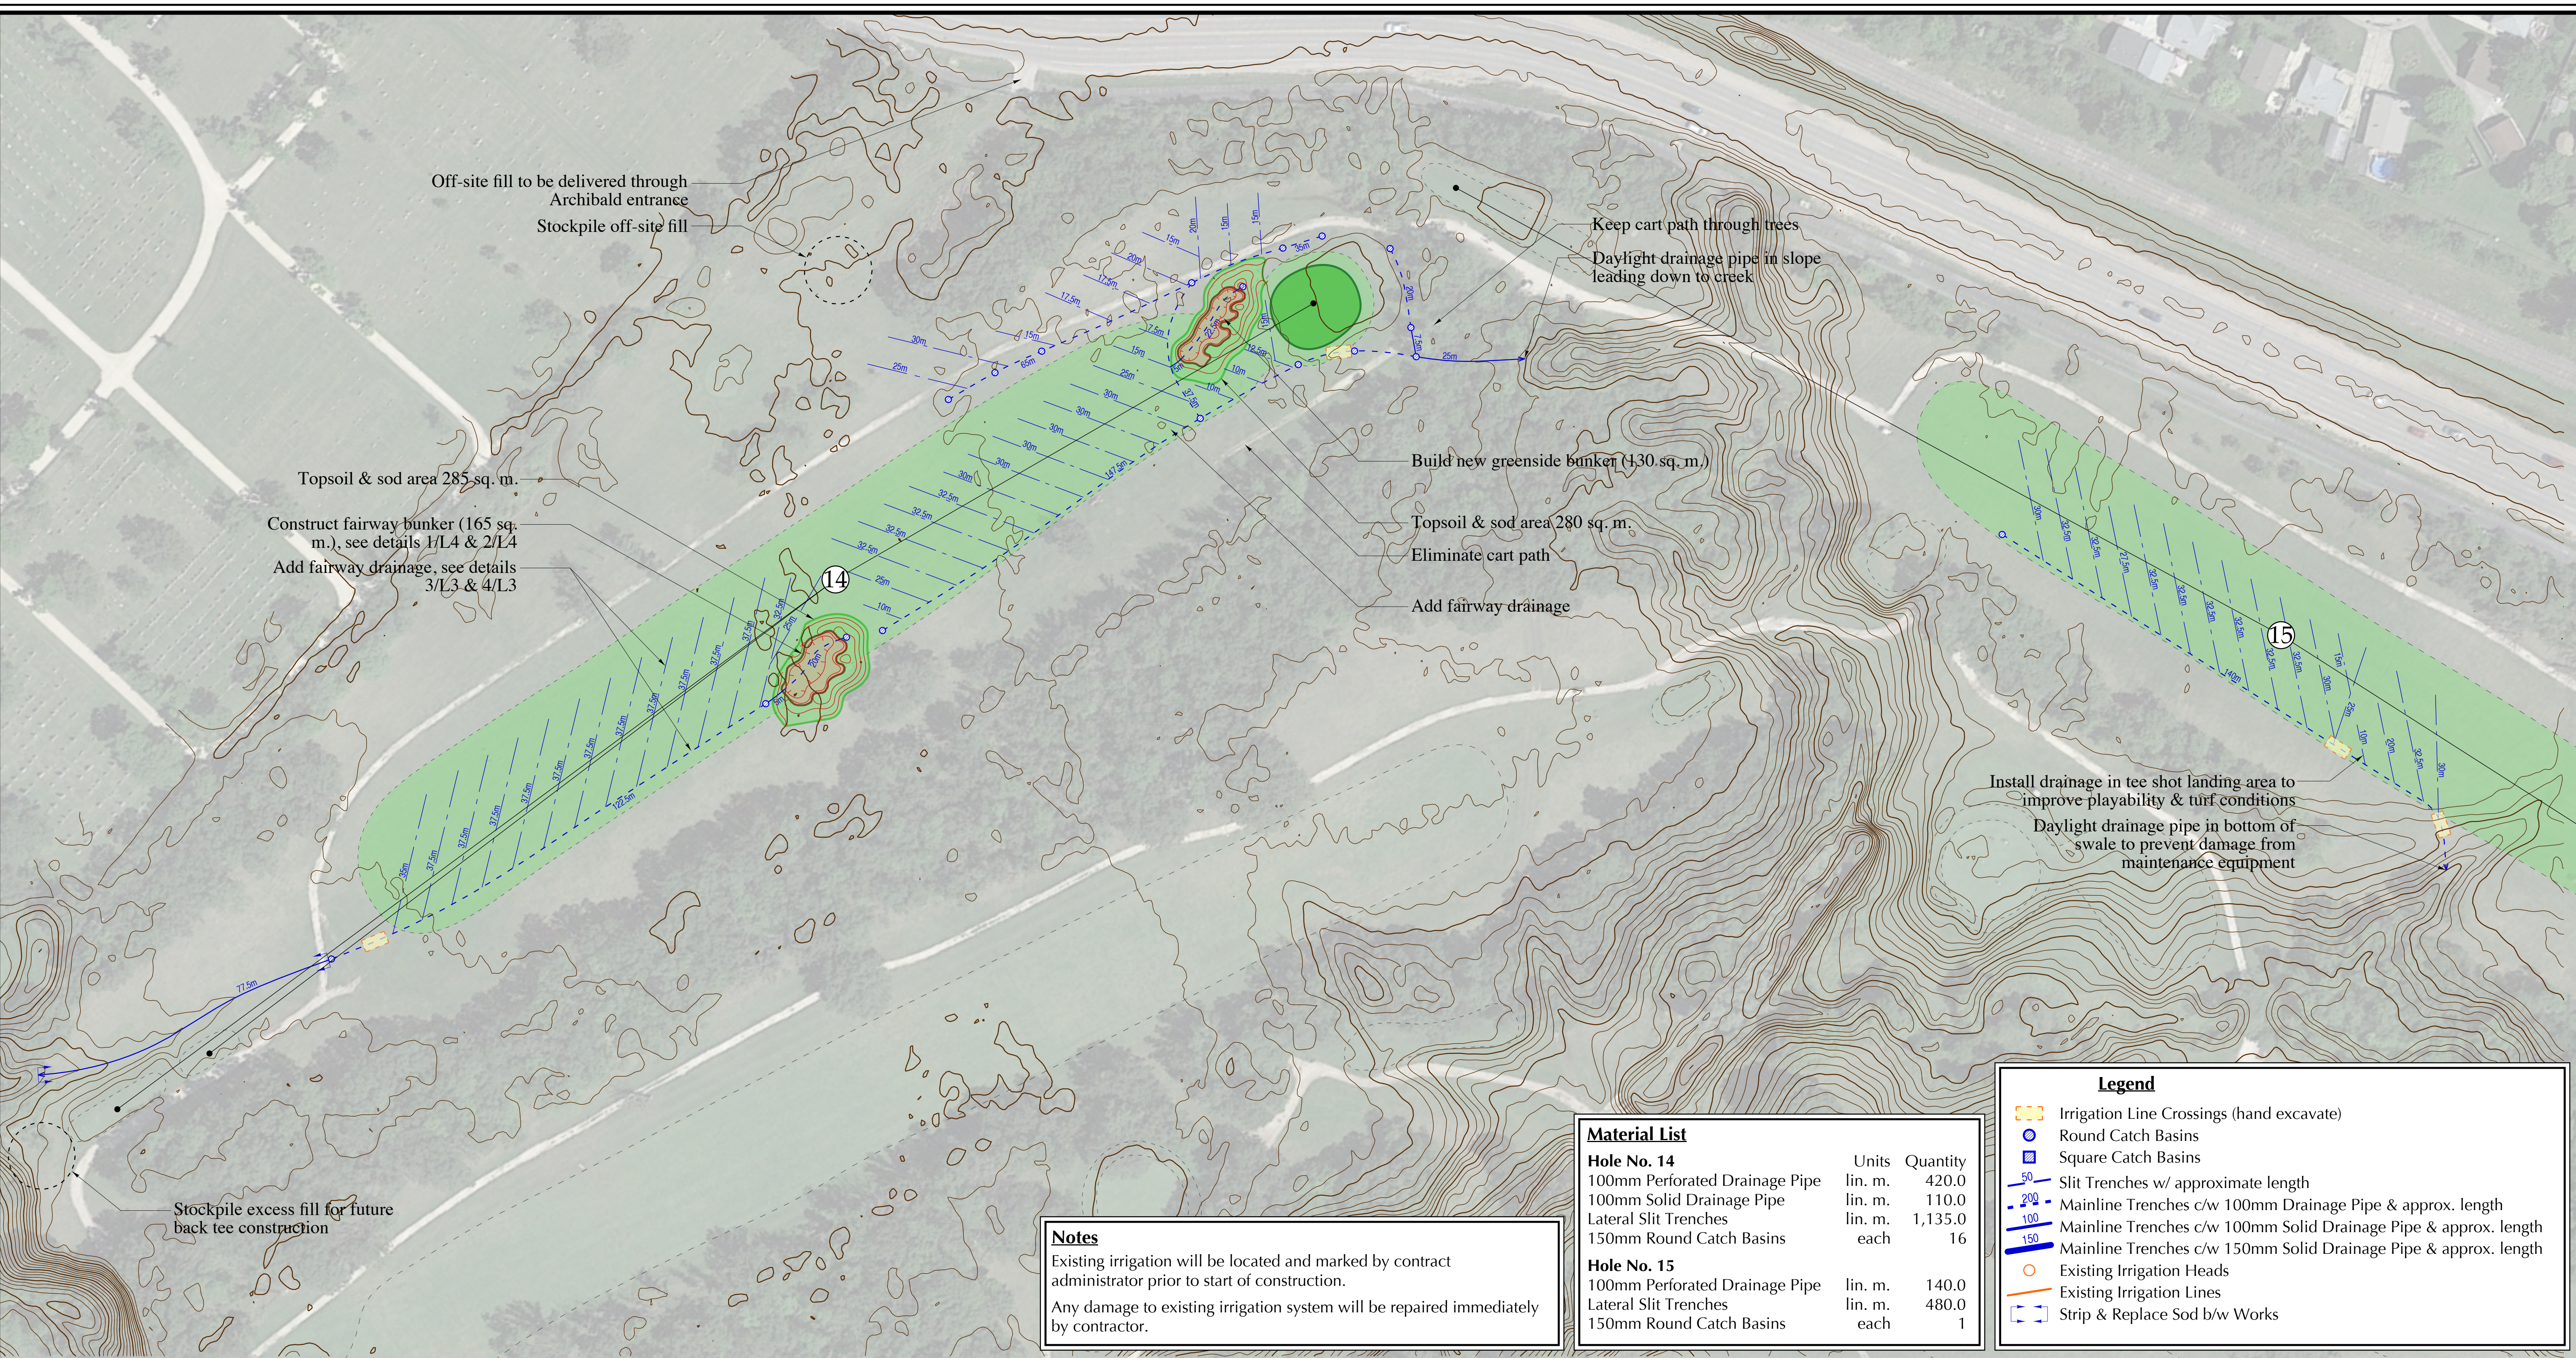
Notes
 Existing irrigation will be located and marked by contract administrator prior to start of construction.
 Any damage to existing irrigation system will be repaired immediately by contractor.
