Outfall Asset Number: S-MA70028480 - 29.87m

Location: 3564 PEMBINA HWY

Drawing: 141

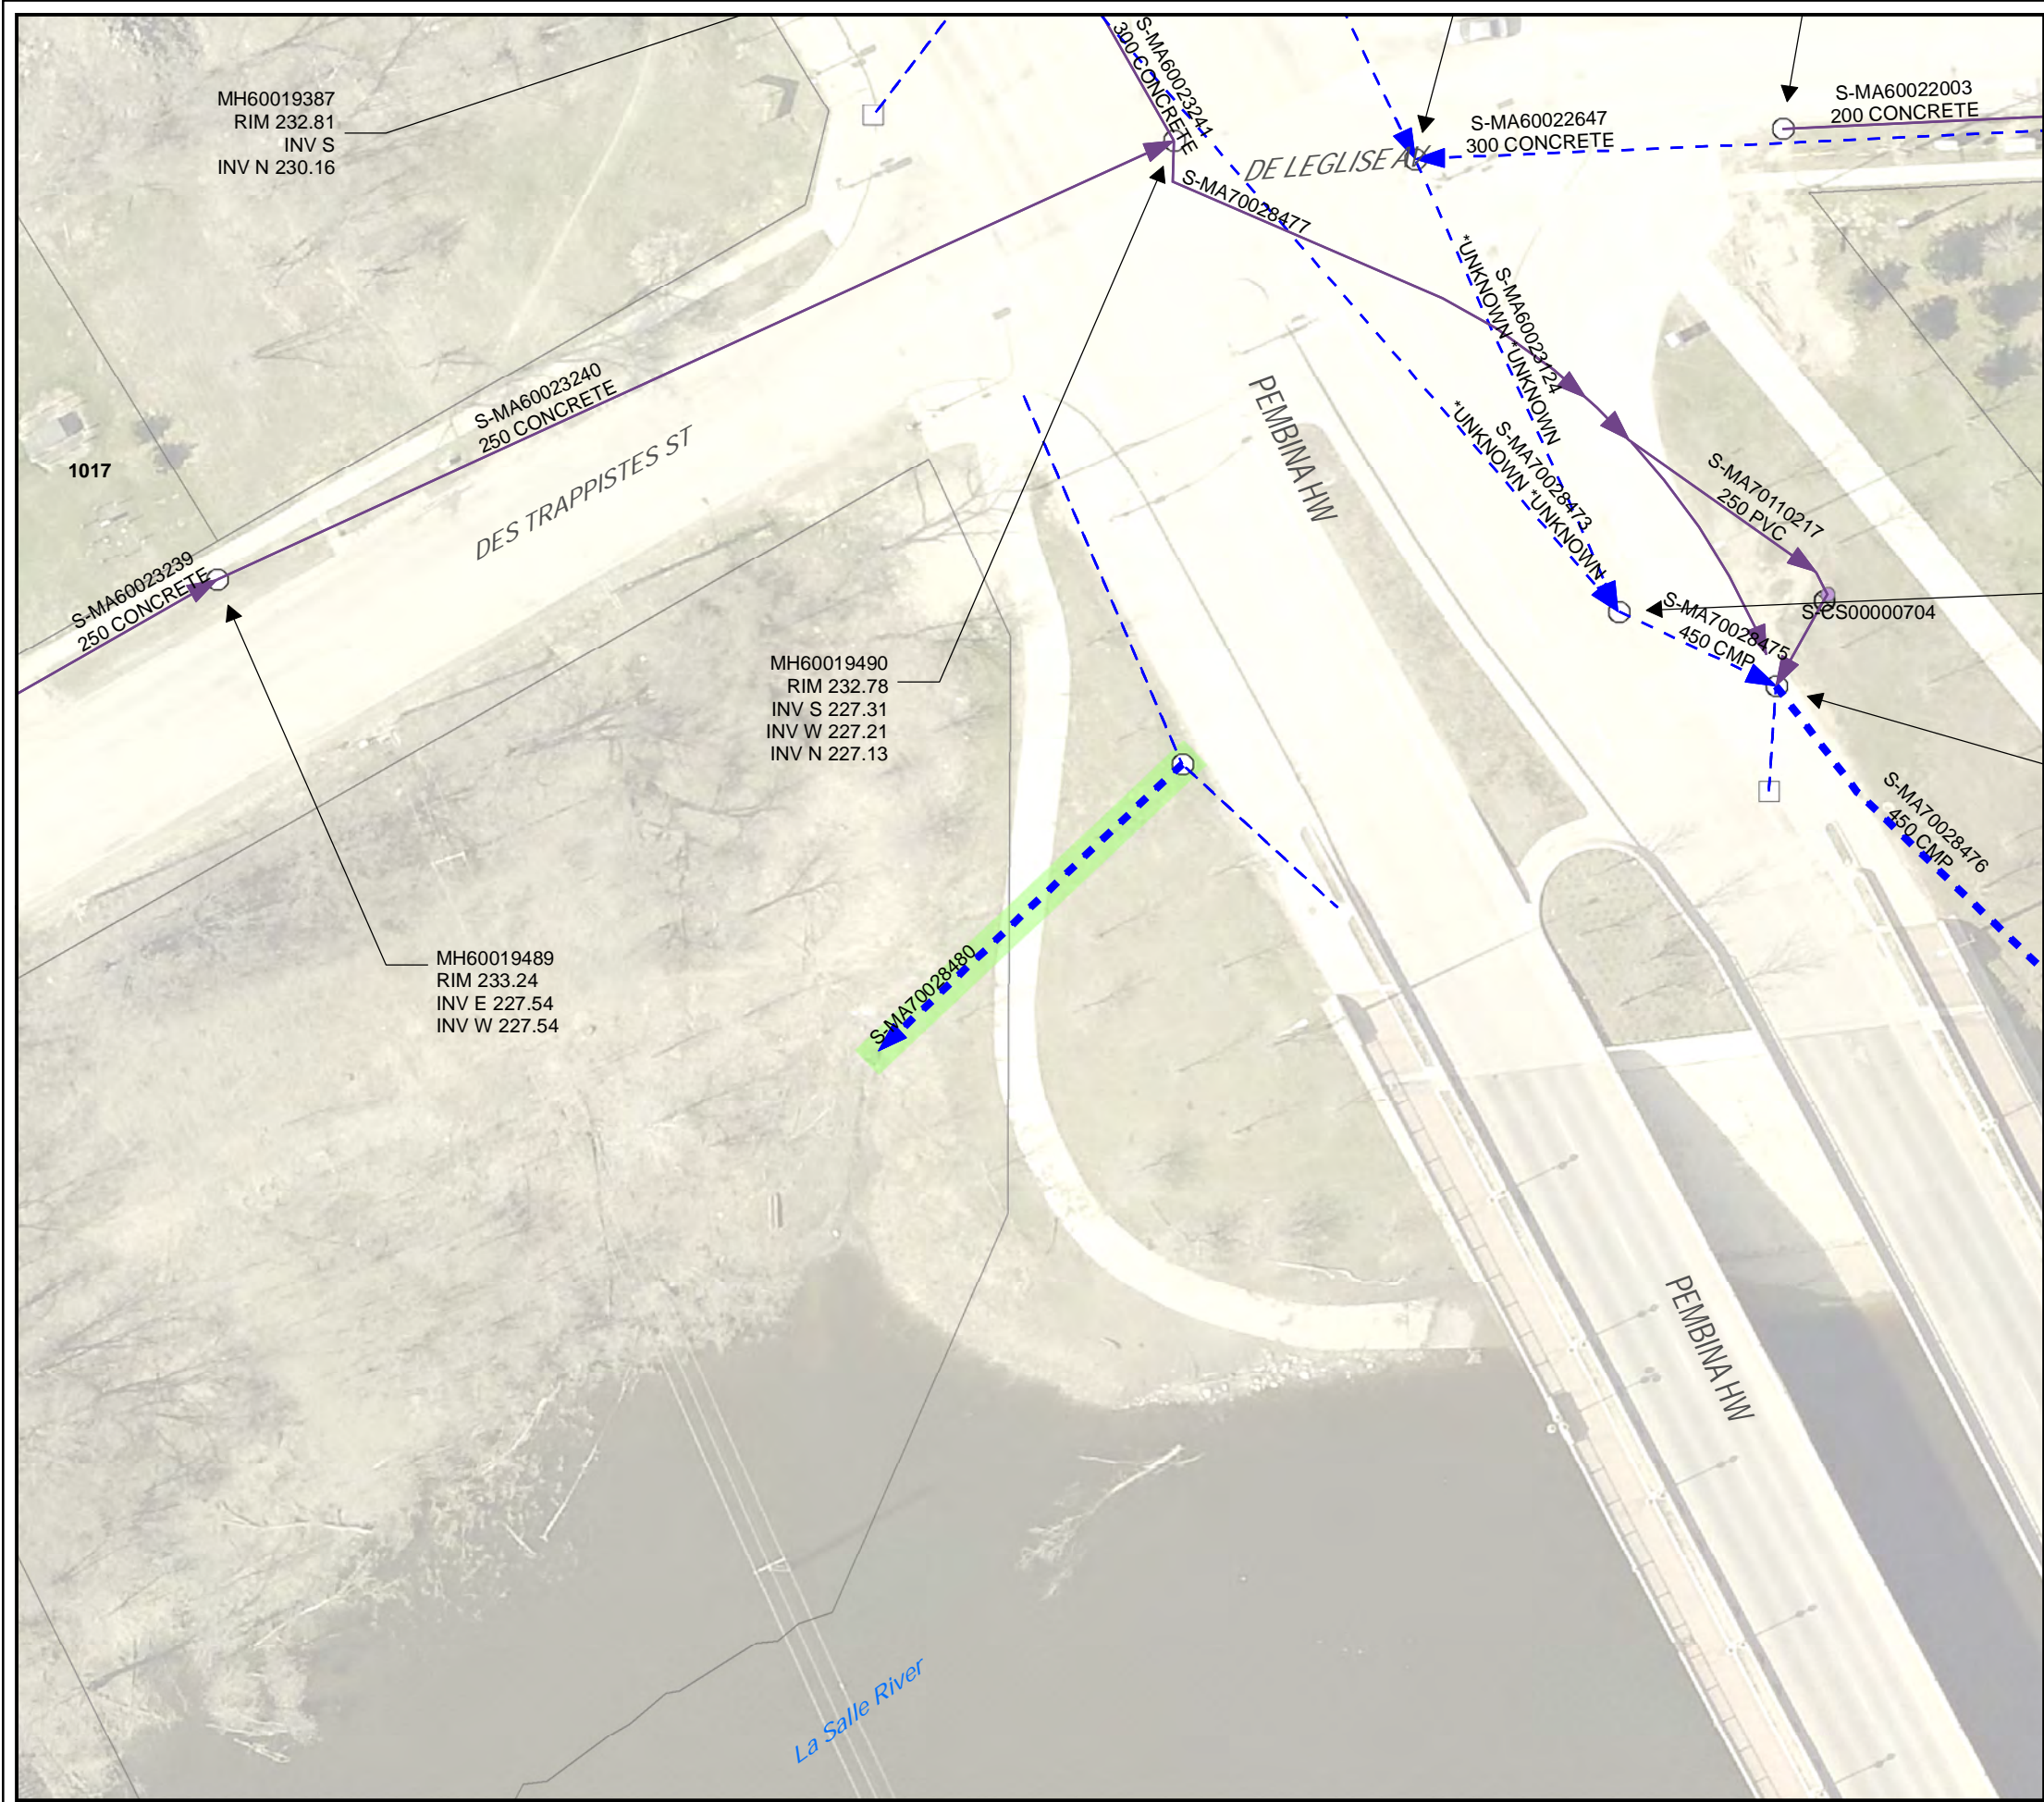
Sonar Required

Upstream Sewer Asset Number: None - 0m

Upstream Manhole Coordinates: 633002.9618E, 5514056.2598N
