**Cockburn and Calrossie  
Combined Sewer Relief Works  
C5 –Taylor Ave Trunk Sewer  
Geotechnical Baseline Report**

**KGS Group 11-0107-18  
November 2017  
Final**

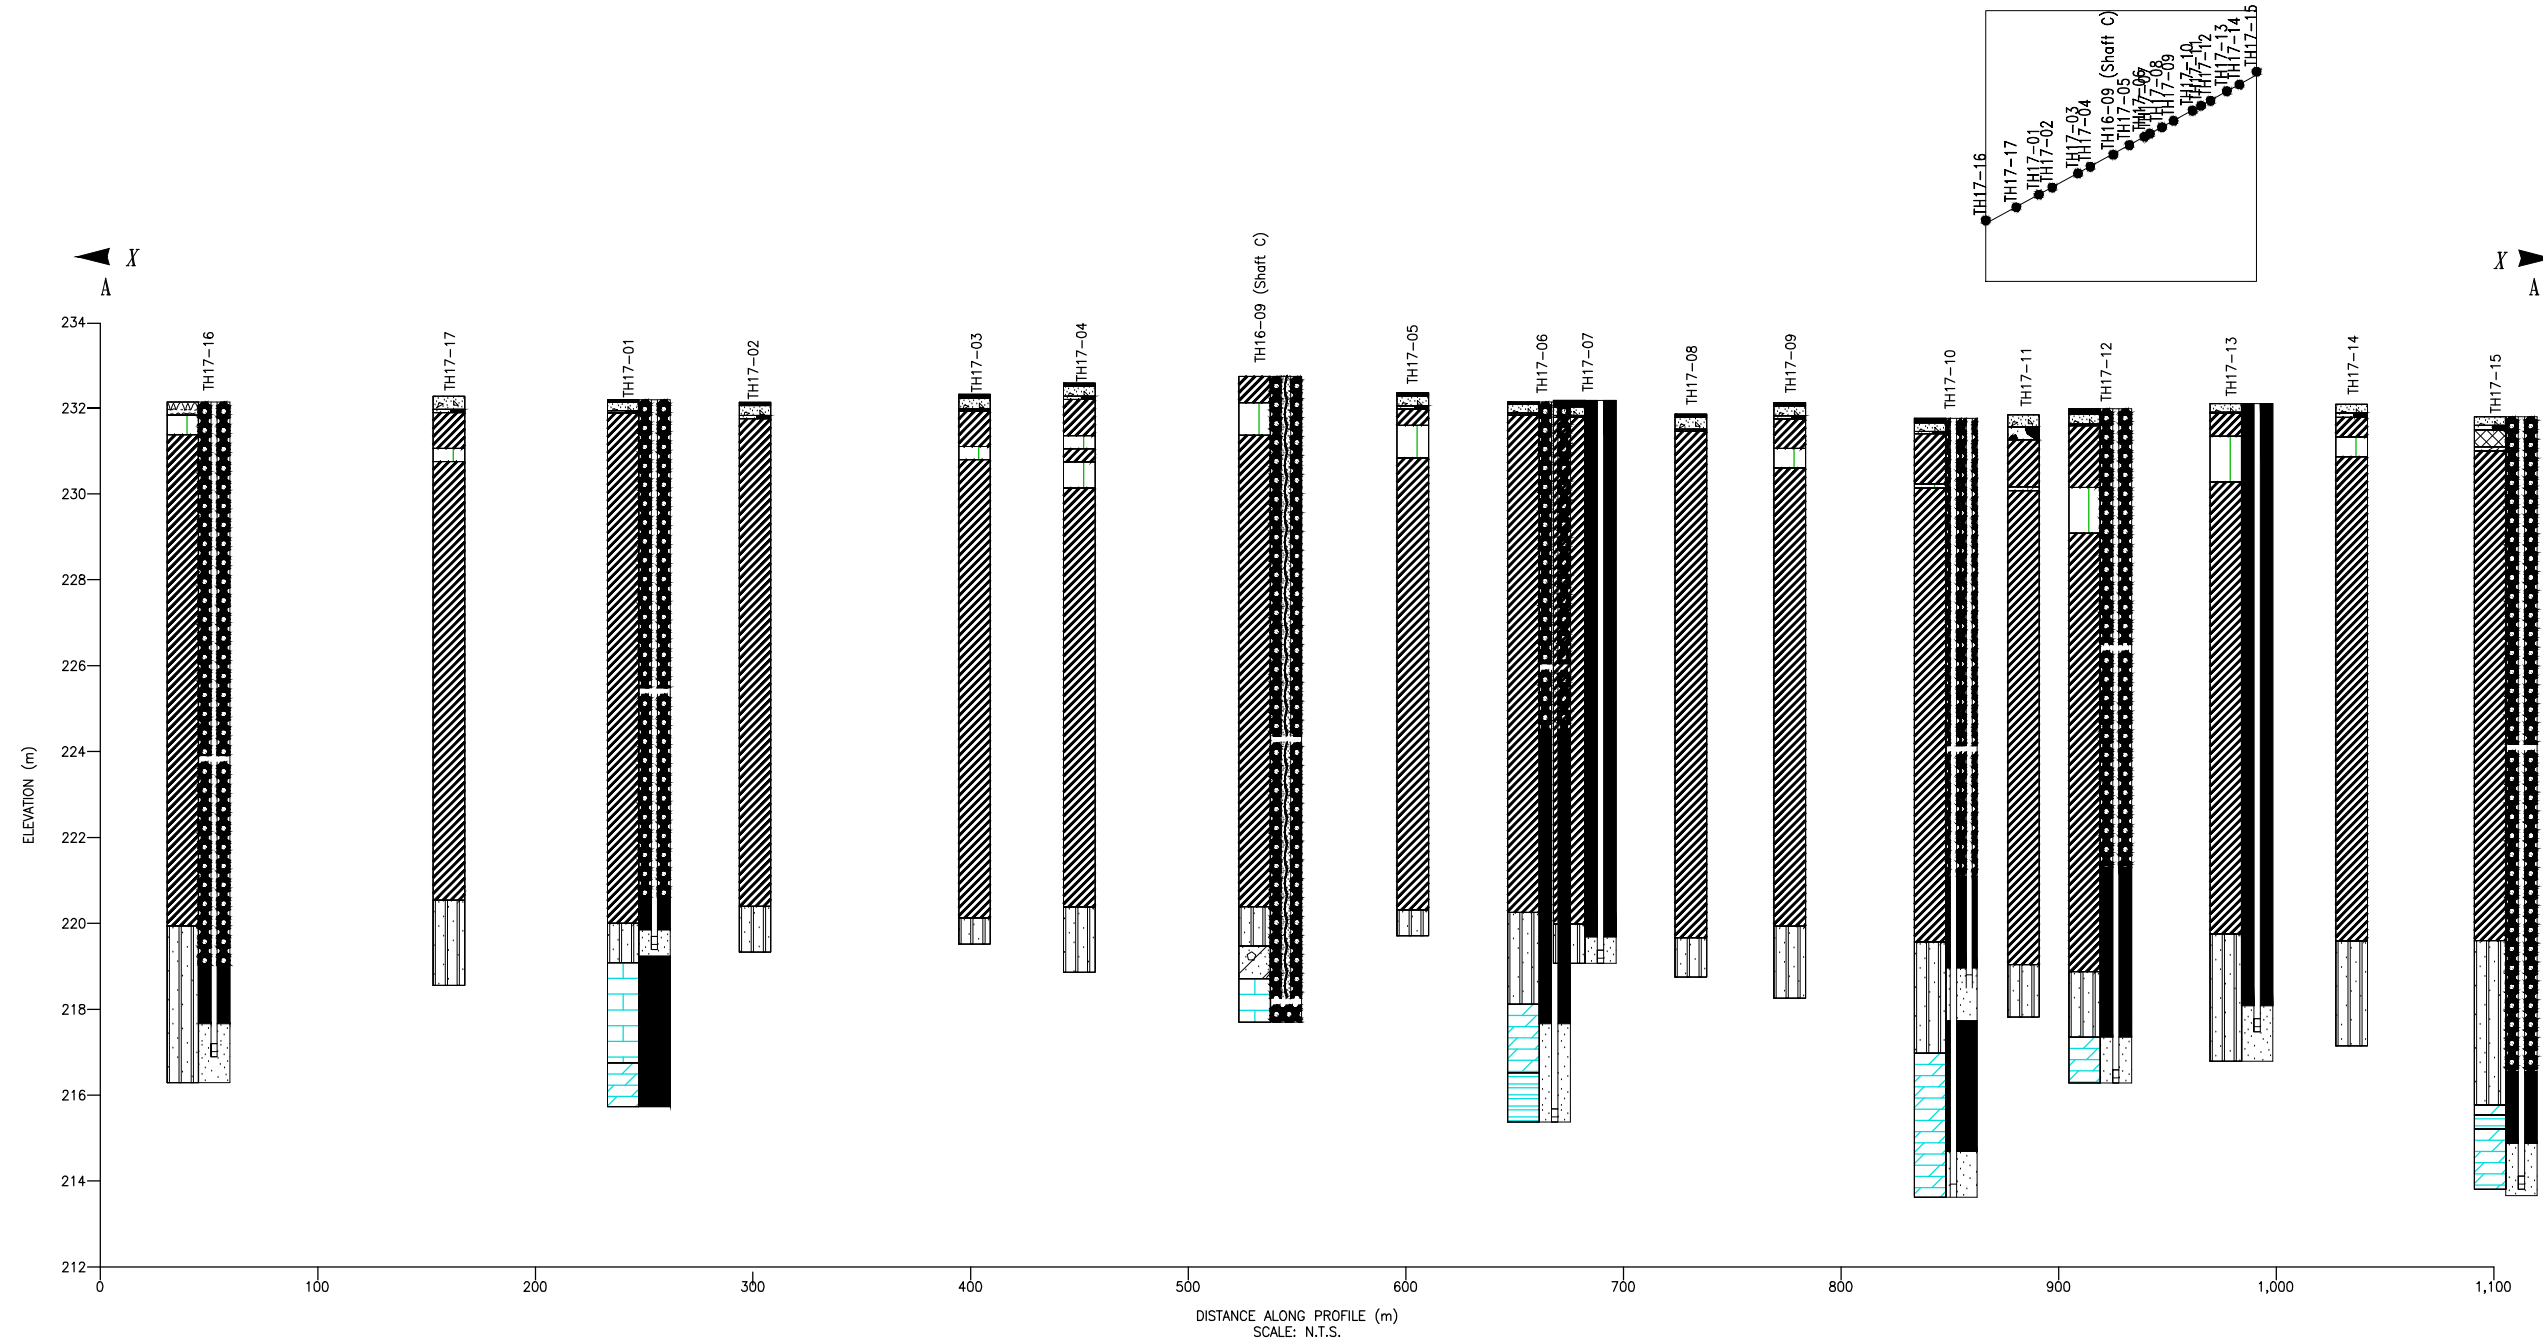
0	17/11/01	ISSUED WITH FINAL REPORT	JRM	DAA
NO.		DESCRIPTION	DESIGN BY	DESIGN CHECK
REVISIONS / ISSUE				
<b>KGS GROUP</b> CONSULTING ENGINEERS				
COCKBURN/CALROSSIE COMBINED SEWER RELIEF CONTRACT 5 WINNIPEG, MB				
STARTIGRAPHIC PROFILE 2016 AND 2017 INVESTIGATION				
NOVEMBER 2017		FIGURE 01		REV: 0

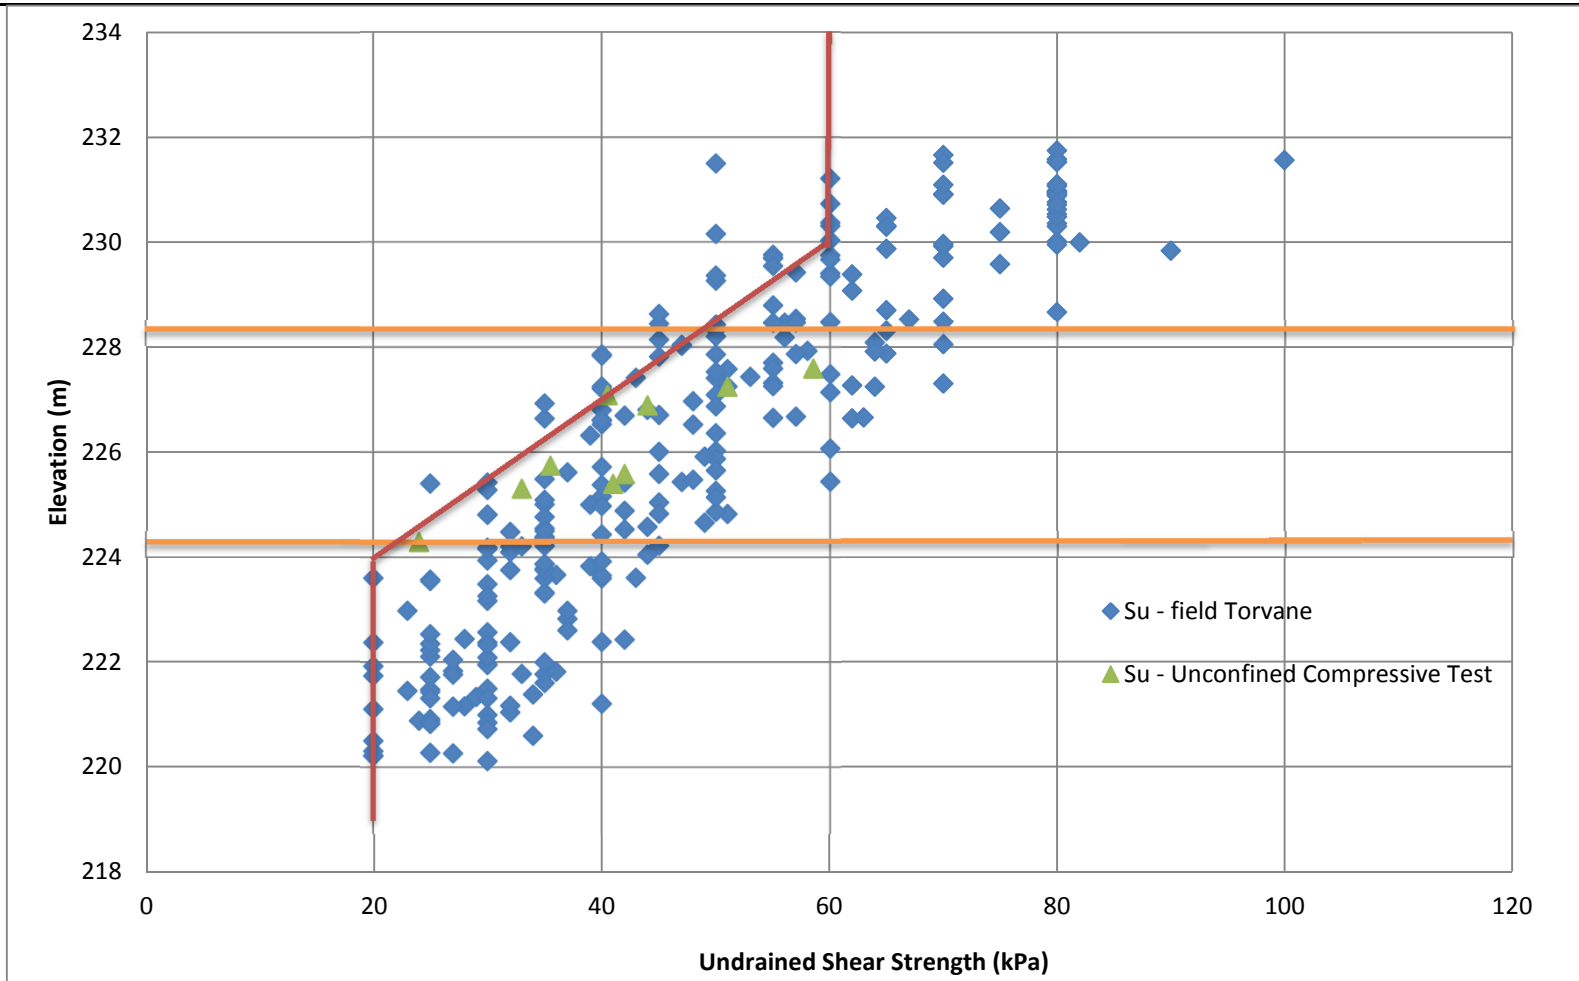
- Baseline undrained shear strengths
- Approximate tunnel elevation

<b>C5 - Cockburn/ Calrossie Combined Sewer Relief Project</b>		
<b>Geotechnical Baseline Report</b>		
Undrained Shear Strength of Clay Deposit versus Elevation		
November 2017	Figure 2	1 Rev

- For baseline purposes, the undrained shear strength of the clay deposit varies uniformly with depth from 60 kPa at El. 230 m to 20 kPa at El. 223 m. The undrained shear strength of the clay is 20 kPa below El. 223 m and 60 kPa above El. 230 m. These strengths are representative of clay at its natural moisture content. The measured undrained shear strengths and baseline undrained shear strengths are shown on Figure 2.
- The baseline effective shear strength parameters and permeability of each soil strata are outlined in Table 6.
- For baseline purposes, the average Liquid and Plastic limits of the clay are 92% and 25%, respectively. The variation of Plasticity Index with elevation is shown on Figure 3.

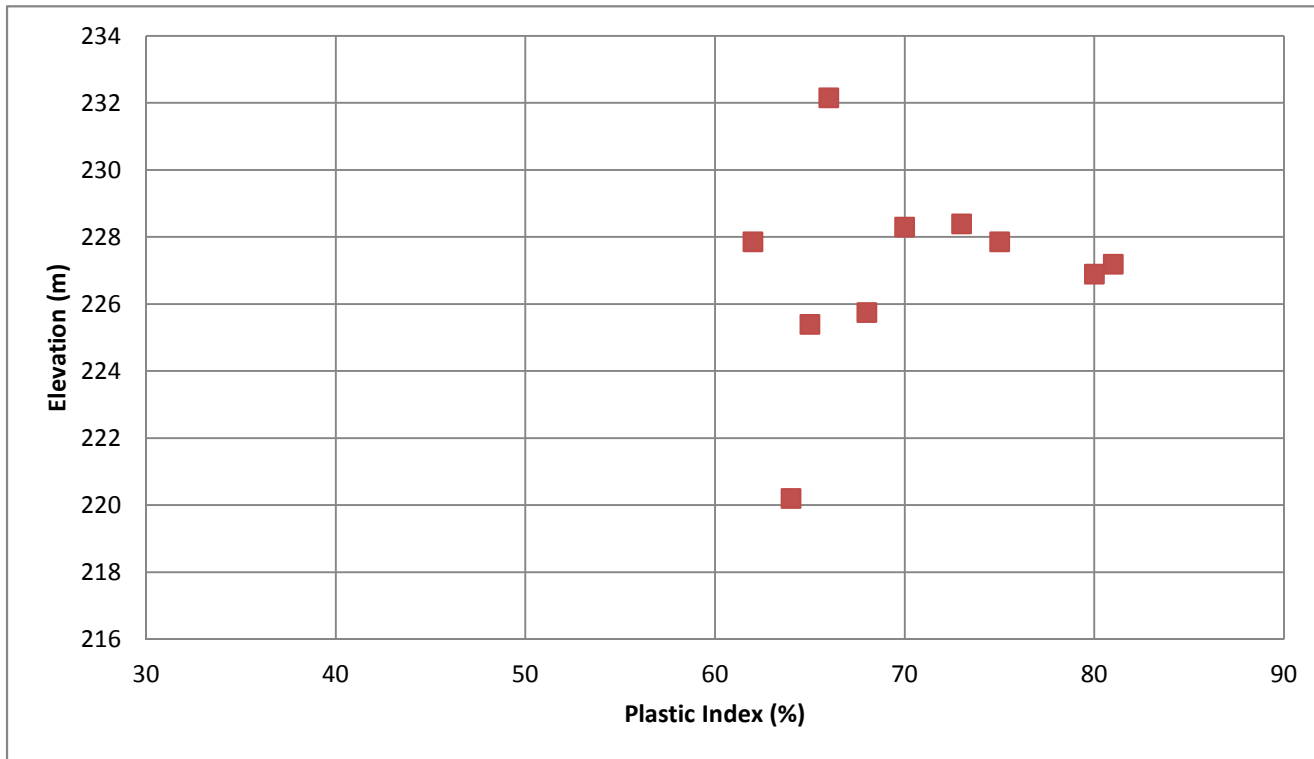
<b>C5 - Cockburn/ Calrossie Combined Sewer Relief Project</b>			
<b>Geotechnical Baseline Report</b>			
Plasticity Index of Clay Deposit versus Elevation			
November 2017	Figure 3	1 Rev

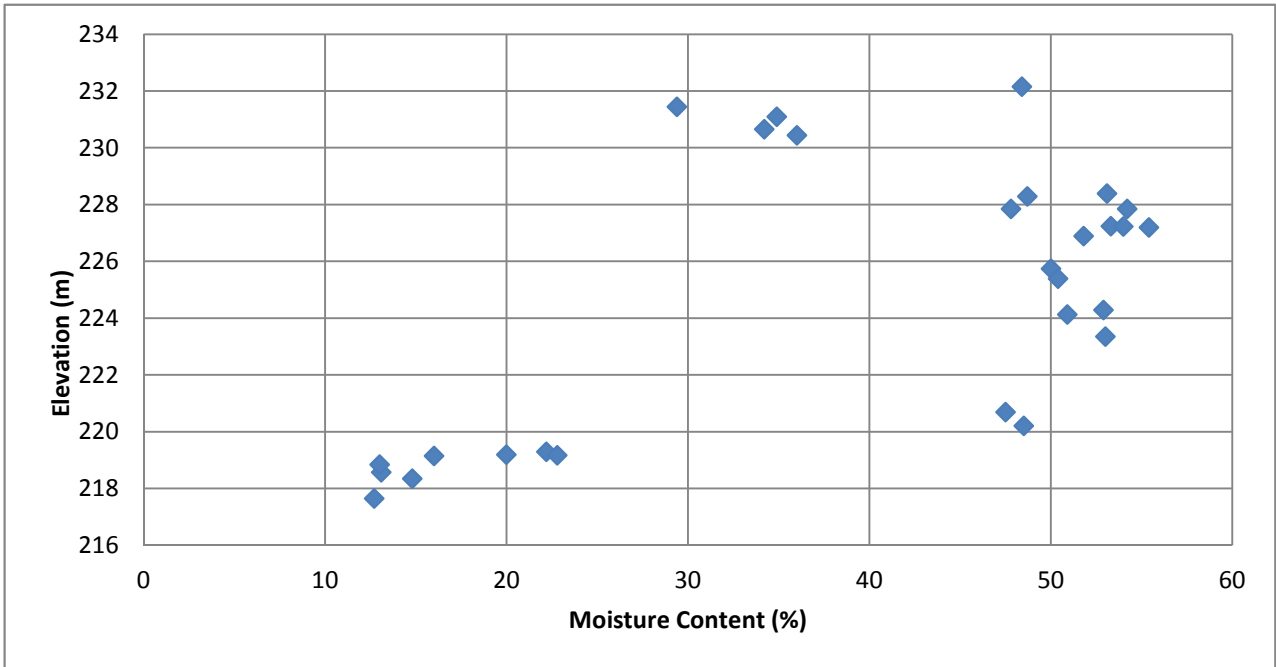
<b>C5 - Cockburn/ Calrossie Combined Sewer Relief Project</b>		
<b>Geotechnical Baseline Report</b>		
Moisture Content versus Elevation		
November 2017	Figure 4	1 Rev

present at the site has very high swelling potential. The variability of moisture content in the clay deposit with elevation is shown on Figure 4.

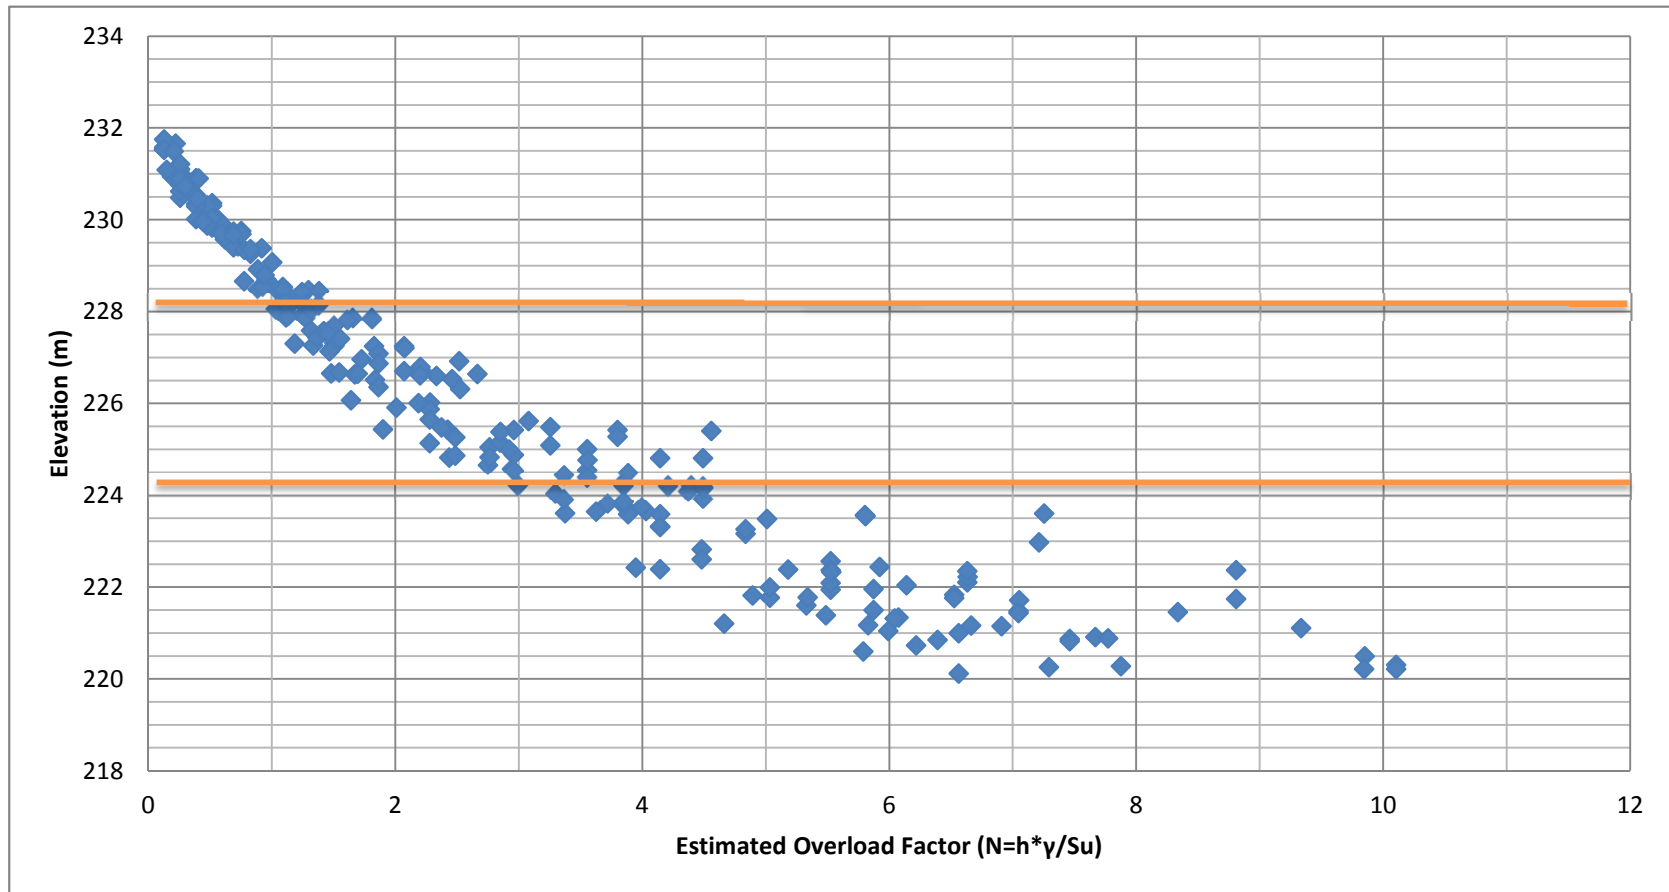
Figure 5

— Approximate tunnel elevation

where  $H$  is the depth to tunnel axis,  $\gamma$  is the soil unit weight, and  $S_U$  is the undrained shear strength of the ground prior to excavation. Field observations (Peck, 1969) show that  $N$  values ranging from 5 to 7 typically result in tunnelling difficulties and may cause tunnel face instability.

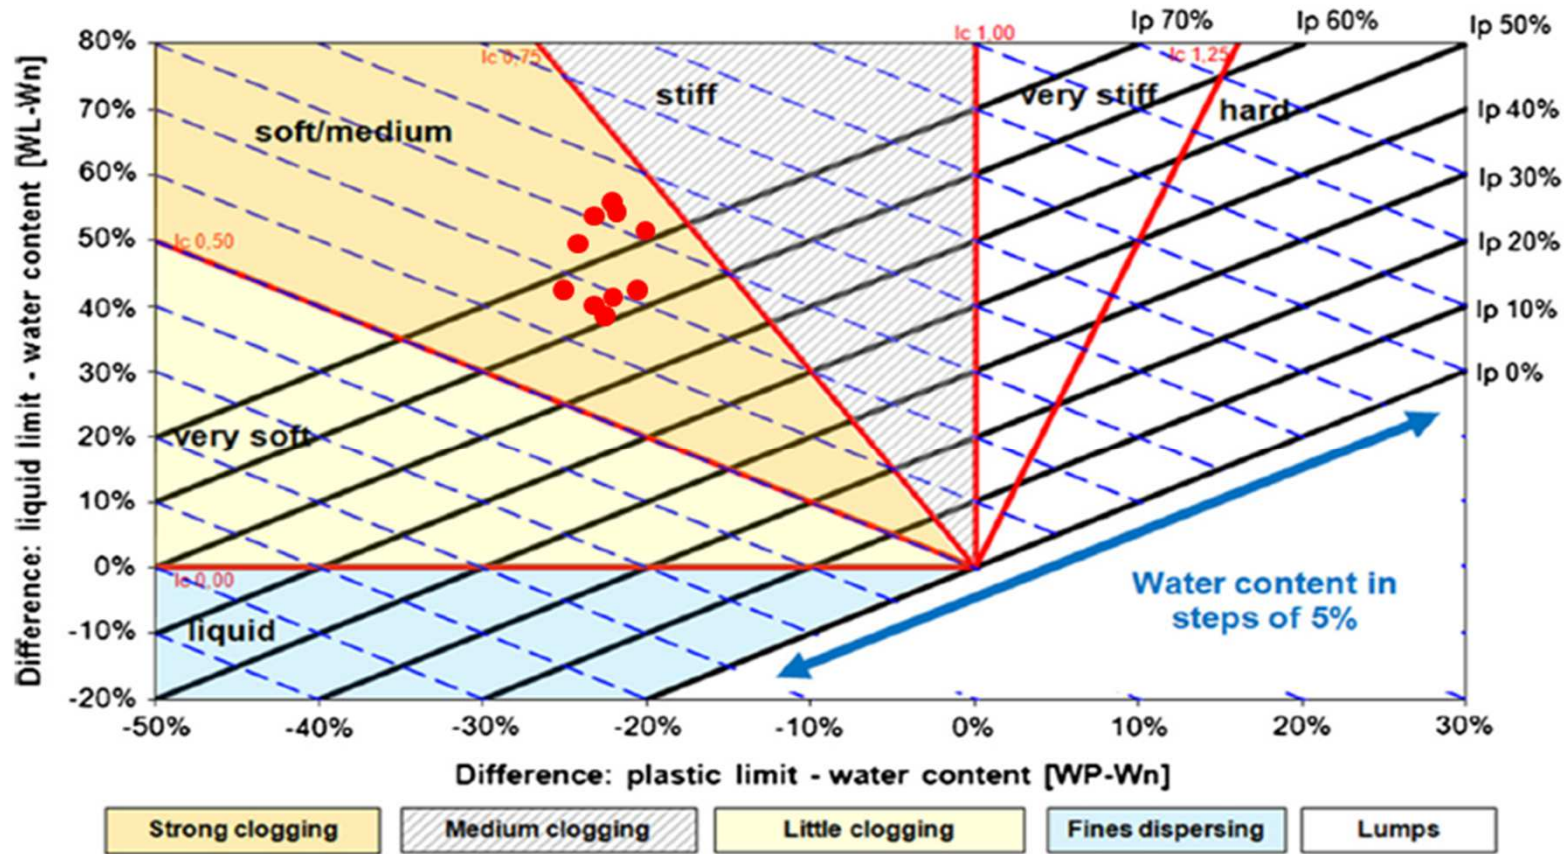
NOTES:  
Adapted from Hollmann and Thewes (2013)

<b>KGS</b> GROUP		
Cockburn/ Calrossie Combined Sewer Relief Project		
<b>Geotechnical Baseline Report</b>		
Clogging Potential of the Clay Deposit		
November 2017	Figure 6	1 Rev

The potential for clogging while tunnelling through the clay formation was evaluated using the chart suggested by Hollmann and Thewes (2013). Atterberg limits (Liquid limit, Plastic limit, and natural moisture content) of clay samples tested in the Laboratory and their Plasticity Indices were plotted on Figure 6 to determine the corresponding clogging potential of the clay. It should be noted that the Hollmann and Thewes chart (Figure 6) was developed from data collected from fluid supported shield drives but are assumed to be applicable to other tunnelling methods. For baseline purposes, the clay deposit at the site has high stickiness and strong clogging potential.
