**436 MAIN STREET
THE BANK OF BRITISH NORTH AMERICA**

Historical Buildings Committee

August 1982

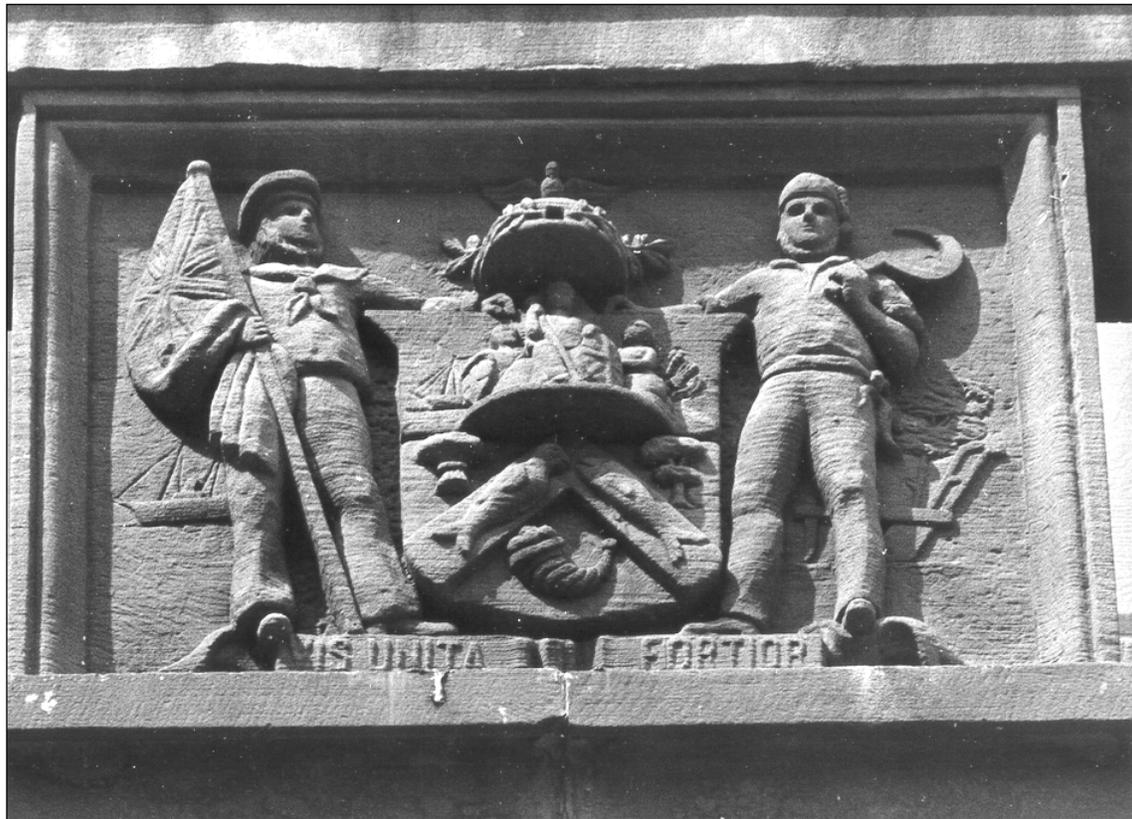
Plate 5 – Stone carving on main façade, 1969. (Courtesy of the Provincial Archives of Manitoba, Architectural Survey.)

An eye-catching façade graced the building's exterior. Constructed entirely of sandstone, the structure displayed a one-storey high rusticated base divided by huge Romanesque windows. On the north side, a protruding portico supported by two unfluted Doric pillars and capped by an entablature and pediment invited the attention of passersby. The upper storeys enhanced the building's appearance. A decorative balustrade divided the main floor from those above. At the second storey level, four unfluted Ionic columns ascended to an entablature bearing the institution's name. A huge pediment complete with coat-of-arms rose above and was topped by an ornamental balustrade. To pedestrians, the Bank of British North America presented an imposing appearance.
