**456 MAIN STREET
THE BANK OF TORONTO**

Historical Buildings Committee

August 1982

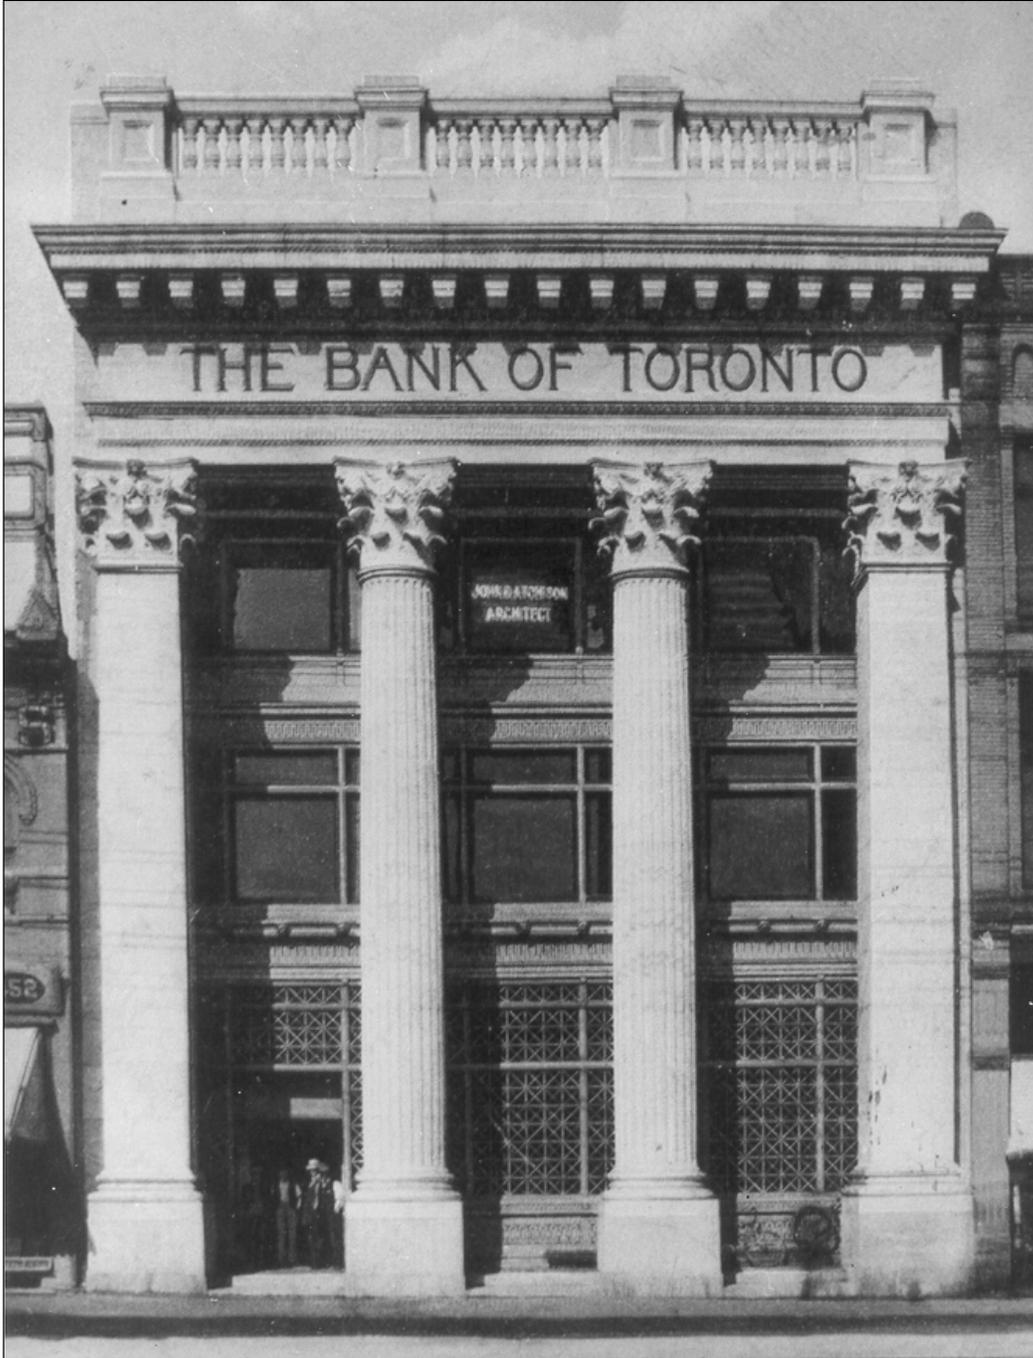
Plate 2 – Bank of Toronto, 456 Main Street, ca.1908. (Courtesy of the Provincial Archives of Manitoba.)

The choice of building materials singles out the Bank of Toronto's façade for attention. Stylistically, the building is indistinguishable from countless others in Canada's major cities. Four Corinthian columns rise from shoulder-high bases and are capped by a fourth storey entablature, cornice, and balustrade. But the white marble composition of these neo-classical components is unusual for Winnipeg. For an expenditure of \$36,240, bank directors purchased a solid marble colonnade, entablature and balustrade from the Blue Ridge Quarries in Georgia.⁷ To reduce weight, individual columns arrived in six sections which totalled forty tons when hoisted into place.⁸ Costly fenestration and ornamental cast-ironworks lay behind the colonnade and provided a vivid contrast to the white marble. Intricate iron designs for window perimeters added \$22,400 to the building's already substantial cost.⁹ Knowledgeable passersby were awed by the building's finery.

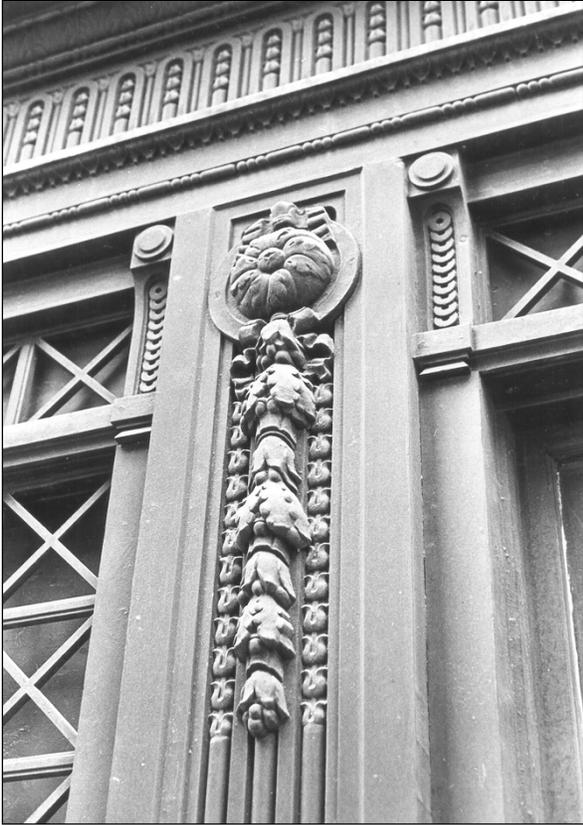
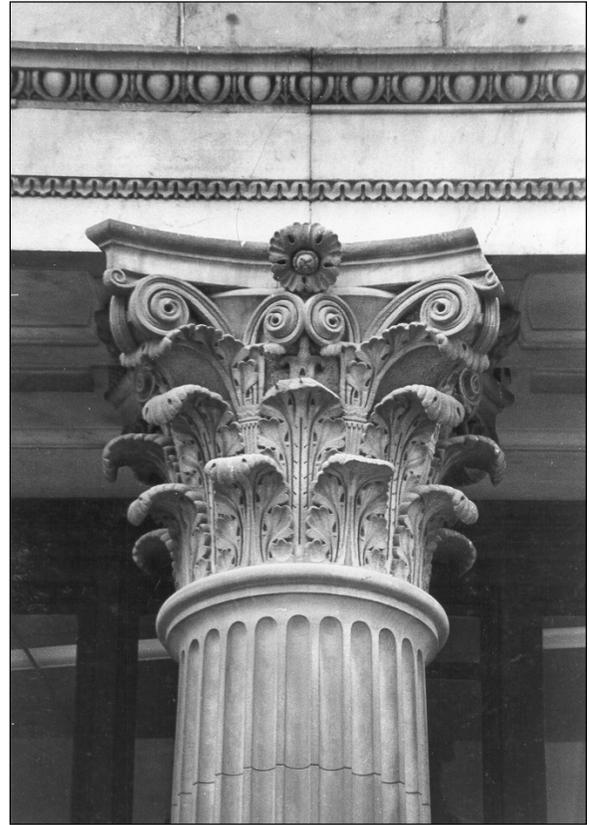
Plate 3 – Details of the exterior ornamentation, no date. (City of Winnipeg.)
