130 NASSAU STREET NORTH – ST. LUKE’S ANGLICAN CHURCH

Charles S. Bridgman, 1904 & 1909, Woodman & Carey, 1914

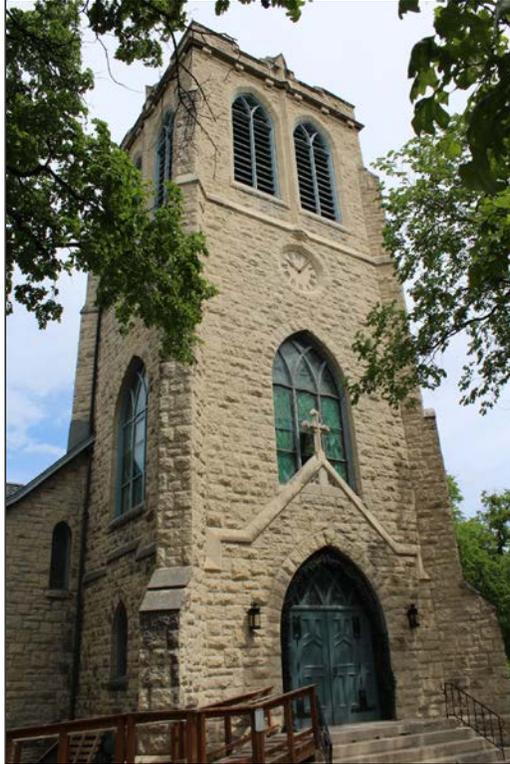
This large, well-designed stone church, was one of several built in the pre-World War I period on or near Nassau Street in Fort Rouge, representing most of the City's religions. St. Luke's Anglican, built on the northeast corner of Nassau Street North and Stradbroke Avenue, was begun in 1904, the front (west) entrance tower and rear extension were completed five years later and the large school building/Parish hall, known as the Church House, was built in 1914. The attention to detail, excellence of design and craftsmanship are evident throughout the exterior and interior.

The church features many elements of Modern or Late Gothic Revival style, popular for many City churches, including low symmetrical massing, monochromatic cladding, a tower, buttresses and pointed arched openings.

One of the most visible elements is the crenellated entrance tower with smooth stone accenting, buttresses, pointed arched openings, intersecting tracery, carved crosses and clocks on the north, south and west façades

Other highlights of the building's exterior include a large stained glass window with wood tracery in the east-facing gable end, numerous dormers on the north and south roof slopes with pointed arch stained glass windows and projecting entrances. The 1914 addition also boasts an ornate entrance at its southeast corner with carved stone signage, carved stone panels below the eaves, bell-cast hipped dormers on the north and south roof slopes and a crocketed copper pinnacle with rooster weather vane.

- Stone church with complex roof on the northeast corner of Nassau Street North and Stradbrook Avenue, its west facade facing Nassau Street North, its south facade facing Stradbrook Avenue, its east facade facing neighbouring buildings and its north facade facing a back lane;

- Its main (west) facade with centrally-placed crenellated tower with smooth stone accenting, buttresses, pointed arched openings, intersecting tracery, carved crosses and clocks on the north, south and west facades;

- The south facade with pointed arched openings, stone buttresses, gable dormers with stained glass panels, cross gables at the east end and projecting entrance west of the cross gable;

- The north facade with pointed arched openings, stone buttresses, gable dormers with stained glass panels, cross gable at the east end and projecting entrance and chimneys east of the cross gable;

- The east facade, partially hidden by the attached hall, with modest buttresses and a large pointed arch window with delicate tracery in the east-facing gable end; and

- The 1914 Church House built on the east end of the original building, with its large basement windows in rounded arch, smooth-cut stone openings on the north and south facades, wide pilasters, sets of four thin windows in rectilinear smooth-cut stone

openings, and the east facade with a one-storey portion, a projecting entrance with wide stone steps, projecting entrance in southeast corner, with carved stone ribbon with the words “ST. LUKE’S CHURCH HOUSE A.D. 1914” inscribed, roof overhang with carved stone panels and the bell-cast hipped roof with bell-cast hipped dormers on the north and south slopes and a crocketed copper pinnacle with rooster weather vane.
