# **GEOTECHNICAL REPORT**

# GEOTECHNICAL INVESTIGATION RESIDENTIAL STREETS RECONSTRUCTION WINNIPEG, MANITOBA

21 January 2015

Amec Foster Wheeler File No. WX17565R1

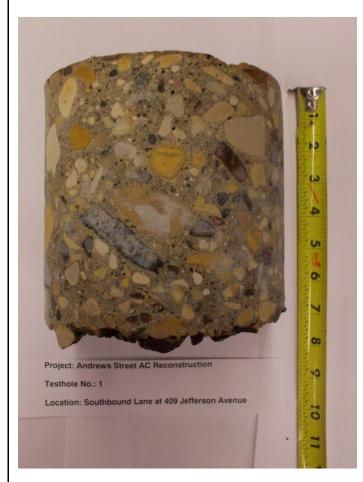
**Photo 1:** TH01: Southbound lane at 409 Jefferson Avenue, 1.0 m from curb

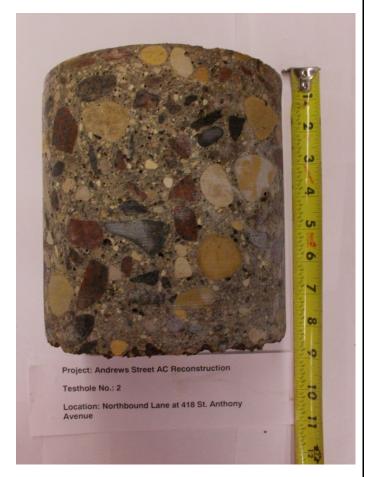
**Photo 2:** TH02: Northbound lane at 418 St. Anthony Avenue, 1.0 m from curb

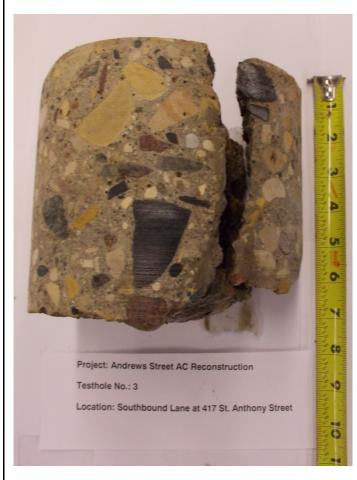
**Photo 3:** TH03: Southbound lane at 417 St. Anthony Street, 1.0 m from curb

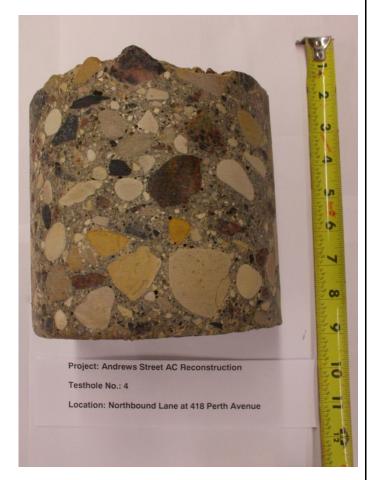
**Photo 4:** TH04: Northbound lane at 418 Perth Avenue, 1.0 m from curb

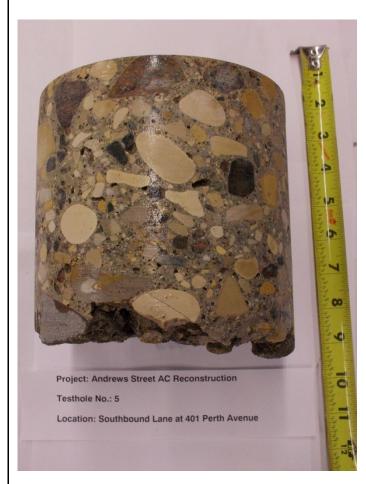
**Photo 5:** TH05: Southbound lane at 401 Perth Avenue, 1.0 m from curb

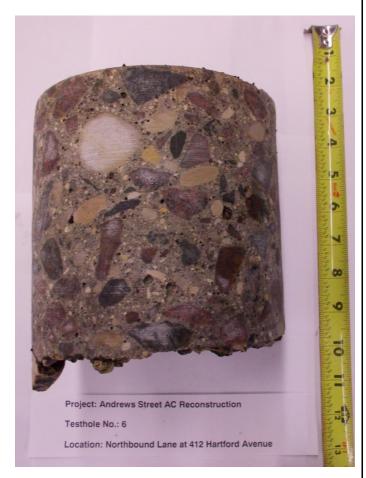
**Photo 6:** TH06: Northbound lane at 412 Hartford Avenue, 1.0 m from curb
